RE: Closure Report for Oxy USA – Cypress 34 Federal #10H Burial Trench
API #30-015-43076, Pit Permit #P2-13-0028

On behalf of Murchison Oil and Gas, R.T. Hicks Consultants submits this closure report for the above-referenced burial trench in accordance with the approved C-144 closure plan. This report includes the following information listed in Part 21 of the C-144 form:

RE: Closure Notice Oxy USA Cypress 34 Federal 10H Burial Trench
SHL Sec 34 T23S R29E,

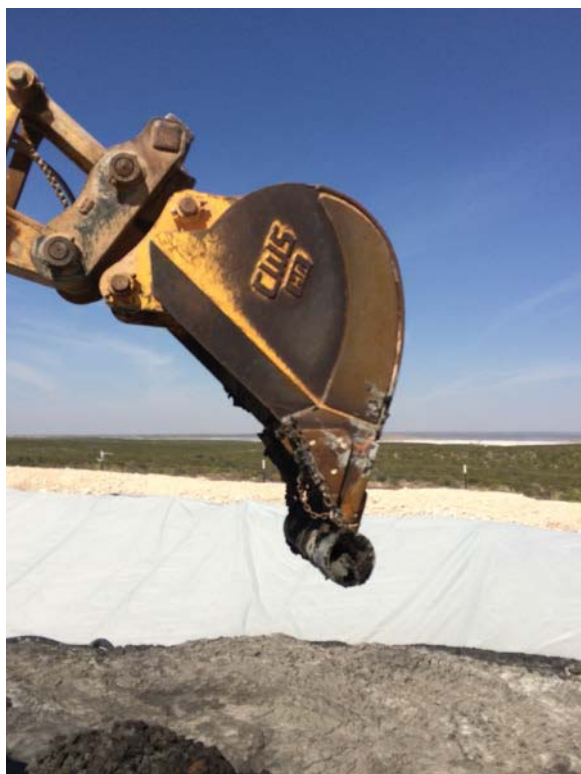
Figure 1 – Track hoe bucket with teeth covered by poly pipe to minimize the potential of ripping the liner.

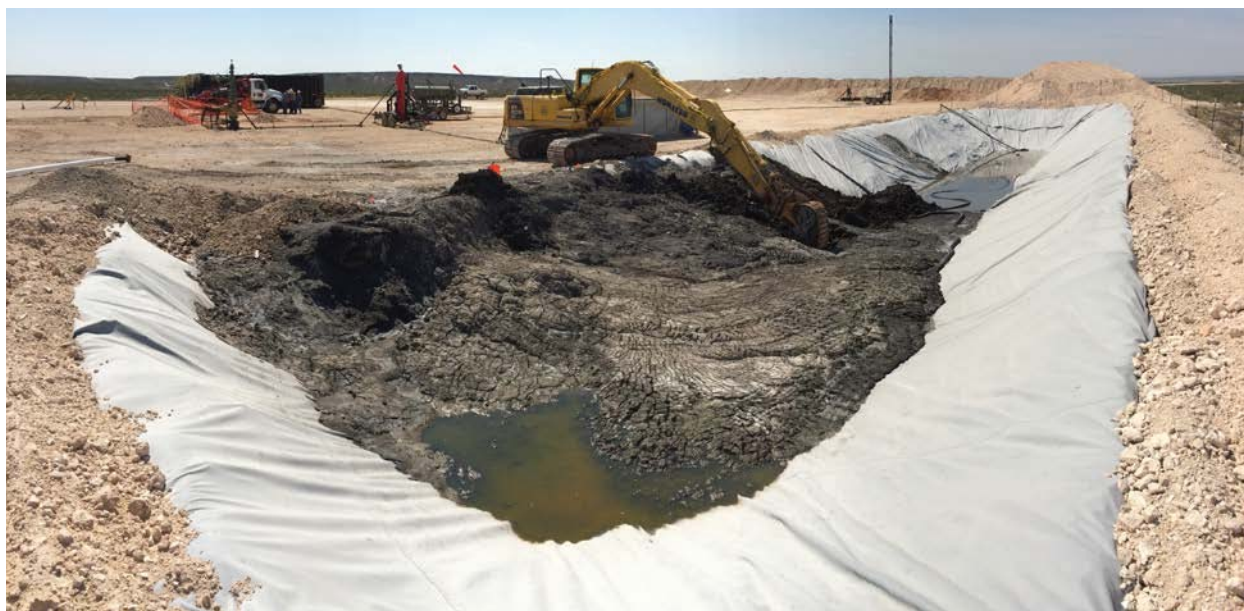
Figure 2 – Photo shows excavation of the second of five sampling trenches. A representative sample of each trench was extracted by scraping the edge of each trench with the bucket. The material was piled on the edge of the pit and Mr. Hicks obtained two composite/representative samples from each pile and placed them in an orange or blue 5-gallon bucket. The final composite sample was a mixture of each bucket.

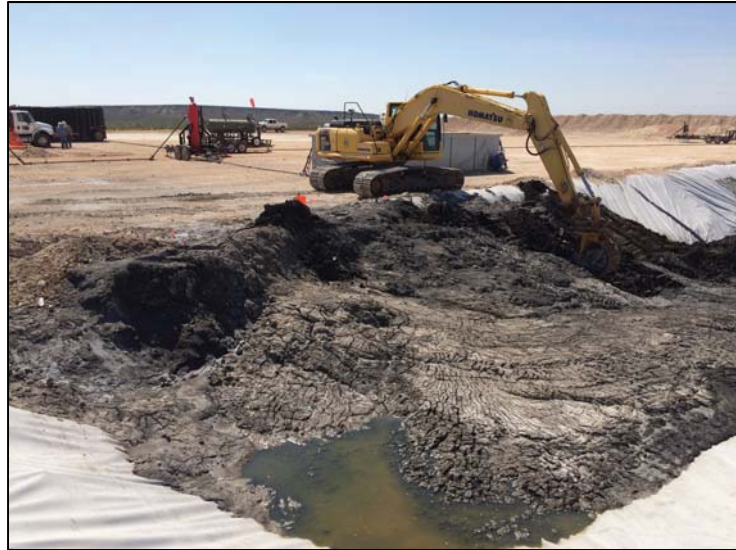
9/30/2015 Sampling

On September 3, 2015, a composite sample of the clean soil of the berms (beneath the liner) of the trench was collected for laboratory analysis. In accordance with the Pit Rule, on September 30, 2015, a 5-point composite sample of the cuttings was collected from the trench using a trackhoe. Both composite samples were analyzed at Hall Environmental Analysis Laboratory in Albuquerque for BTEX (8021B), GRO+DRO (8015M/D), TPH GRO+DRO+MRO (8015M/D), and Chloride (300.0).

These component samples were used to determine a calculated concentration for the “3:1 stabilized cuttings” by mathematically combining 1 part pit contents and 3 parts clean soil (mixing dirt). As shown in the table below, laboratory analyses of the component samples and the calculation of the “3:1 Stabilized Cuttings” concentration “demonstrate that, after the waste is solidified or stabilized with soil or other non-waste material at a ratio of no more than 3:1 soil or other non-waste material to waste, the concentration of any contaminant in the stabilized waste is not higher than the parameters listed in Table II of 19.15.17.13 NMAC.”

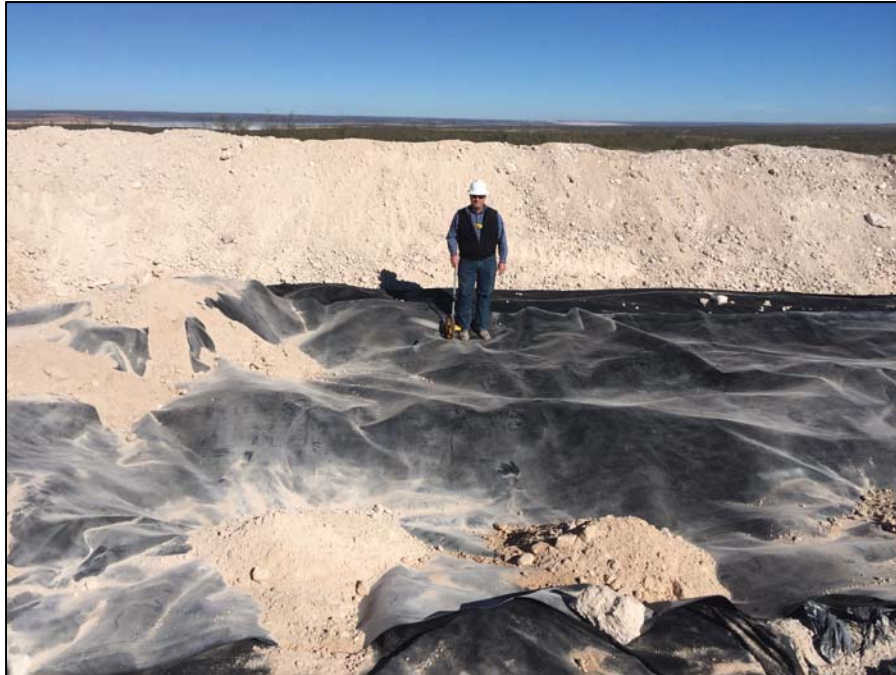
11/18/2015

Geomembrane cover over stabilized cuttings >4 ft below grade

5. Following the inspection, after receipt of the confirmation analysis and having achieved all applicable stabilization requirements associated with in-place burial, a geomembrane cover was installed to completely cover the stabilized cuttings on November 18, 2015. The pit contents and liner were sloped in a manner that would cause the liner to shed infiltrating water.

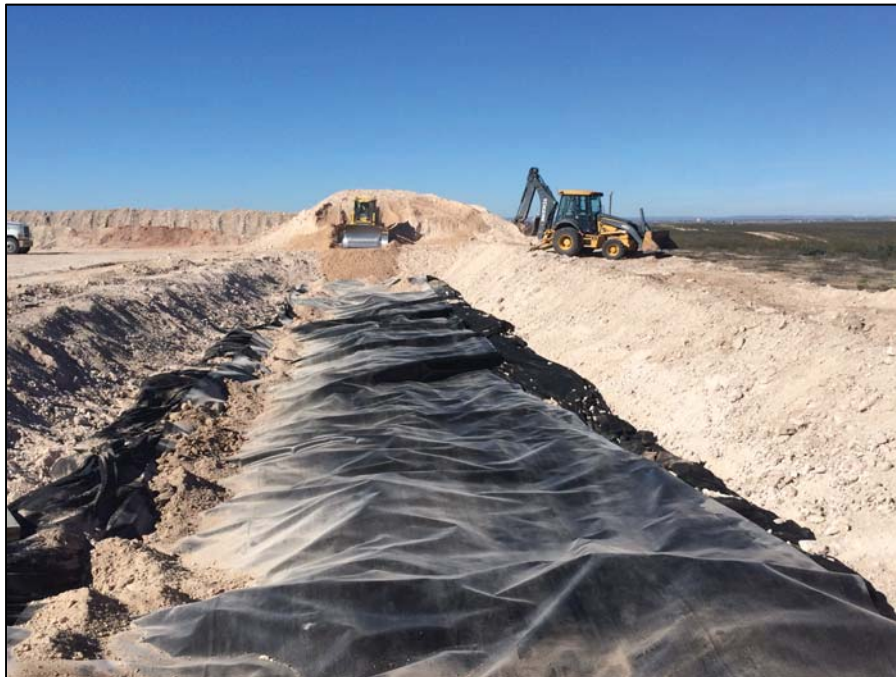
11/18/2015

Backfilling over geomembrane cover; felt visible on edges of liner

6. Once the geomembrane cover was in place, approximately 4 feet or more of non-waste containing, uncontaminated, earthen material and the reserved topsoil were replaced to their relative positions in accordance with Subsection (3) of Paragraph H of 19.15.17.13 NMAC. The soil cover consists of at least four feet of compacted, non-waste containing, earthen material. The uppermost topsoil is equal to the background thickness at least one foot. The surface was contoured to blend with the surrounding topography and to prevent
