RE: Strata - Roadrunner Federal #2H Temporary Pit
API #30-015-41041, Permit #P2-13-0016

On behalf of Strata Production Company, R.T. Hicks Consultants submits this closure report for the above-referenced temporary pit in accordance with the BLM-approved C-144 closure plan. This report includes the following information listed in Part 21 of the C-144 form:

On-Site Burial Location of Temporary Pit
Relative to Well Pad
Strata Production Company, Inc
Forty Niner Ridge - Roadrunner Fed #2H

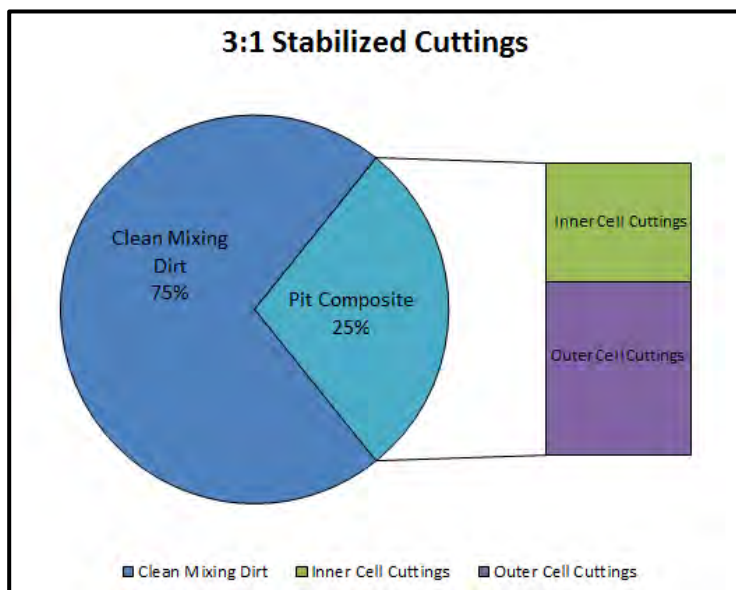
Samples collected on January 5, 2017 consisted of a 3-point composite from the inner horseshoe cell, a 4-point composite from the outer horseshoe cell, and a 4-point composite from the clean soil on site that will be used for stabilization mixing. The table on page 2 of this notice demonstrates the calculated concentration for "3:1 stabilized" material that results when the pit contents are combined with available mixing soil during the closure process. The calculated value mathematically mixes 3 parts clean soil (mixing dirt) with 1 part of the weighted pit composite calculation, as depicted in the adjacent chart. The pit

composite consists of 48.64% solids from the inner cell of the drilling pit and 51.36% of the solids from the outer cell, representative of the volume of cuttings in each cell.

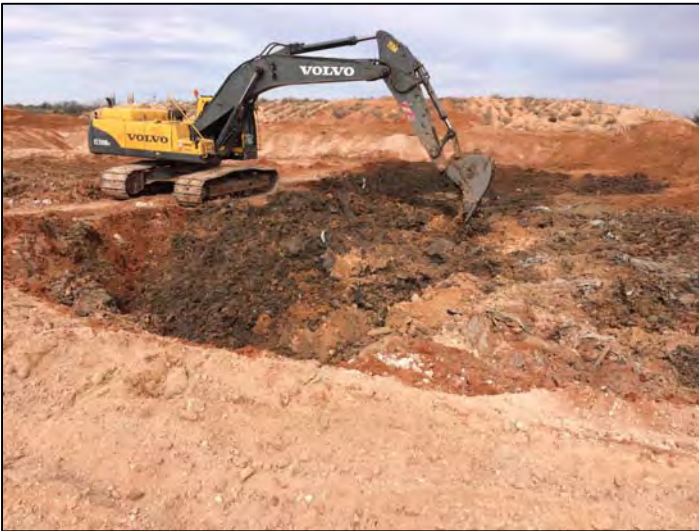
Mixing cuttings 2/6/2017

4. On February 2, 2017, closure activities commenced and stabilization of the pit contents was achieved by mixing the pit contents with the dry soil beneath the liner of the pit and the dividing berms. On February 6, 2017, a paint filter test was performed by R.T. Hicks Consultants that confirmed that the process was complete and that the stabilized cuttings were located at least 4 feet below grade.

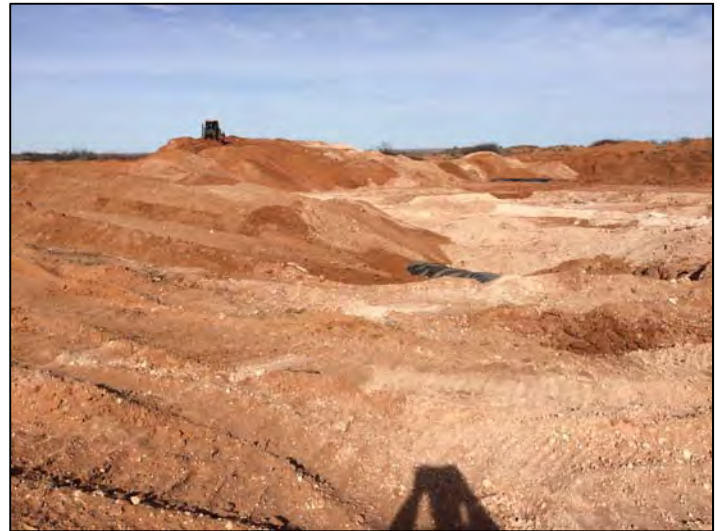
Backfilling over geomembrane liner
2/8/2017

5. Following inspection, having achieved all applicable stabilization requirements associated with in-place burial, a geomembrane liner was installed to completely cover the stabilized cuttings on February 8, 2017. The pit contents were shaped to shed infiltrating water off the cap liner.

6. Once the geomembrane cover was in place, approximately 4 feet or more of non-waste containing, uncontaminated, earthen material and the reserved topsoil were replaced to their relative positions in accordance with Subsection (3) of Paragraph H of 19.15.17.13 NMAC. The soil cover consists of at least four feet of compacted, non-waste containing, earthen material. The uppermost topsoil is equal to the background thickness at least one foot. The surface was contoured to blend with the surrounding topography and to prevent erosion and the ponding of water over the on-site closure. This work was completed on February 10, 2017.

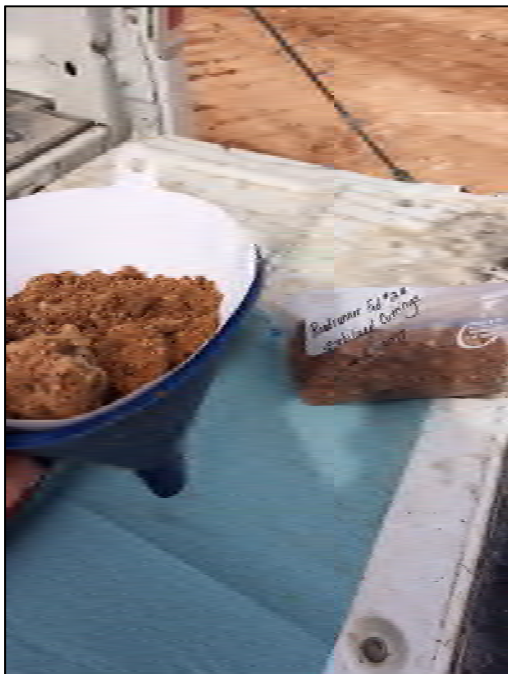
Paint Filter Test on Stabilized Cuttings
2/6/2017
