**Pit or Below-Grade Tank Registration or Closure**

**Final Report**

# Closure Report

**Potomac A9 Fee #2H**  
**API # 30-015-35281**  
**Eddy County, NM**

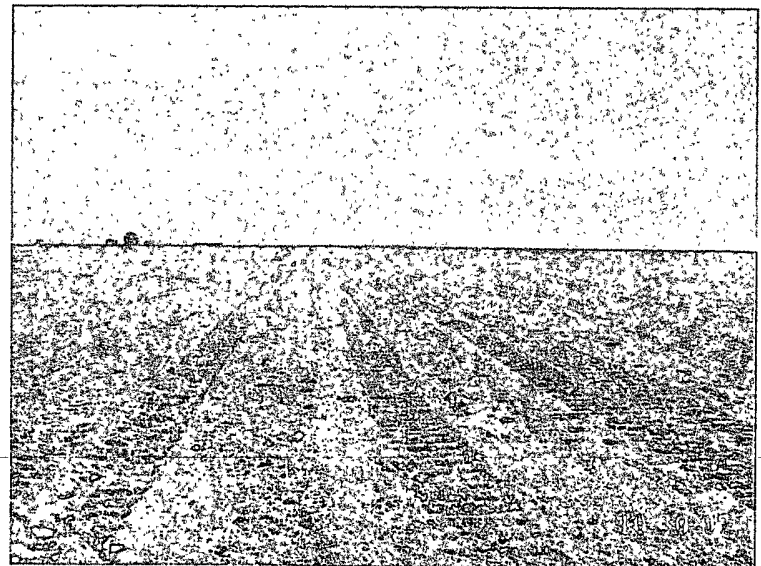
Drilling pit and burial pit after backfill and
