Incident ID	NCH1903660967
District RP	1RP-5345
Facility ID	fGP0000000008
Application ID	pCH1903661277

Re: Site Assessment and Closure Report
Site Name: 2B2
GPS: Latitude: 32.17311 Longitude: -103.17584
Legals: UL "L", Sec. 33, T24S, R37E
Lea County, New Mexico
NMOCD Ref. No. 1RP-5345

Lowry Environmental & Associates, LLC (LEA), on behalf of ETC Texas Pipeline, Ltd. , has prepared this Site Assessment and Closure Report for the Release Site known as the 2B2 . Details of the release are summarized on the table below:

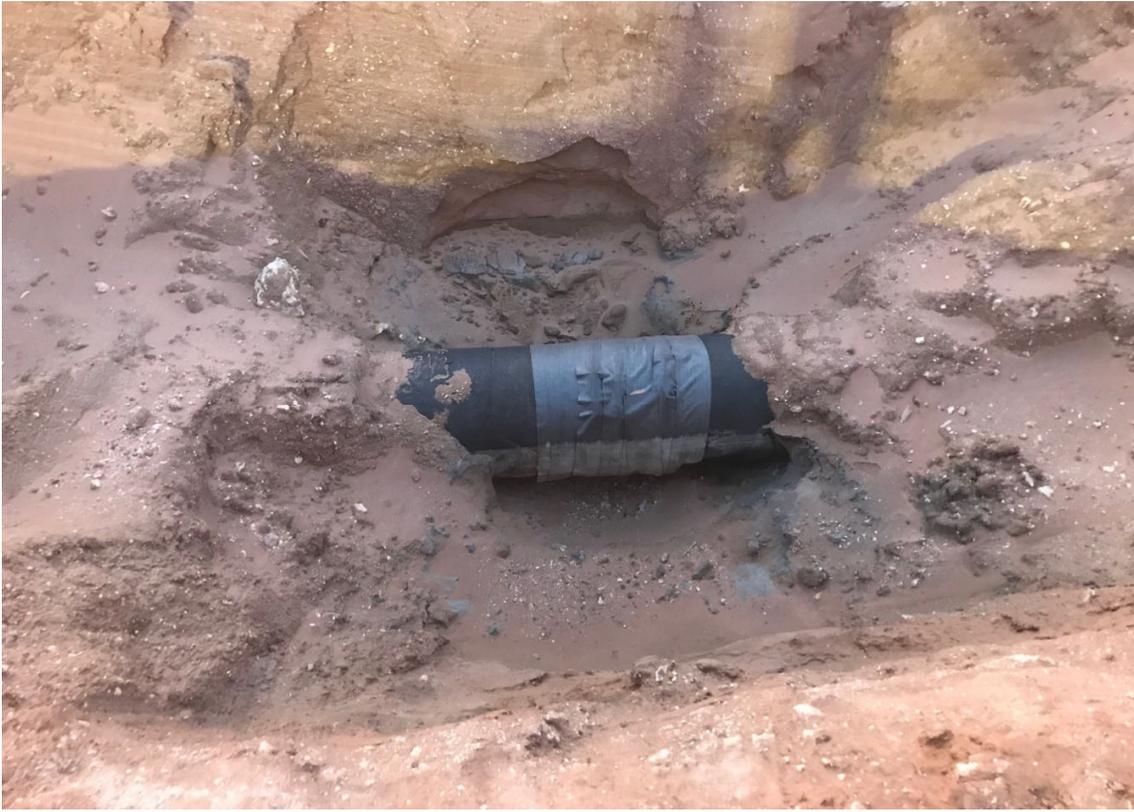
Photo 1: View of subject area after initial response activities.

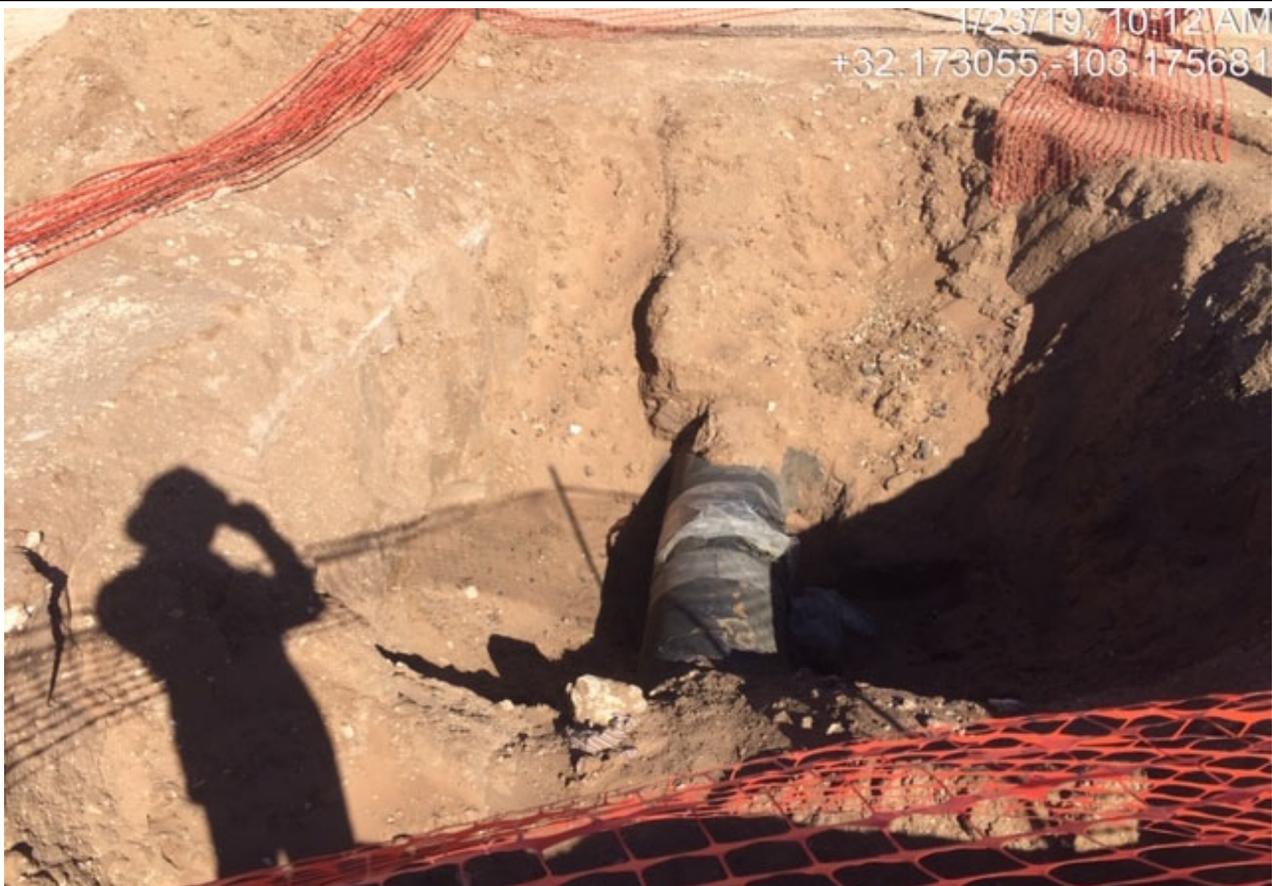
Photo 2: View of open excavation and sample locations, facing North.

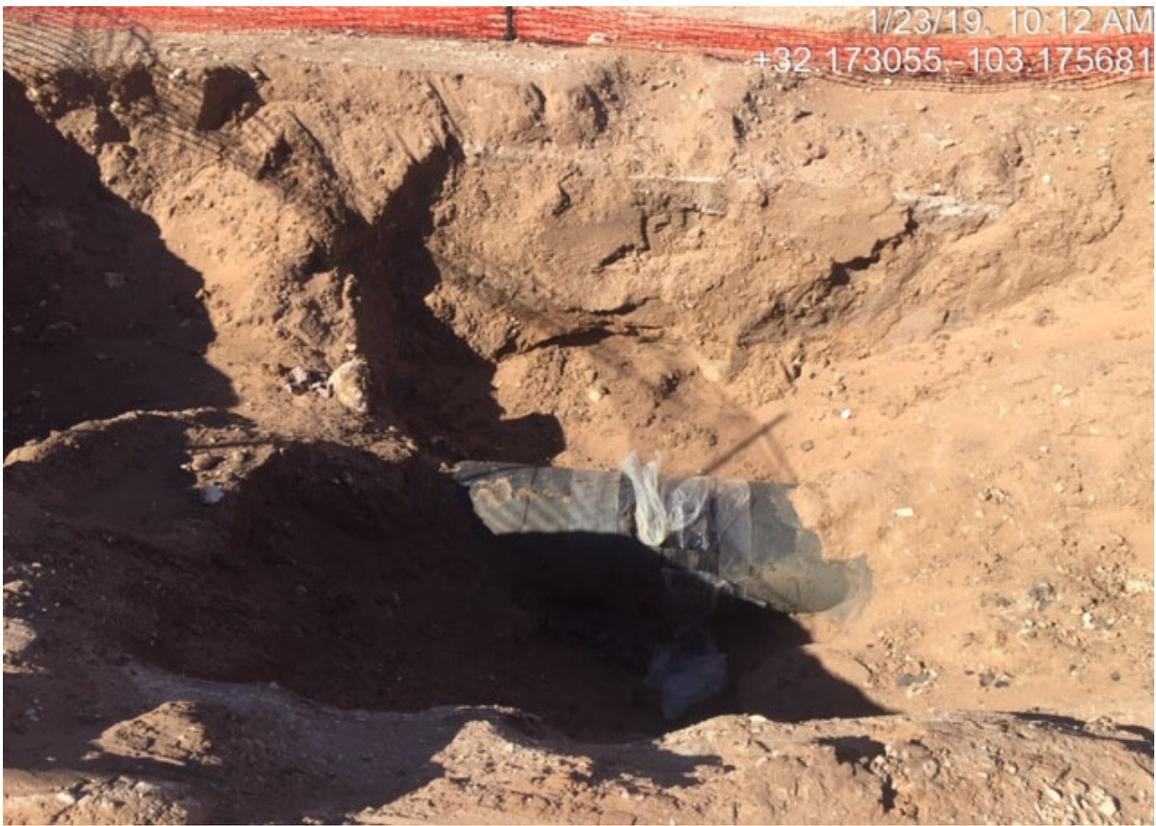
Photo 3: View of open excavation and sample locations, facing West.

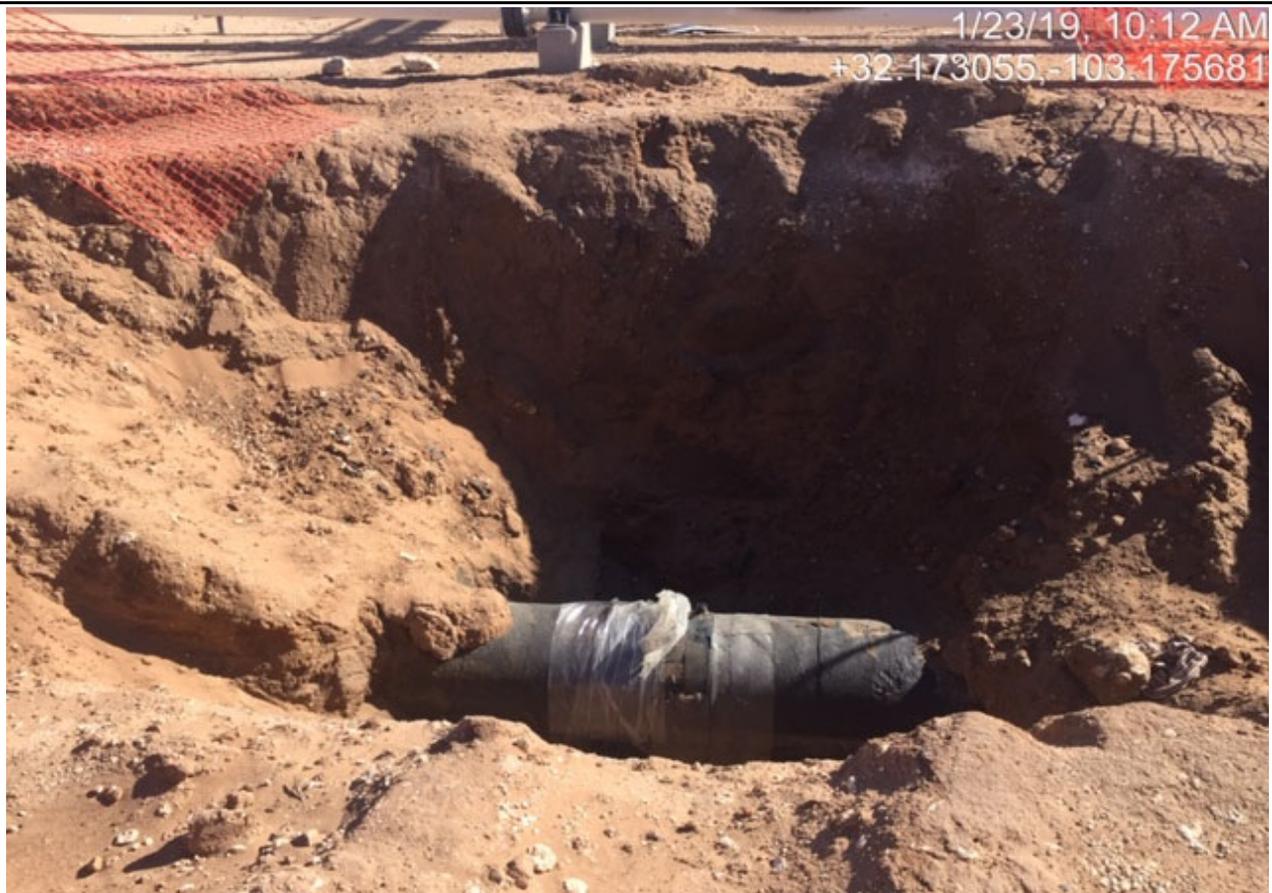
Photo 4: View of open excavation and sample locations, facing East.

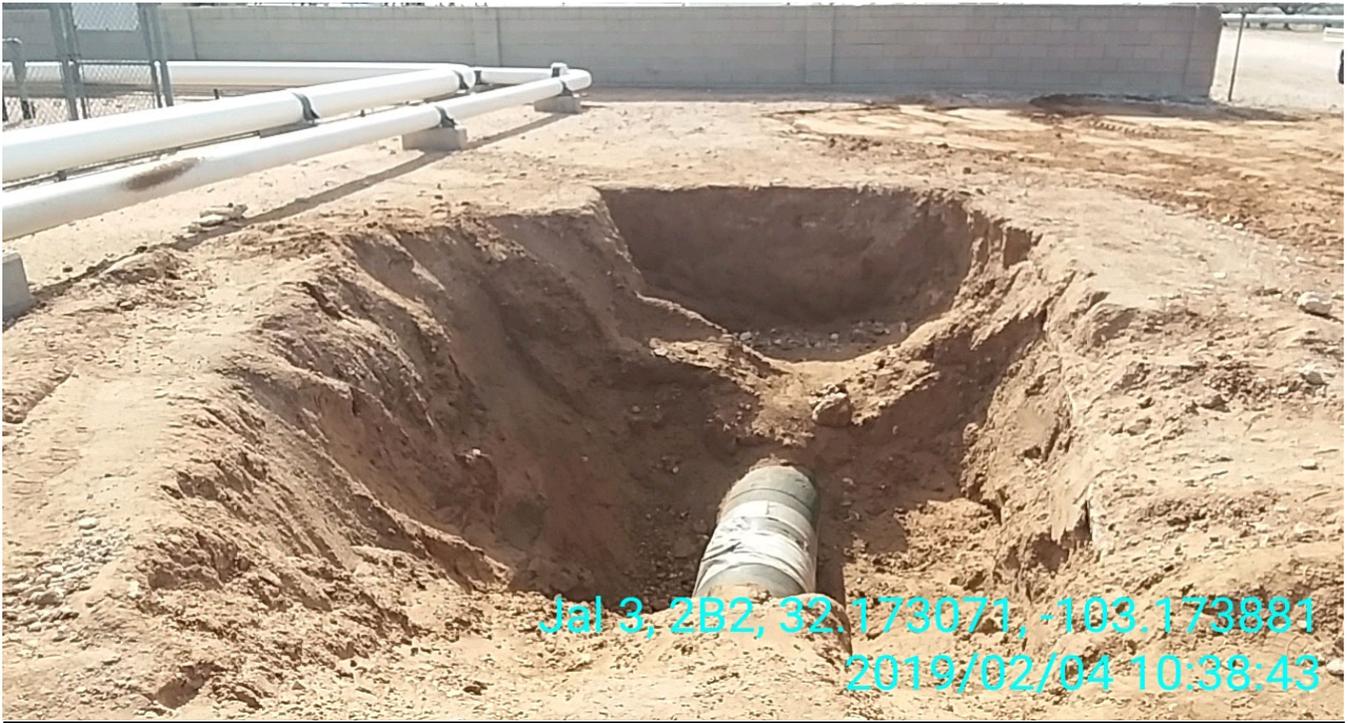
Photo 5: View of open excavation before backfilling activities, facing South.

On **February 4, 2019**, upon receiving laboratory analytical results from confirmation soil samples, the excavated area was backfilled with locally sourced, non-impacted material. Excavation backfill was contoured to meet the needs of the facility.

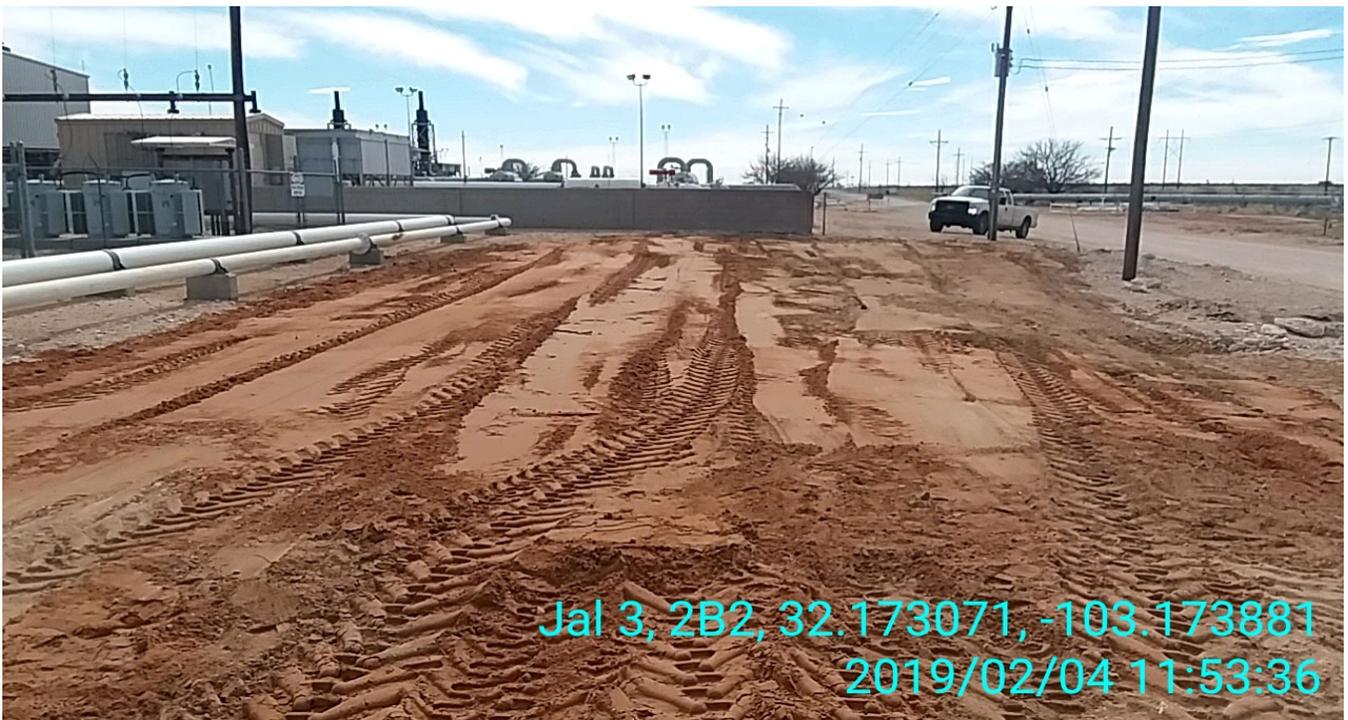
Photo 6: View of the affected area upon completion of remediation activities, facing South.

Upon receiving laboratory analytical results from confirmation soil samples, the excavated area was backfilled with locally sourced, non-impacted "like" material placed at or near original relative positions. The affected area was contoured and/or compacted to achieve erosion control, stability and preservation of surface water flow, to the extent practicable. Areas affected by remediation and closure activities are within an active gas processing plant therefore reseeding is not applicable at this time.
