**AKA Frontier Field Services, LLC
Bulldog 12" Value Setting**

Closure Report

**Section 24, T19S, R32E
Lea County, New Mexico
1RP-5349**

February 22, 2019

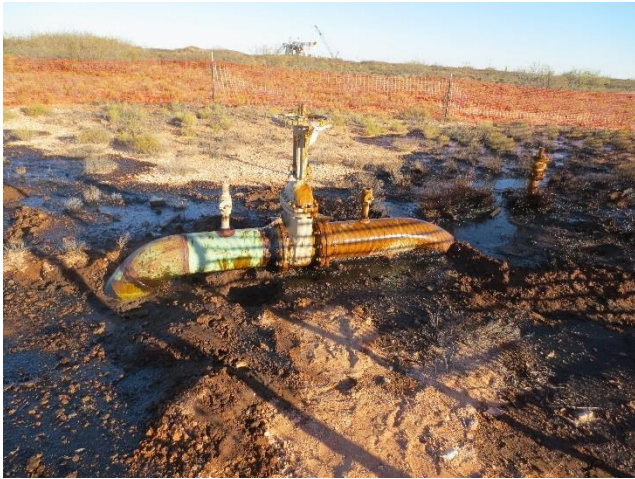
Source

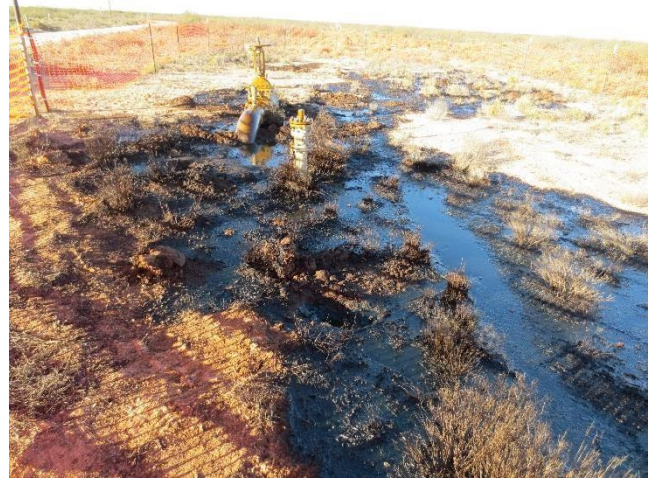
Spill traversed area

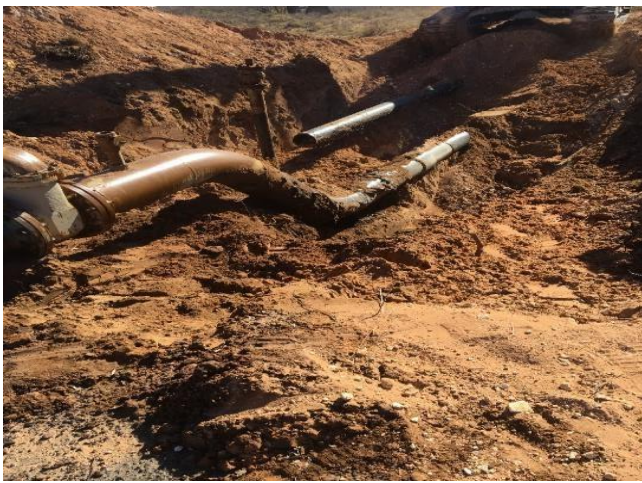
Proactive repair

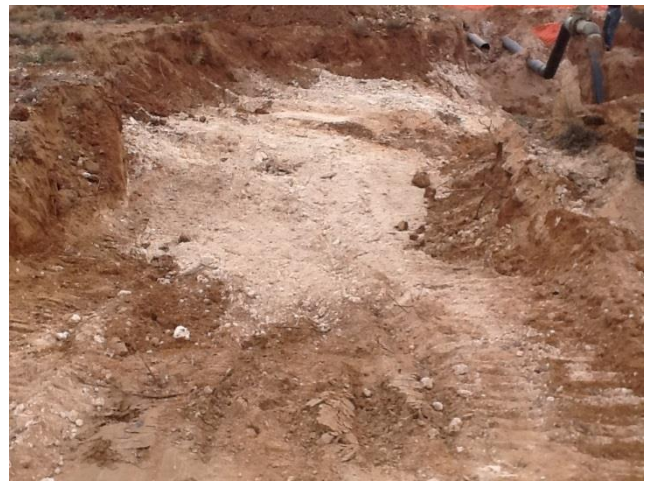
Removal of fluids

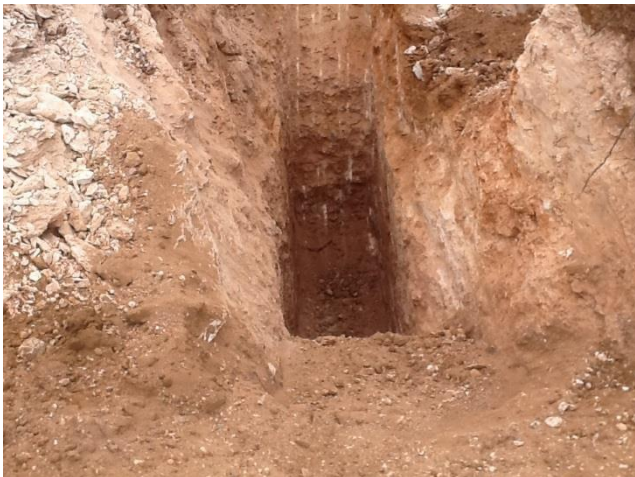
Test Trench

On December 6, 2018, SESI personnel were onsite with Rocky Peak crew, two Backhoes w/operators and AKA personnel at the AKA Santo Nino release to install test trenches to determine vertical extent of TPH & Chloride contamination. Test trenches were installed and field tested for TPH & Chlorides. The test trench locations were mapped using the Juno 3B. All soil samples were properly packaged, preserved and transported to Cardinal Laboratories, Hobbs, NM by chain of custody, and analyzed for TPH (total petroleum hydrocarbons)(Method 8015M), BTEX, and Chlorides (Method 300). The results are presented in the following table:

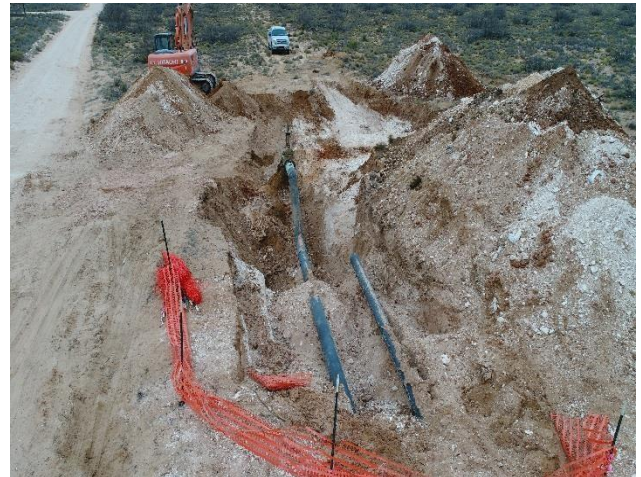
Aerial of test trenches

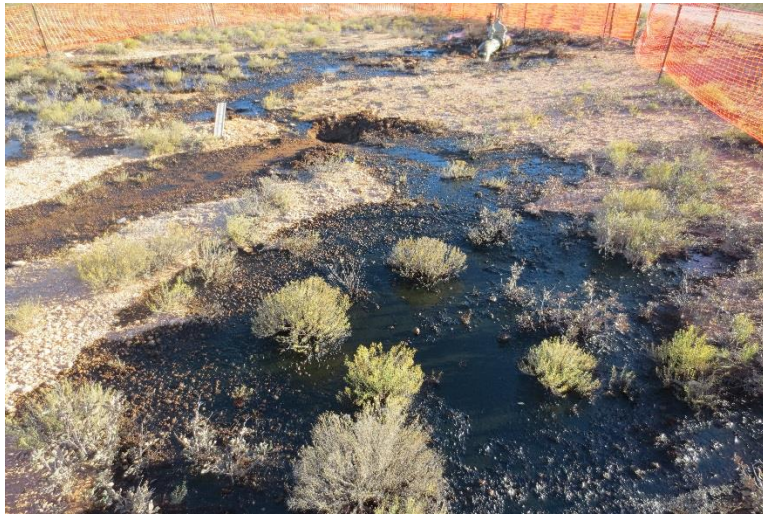
2. Liquids having this heavy consistency are unlikely to have penetrated more than three-inches below ground in a silty soil, especially in cooler temperatures in November. Therefore for volume calculations an infiltration depth of three-inches was chosen (see image 1742).

Image 1742 Depth of Impact

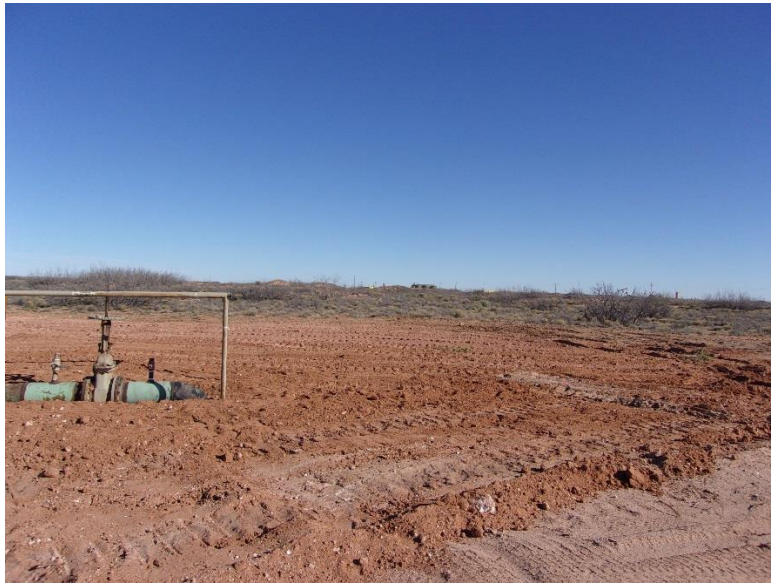
Source Site at Completion

The impacted area was excavated to depths of 1.5' bgs. All impacted soil was transported to R360 Landfill (an NMOCD approved facility), on December 18, 2018. A total of 572 (Five Hundred Seventy Two Yards) were disposed of, which correlates to the spill area calculations and soil parameters. The excavated area was backfilled with fresh topsoil and returned to grade. Per BLM guidelines; the site is scheduled to be reseeded in the spring of 2019.

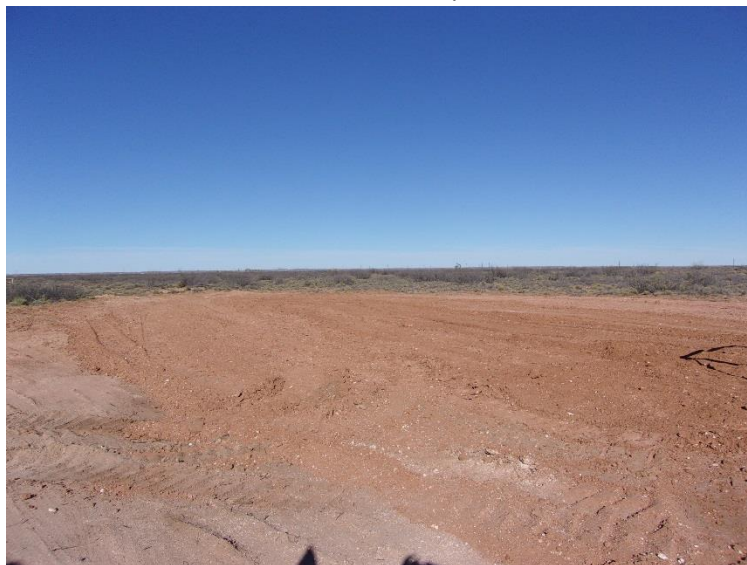
Pasture Area at Completion
