Soil Assessment Report

C-1 Compressor Station

1RP-5048

Cud 12" Pipeline Purge

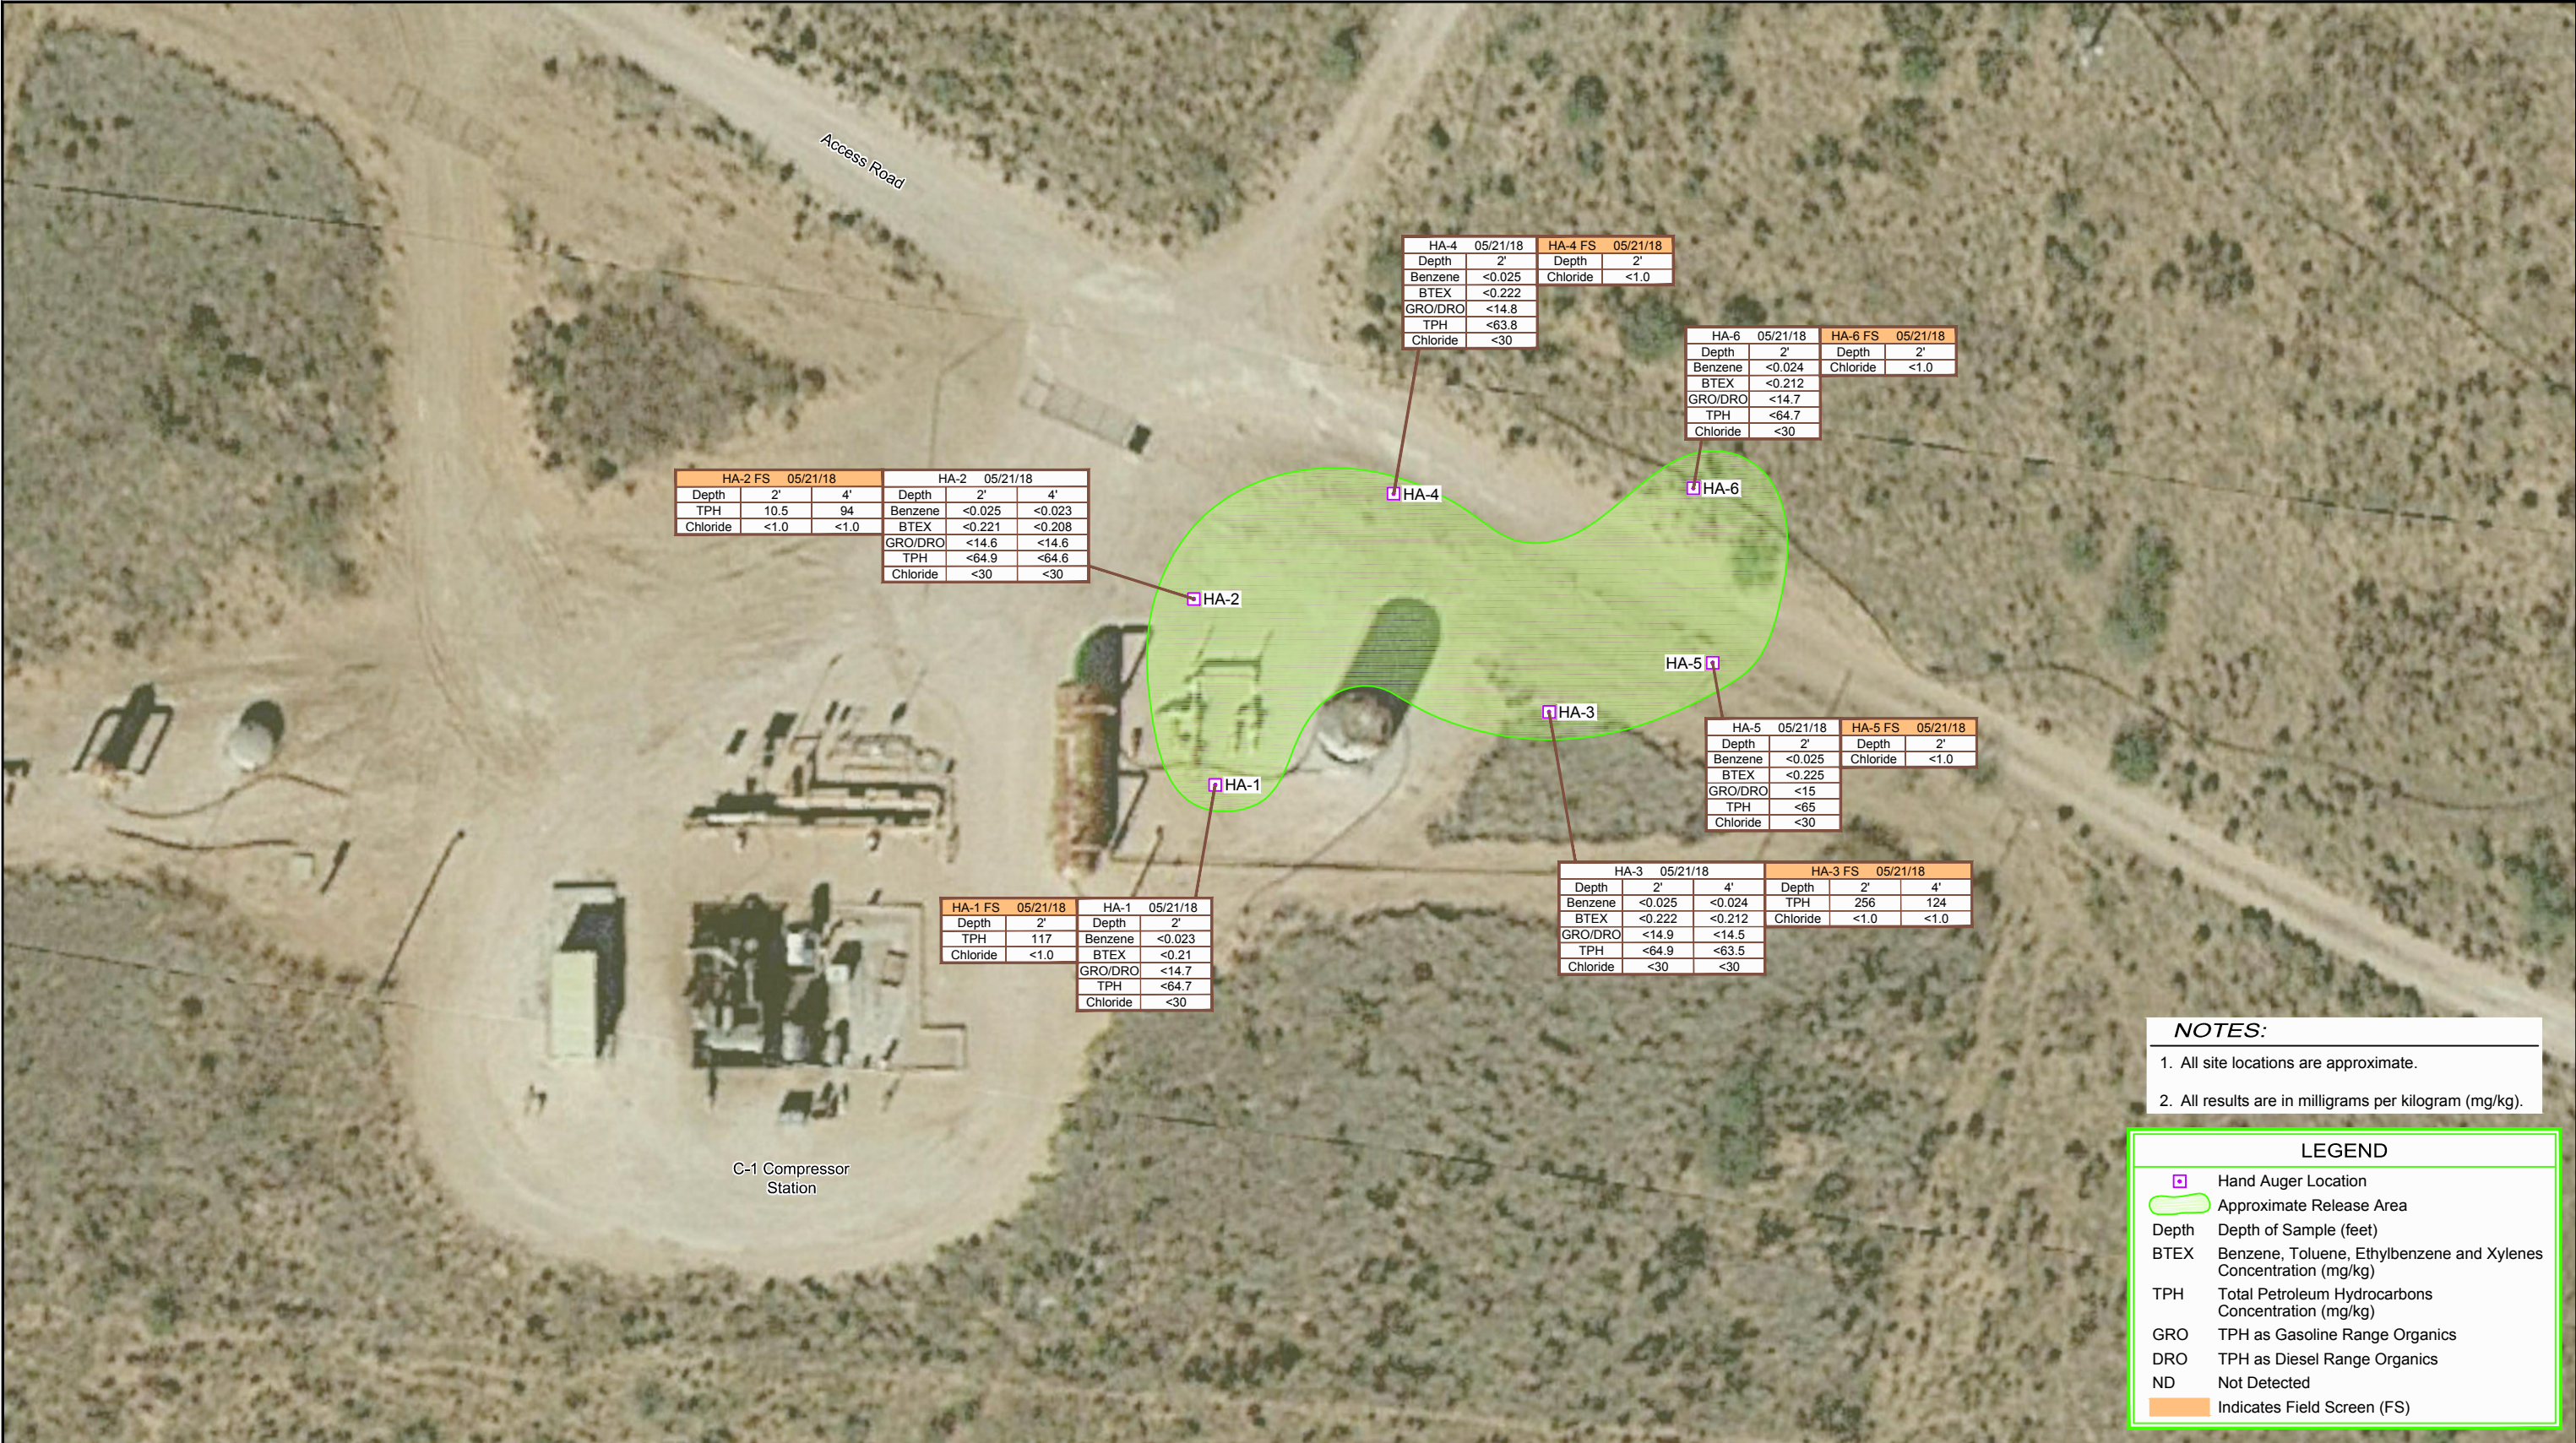
Figure 2 Sample Location Map

A soil analytical summary of results from the May 2018 sampling is presented in Table 1. A Sample Location Map including field screening and analytical results is presented as Figure 2.

- Laboratory analytical results were non-detect for chloride, BTEX, and TPH at a depth of two feet bgs in each of the six sampling locations.

Evaluation of the analytical data obtained from soil assessment and delineation activities performed in May of 2018 indicate horizontal and vertical delineation of TPH and chloride impacts has been achieved at the Site. Soil remediation activities per NMAC 19.15.29.13 will be conducted at the Site following NMOCD approval of the 2018 Remediation Work Plan attached as Appendix D. Proposed remedial activities will be excavation of the upper foot to two feet of soil in the area of the release. Confirmation soil samples will be collected from the sidewalls and bottom of the excavation area.
