**Report Type: Closure Report      1RP-5322**

Site:	Magnum Pronto State Com #4H					
Company:	COG Operating LLC					
Section, Township and Range	Unit P	Sec. 32	T 19S	R 32E		
Lease Number:	API No. 30-025-39951					
County:	Lea County					
GPS:	32.61058			-103.78053		
Surface Owner:	Federal					
Directions:	From the intersection of 243 and 126A head north on 126A for 3.34 miles, turn east onto unnamed lease rd and go 0.65 miles, turn south and go 0.36 miles, turn east and go 0.29 miles and arrive at location

**Re: Closure Report for the COG Operating, LLC, Magnum Pronto State Com #4H, Unit P, Section 32, Township 19 South, Range 32 East, Lea County, New Mexico. 1RP-5322**

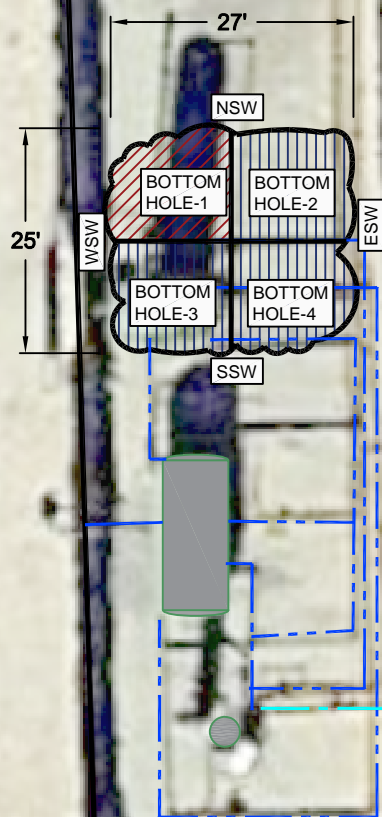
FIGURE 4

Tetra Tech personnel were onsite from March 4<sup>th</sup> to the 6<sup>th</sup>, 2019 to supervise the remediation activities. The areas of auger holes (#1 and #4) were excavated to total depths between 3.0' to 4.0' below surface. Four (4) bottom hole composite confirmation samples and five (5) sidewall composite confirm samples were collected every 200 square feet to ensure proper removal of the impacted soils. The samples were submitted to the laboratory to be analyzed for TPH method 8015 extended, BTEX method 8021B, and Chloride by EPA Method 300.0. The sampling results are summarized in Table 2. The excavation depths and sample locations are shown in Figure 4.

EXCAVATED AREA & DEPTH MAP  
LEA COUNTY, NEW MEXICO

Approximately one hundred five (105) cubic yards of impacted soil was excavated and transported offsite for proper disposal. Once the excavation activities were completed, the areas were backfilled with clean material to surface grade, the new liner was installed and equipment at the facility has been replaced.

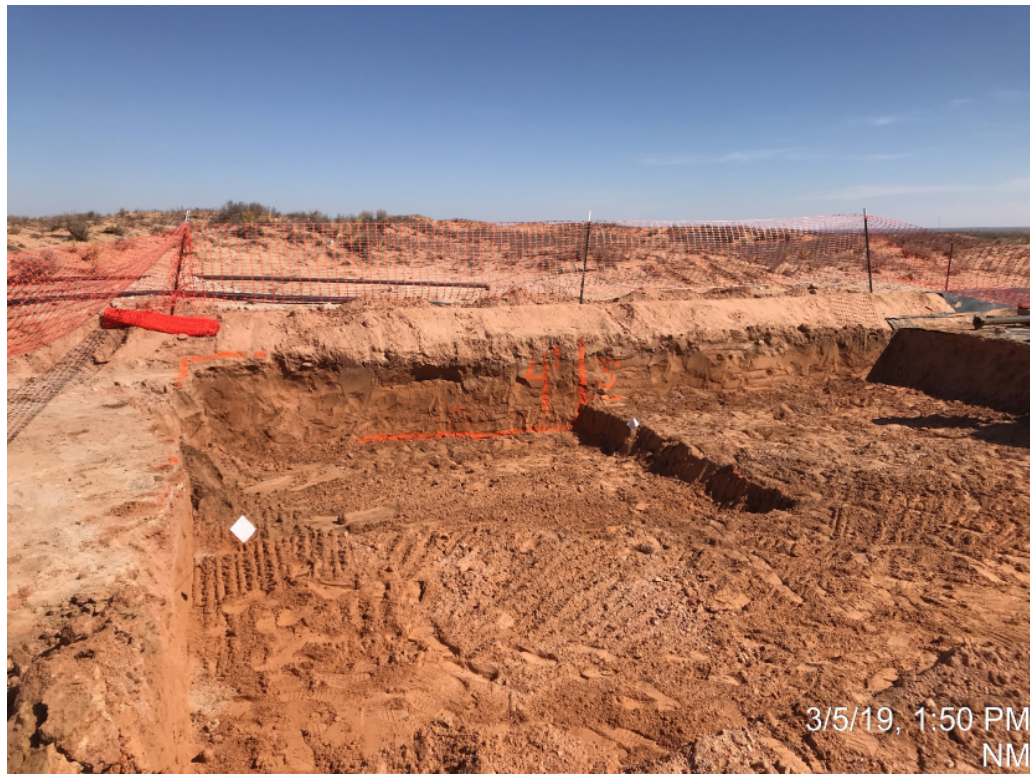
Area of Excavation – View East-southeast

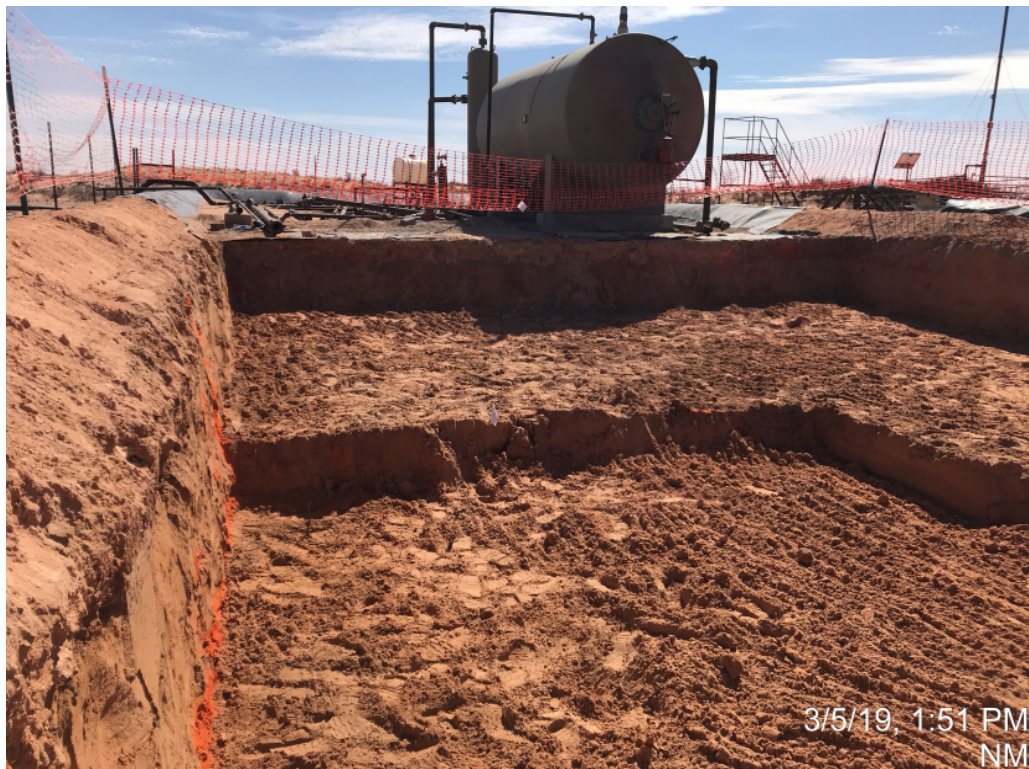
Area of Excavation – View Southwest
