Name of Company Legacy Reserves	Contact Clyde Wilhoit
Address 303 W Wall street, Suite 1800, Midland Tx, 79701	Telephone No. 432.425.4137
Facility Name Lea Unit South Battery	Facility Type Flowline

Based on laboratory analytical results, field activities conducted to date and conditions at the site, LEA recommends Legacy Reserves Operating, LP provide a copy of this Remediation Summary and Closure Report to the NMOCD and request closure be granted to the Lea Unit South Battery Site.

ATTACHMENT #7
Photographic Log

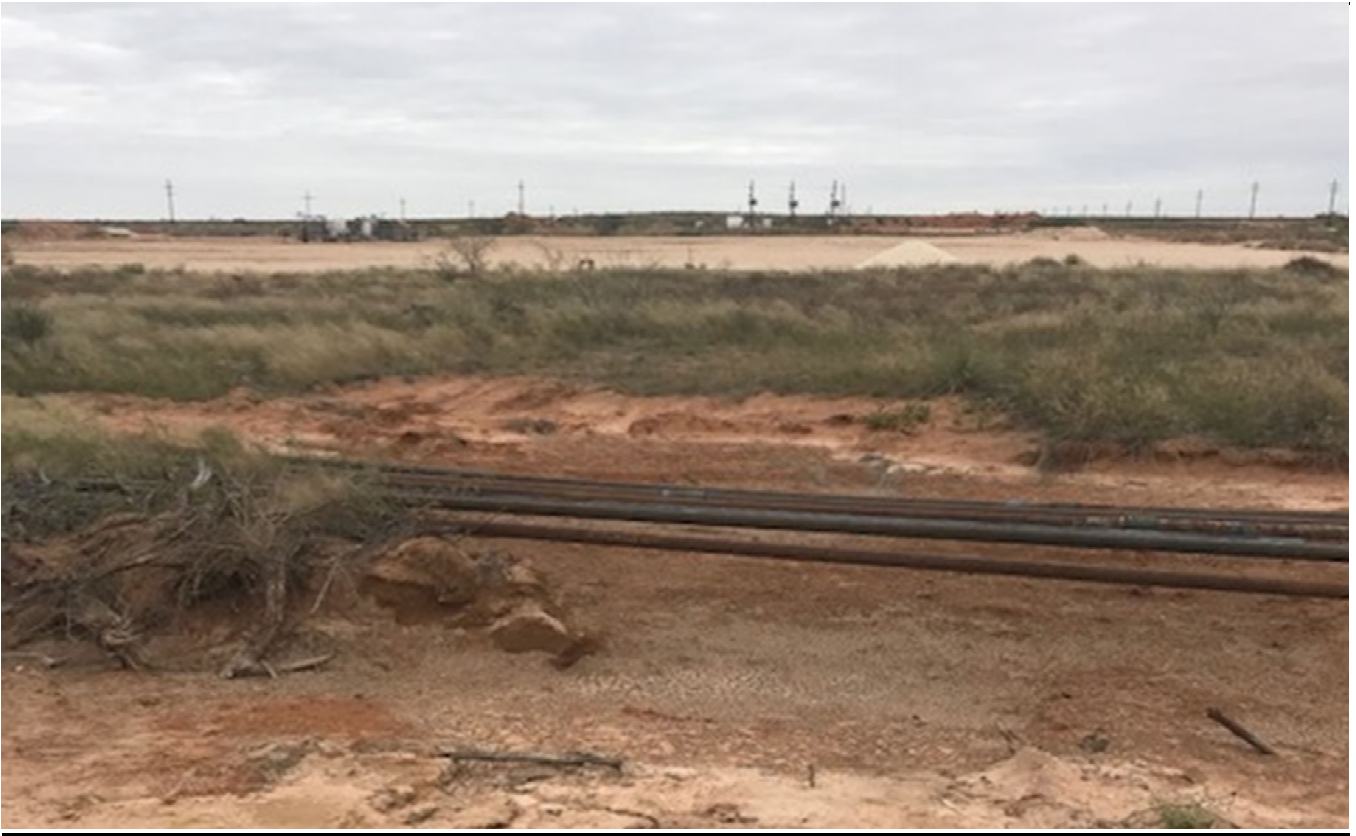
Figure 1 View of portion of the excavated area, facing East.

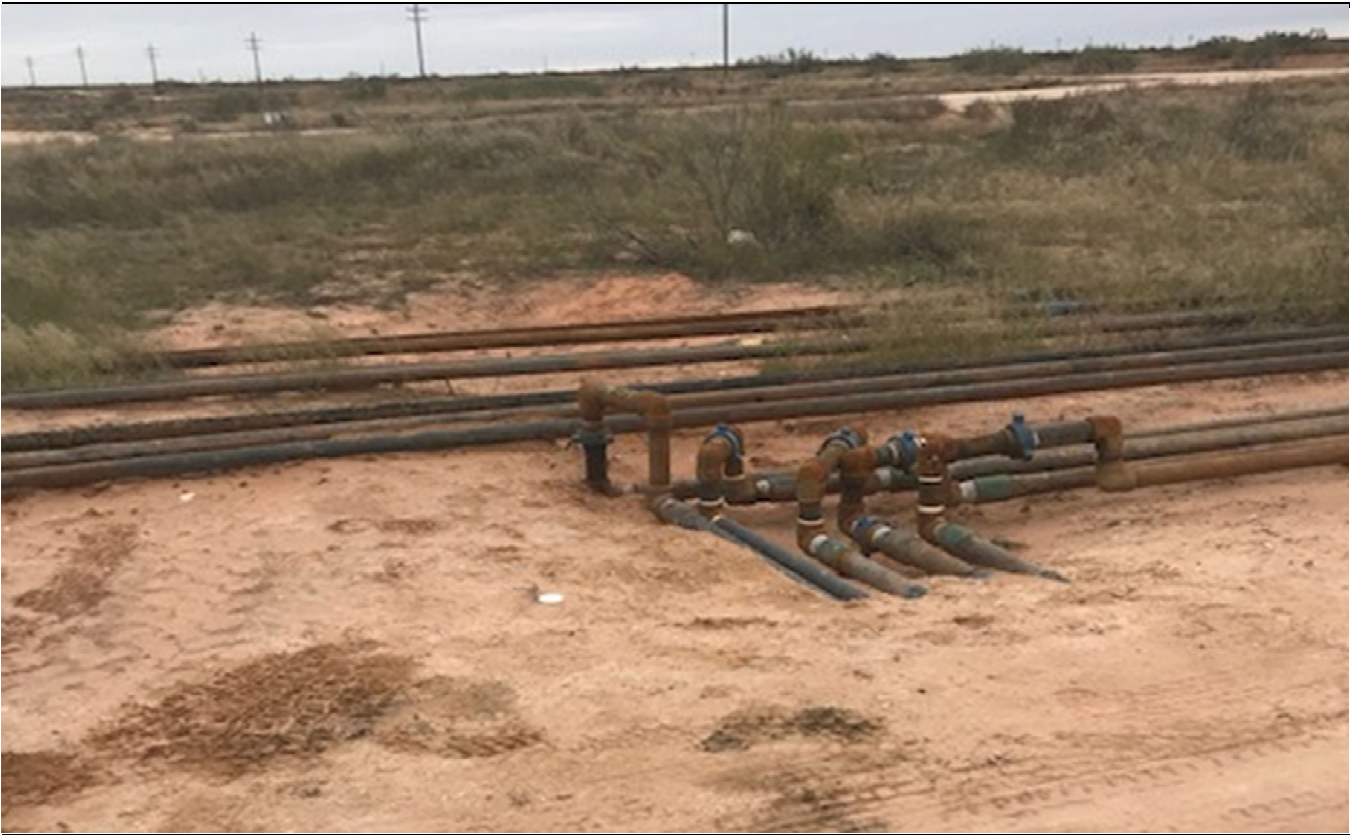
Figure 2 View of portion of the excavated area, facing East.

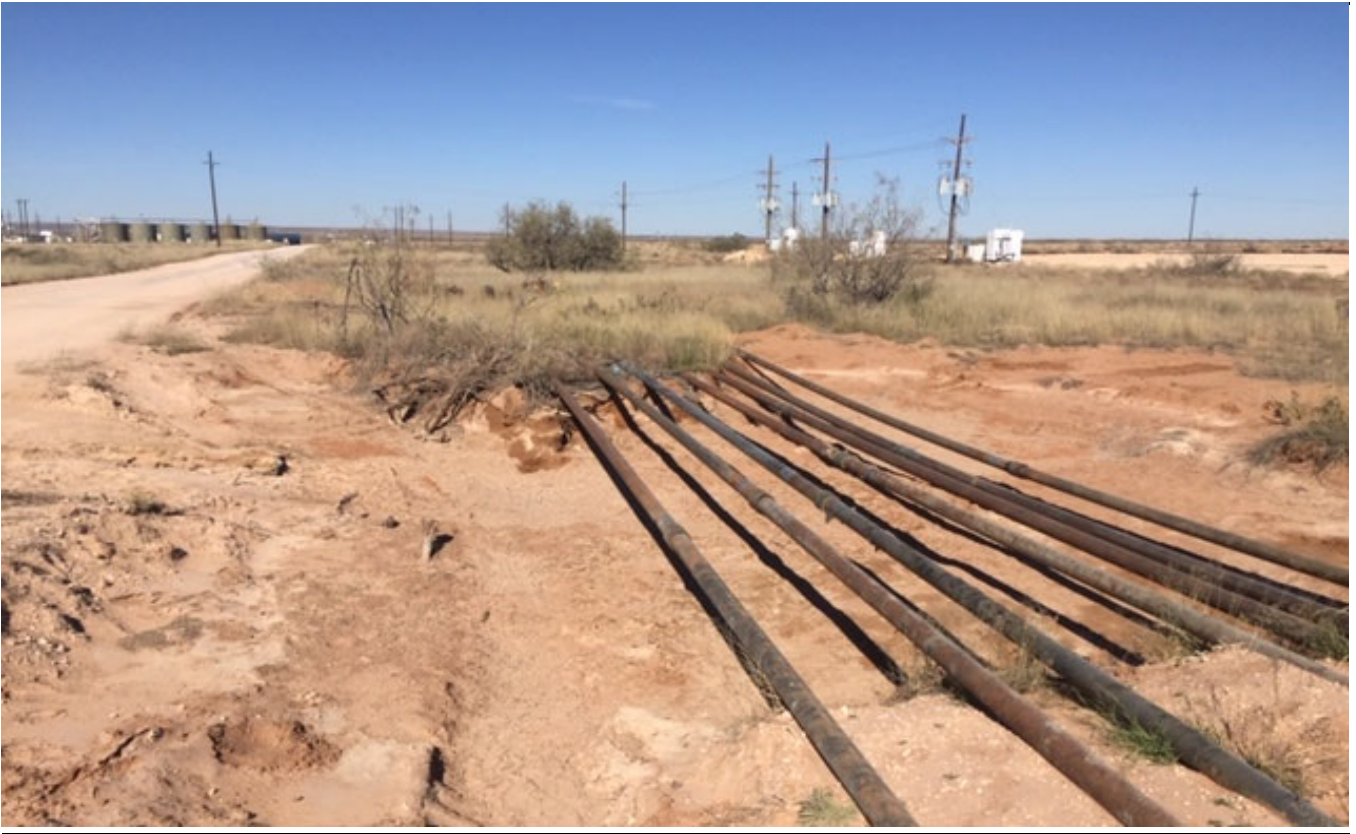
Figure 3 View of portion of the excavated area, facing North.

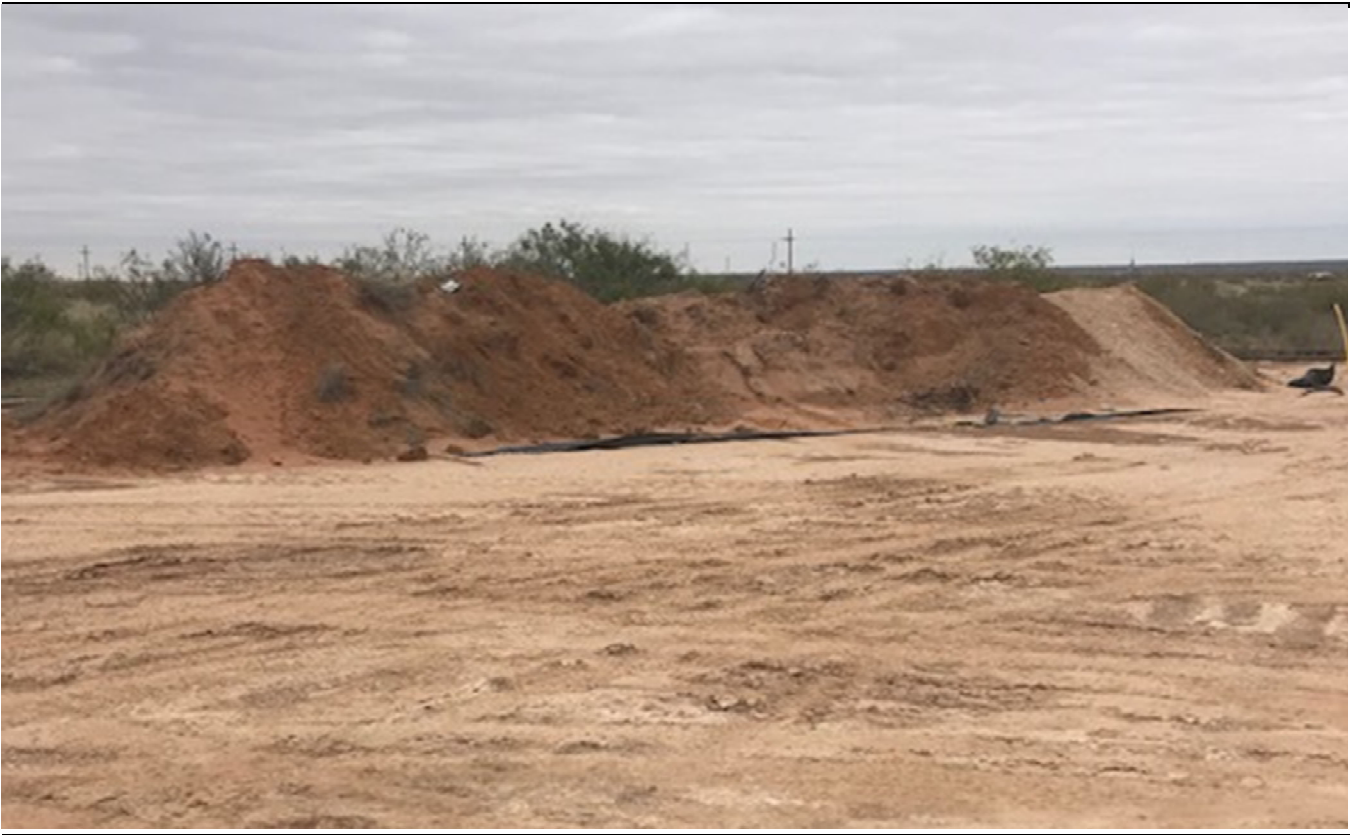
Figure 4 View of soil excavated during initial remediation activities.

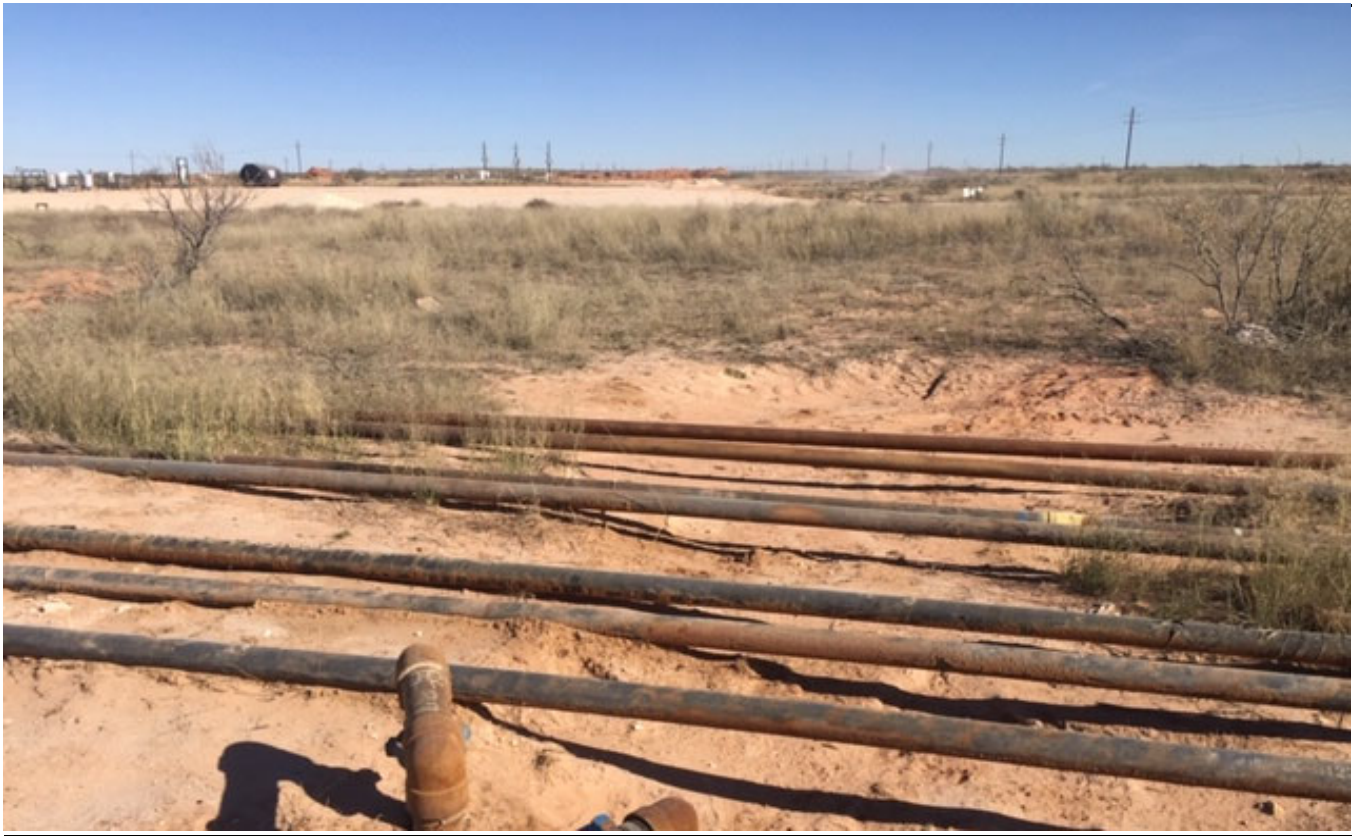
Figure 5 View of portion of the excavated area, facing Northeast.

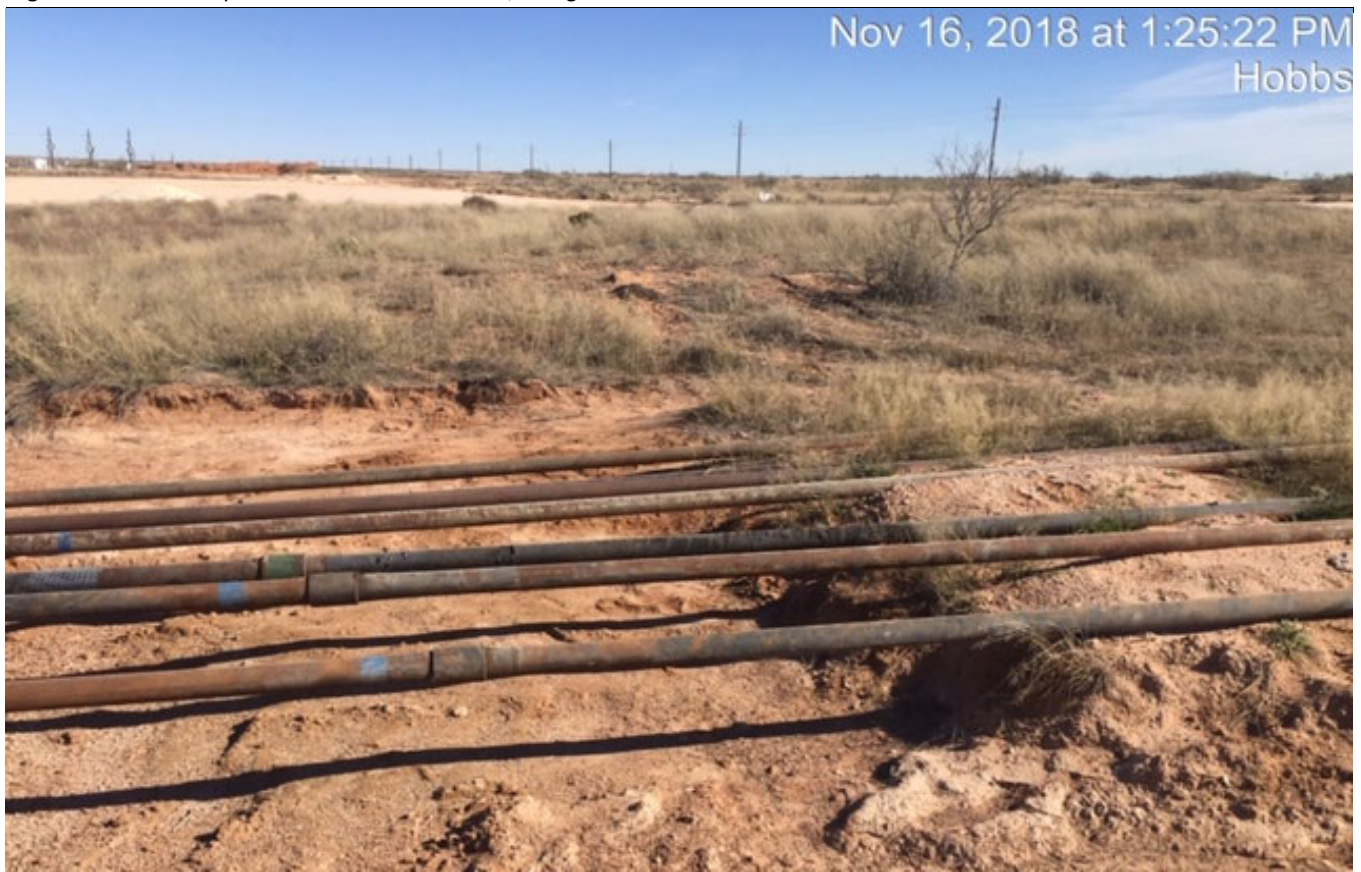
Figure 6 View of portion of the excavated area, facing East.

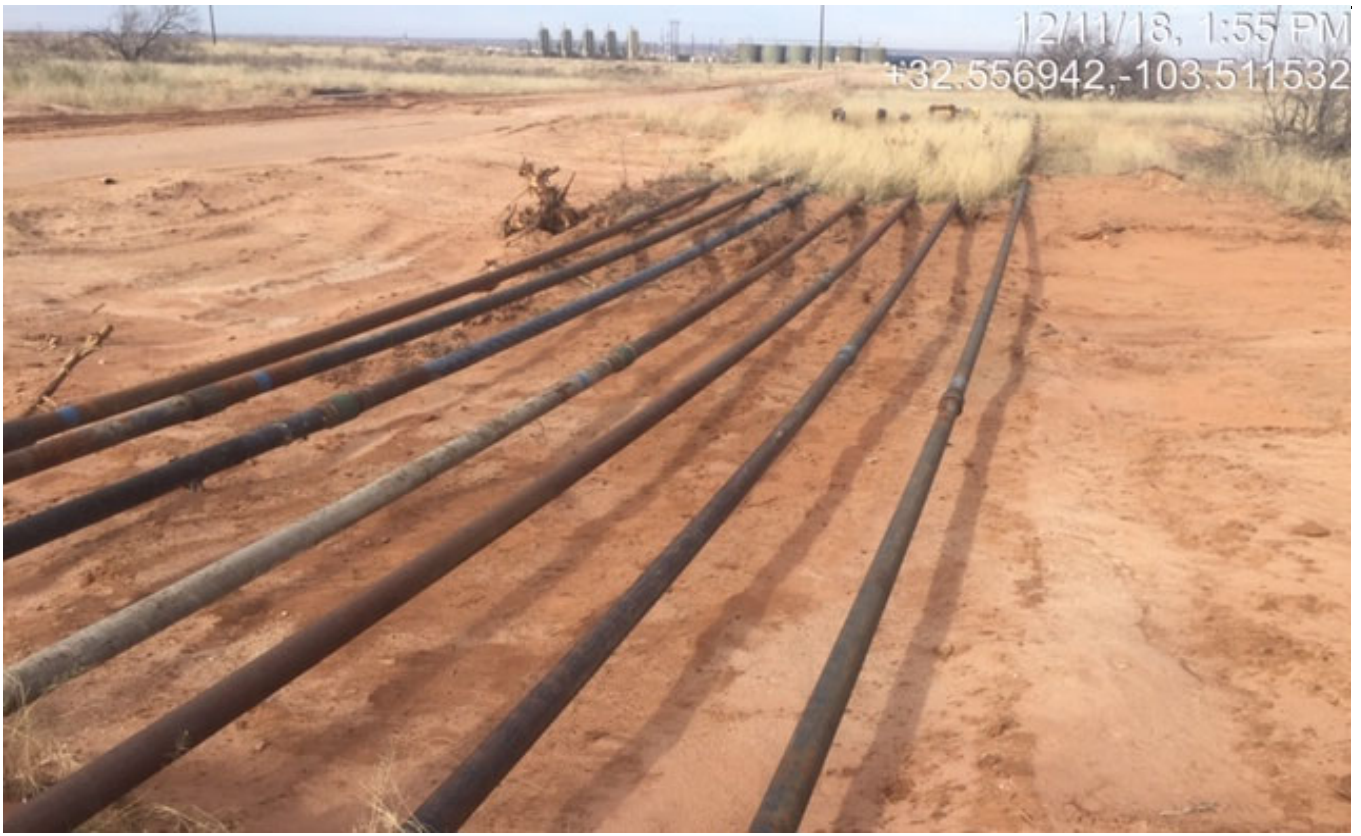
Figure 7 View of surface staining from the initial release, facing North.

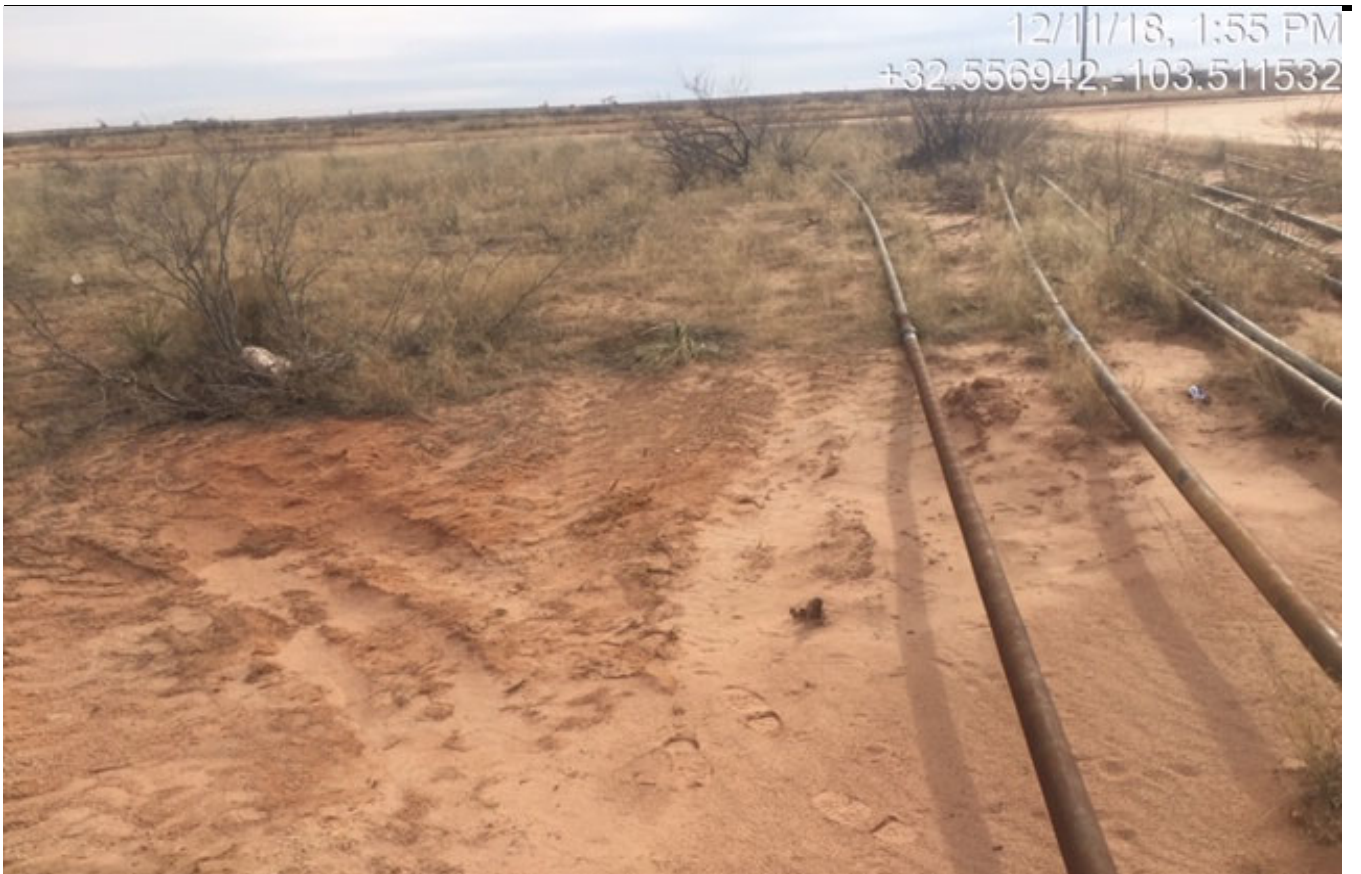
Figure 8 View of portion of the excavated area, facing South.

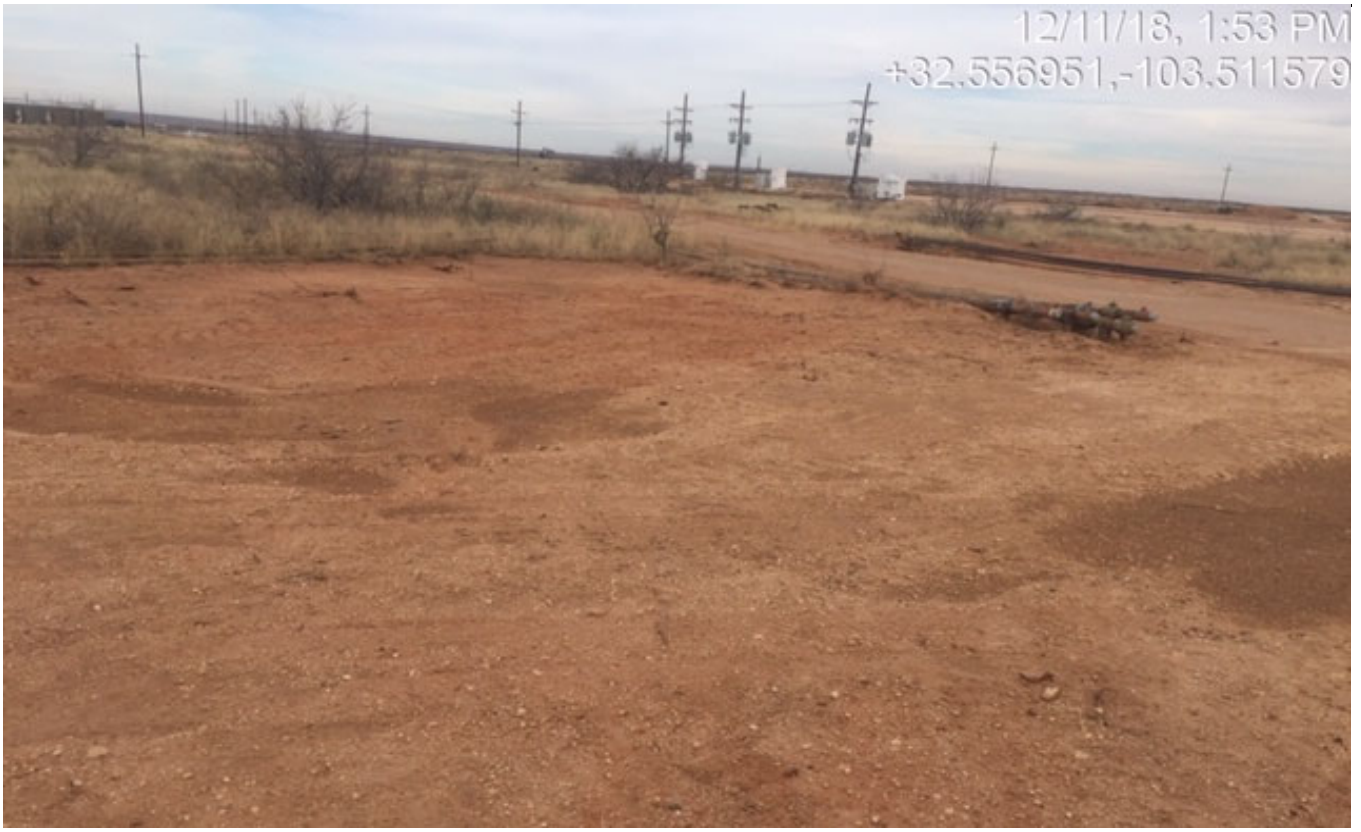
Figure 9 View of excavated pasture area, facing Northeast.

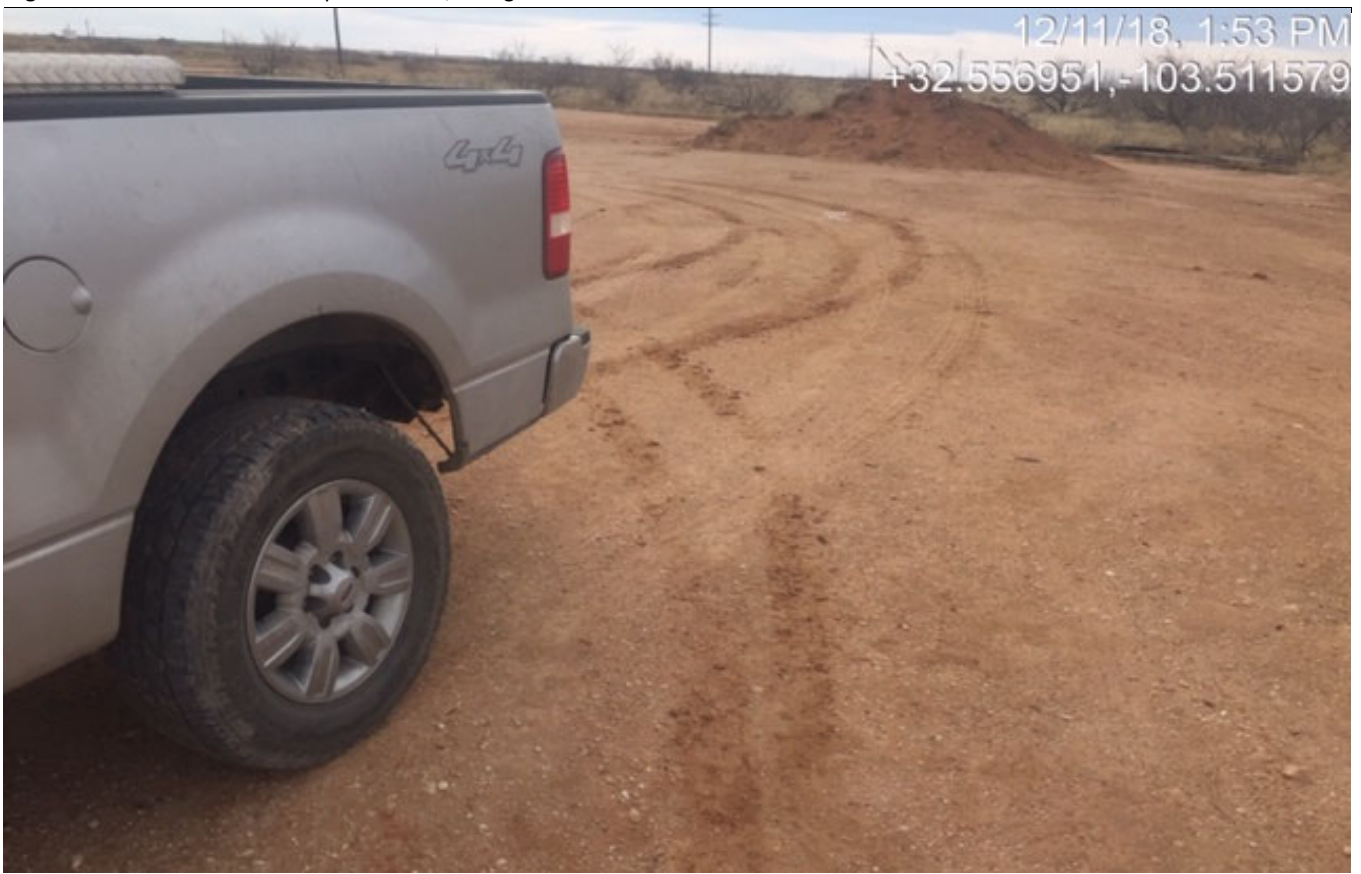
Figure 10 View of scrapped well pad, facing West.

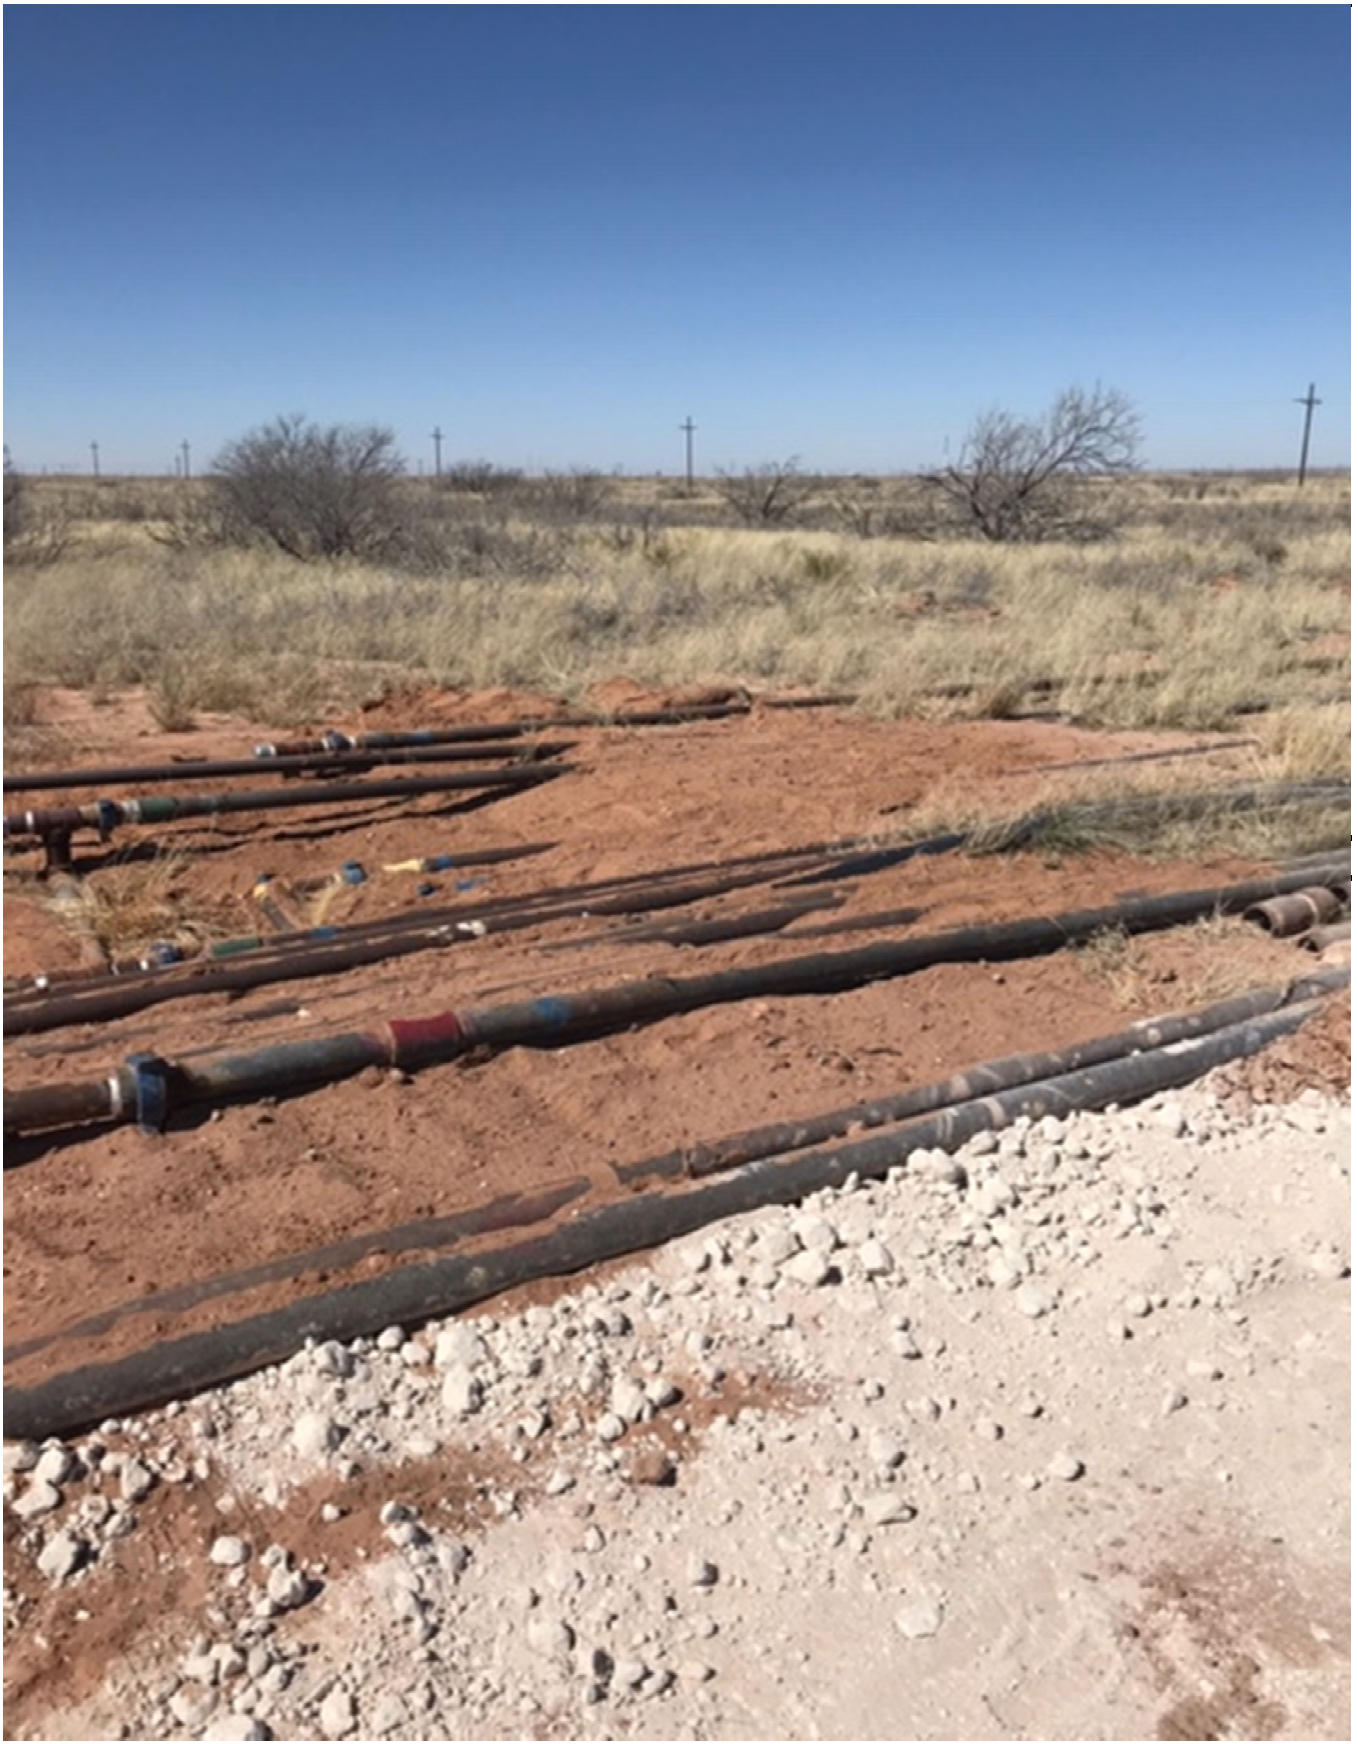
Figure 11 View of the affected area after remediation activities, facing Southeast.

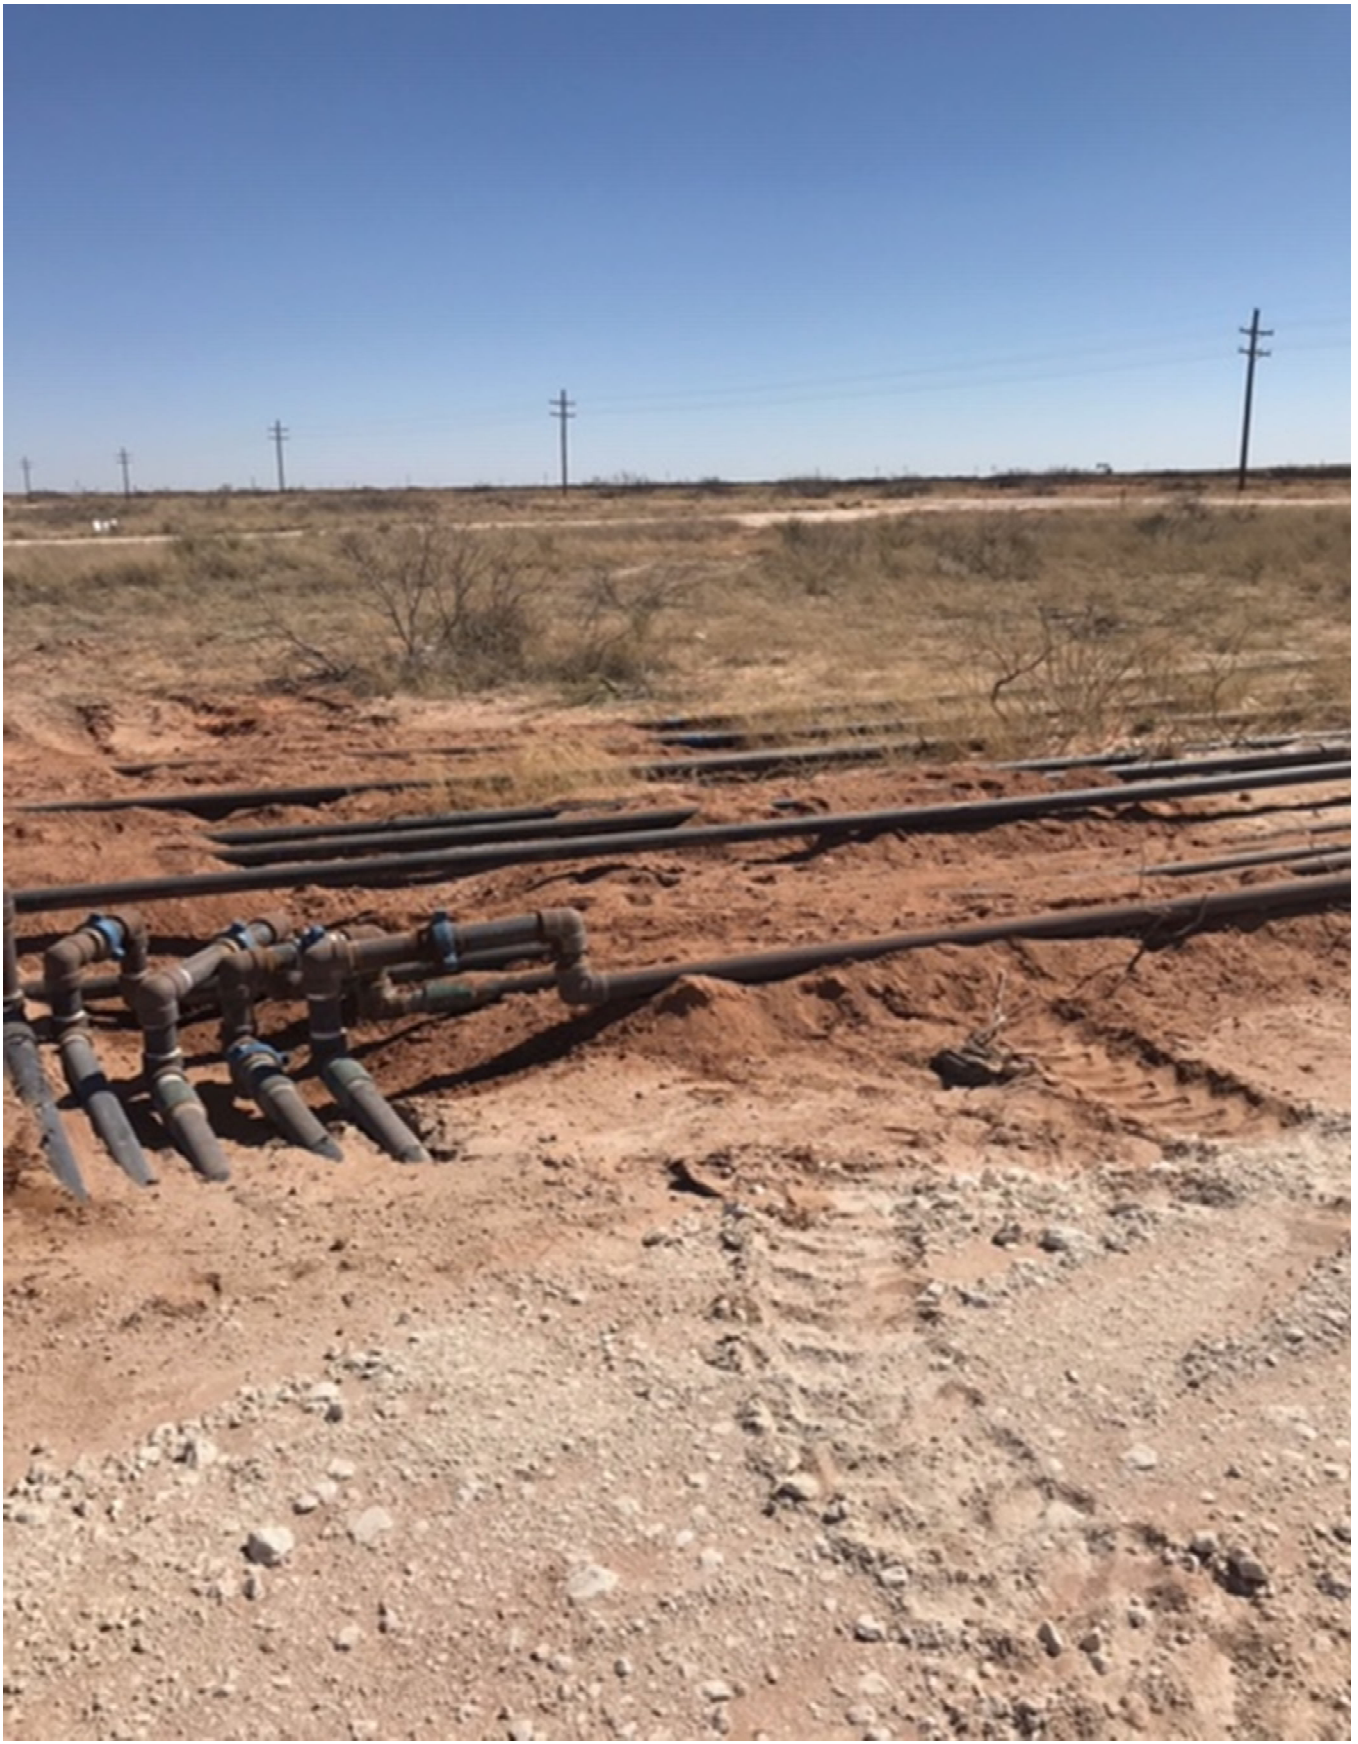
Figure 12 View of the affected area after remediation activities, facing Southeast.
