SITE CHARACTERIZATION REPORT AND STAGE 1 ABATEMENT PLAN

**KAUFMAN NO. 1
HILCORP ENERGY COMPANY
SAN JUAN COUNTY, NEW MEXICO
OCD Incident No.: NCS1833331001**

June 17, 2019

Timberwolf Project No. HEC-180061

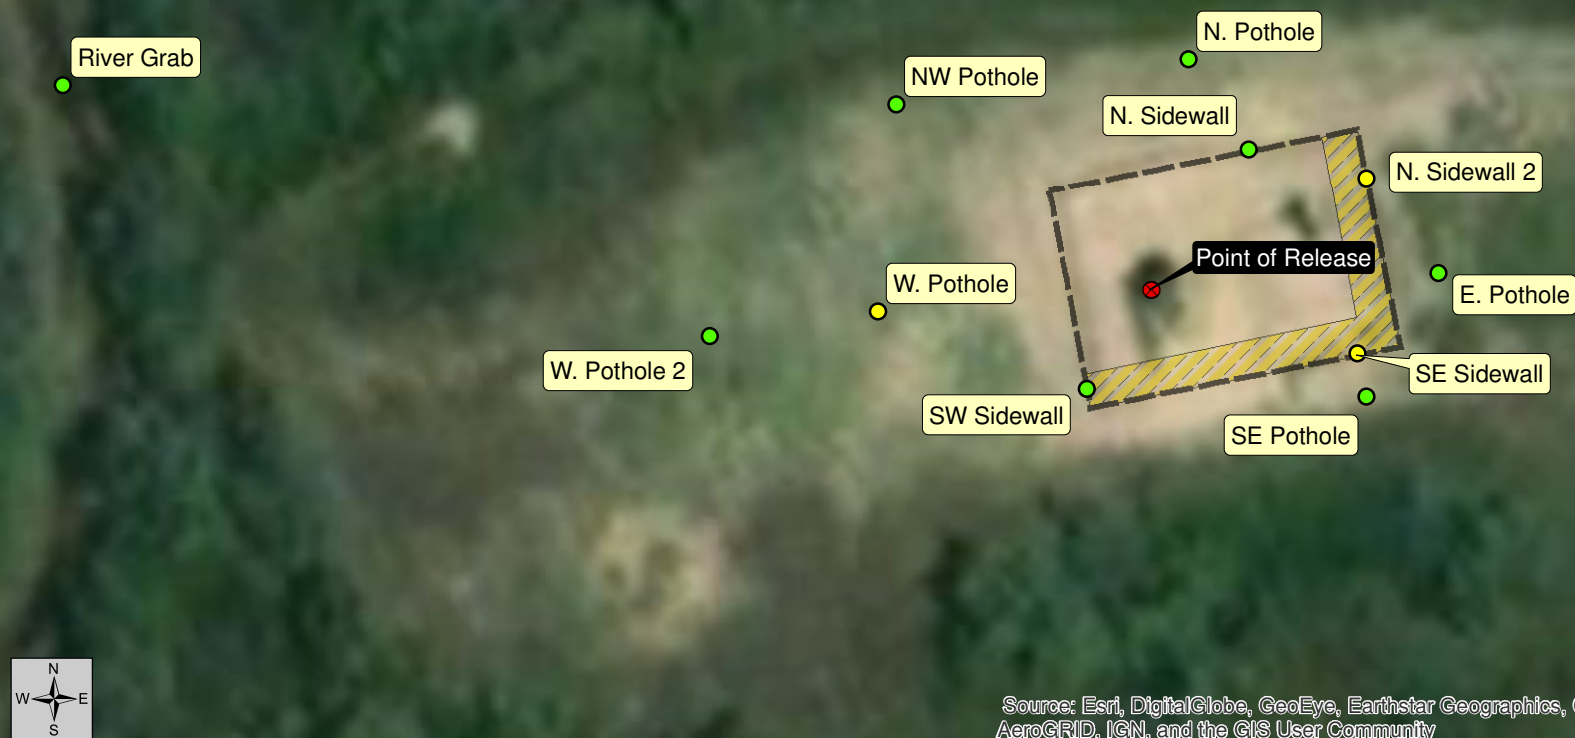
Figure 4
Initial Sample Location Map

Sample ID	Volatile Organic Compounds (mg/kg)				Total BTEX (mg/kg)	GRO (mg/kg)	DRO (mg/kg)	MRO (mg/kg)	Total TPH (mg/kg)
	B	T	E	X					
N Sidewall	< 0.016	0.031	0.061	0.37	0.462	17	< 9.8	< 49	17.0
N Sidewall 2	< 0.099	< 0.20	< 0.20	< 0.40	0	< 20	380	< 49	380.0
SW Sidewall	< 0.026	< 0.052	0.08	< 0.10	0.08	15	120	< 48	135.0
SE Sidewall	1.7	29	6.4	85	122.1	1,300	220	< 48	1,520.0
N Pothole	< 0.016	< 0.032	< 0.032	< 0.064	< 0.064	< 3.2	< 9.4	< 47	< 47
NW Pothole	< 0.018	< 0.035	< 0.035	< 0.071	< 0.071	< 3.5	< 9.3	< 49	< 49
W Pothole	< 0.094	< 0.19	2.1	17	19.1	790	210	< 49	1,000.0
W Pothole 2	< 0.02	< 0.039	< 0.039	< 0.079	< 0.079	< 3.9	< 9.6	< 48	< 48
E Pothole	< 0.014	< 0.028	< 0.028	< 0.055	< 0.055	< 2.8	< 9.8	< 49	< 49
SE Pothole	< 0.017	< 0.035	< 0.035	< 0.07	< 0.07	< 3.5	< 9.6	< 48	< 48
River Grab	< 0.017	< 0.033	< 0.033	< 0.067	< 0.067	< 3.3	< 10	< 50	< 50
Regulatory Criteria	10	--	--	--	50	--	--	--	100

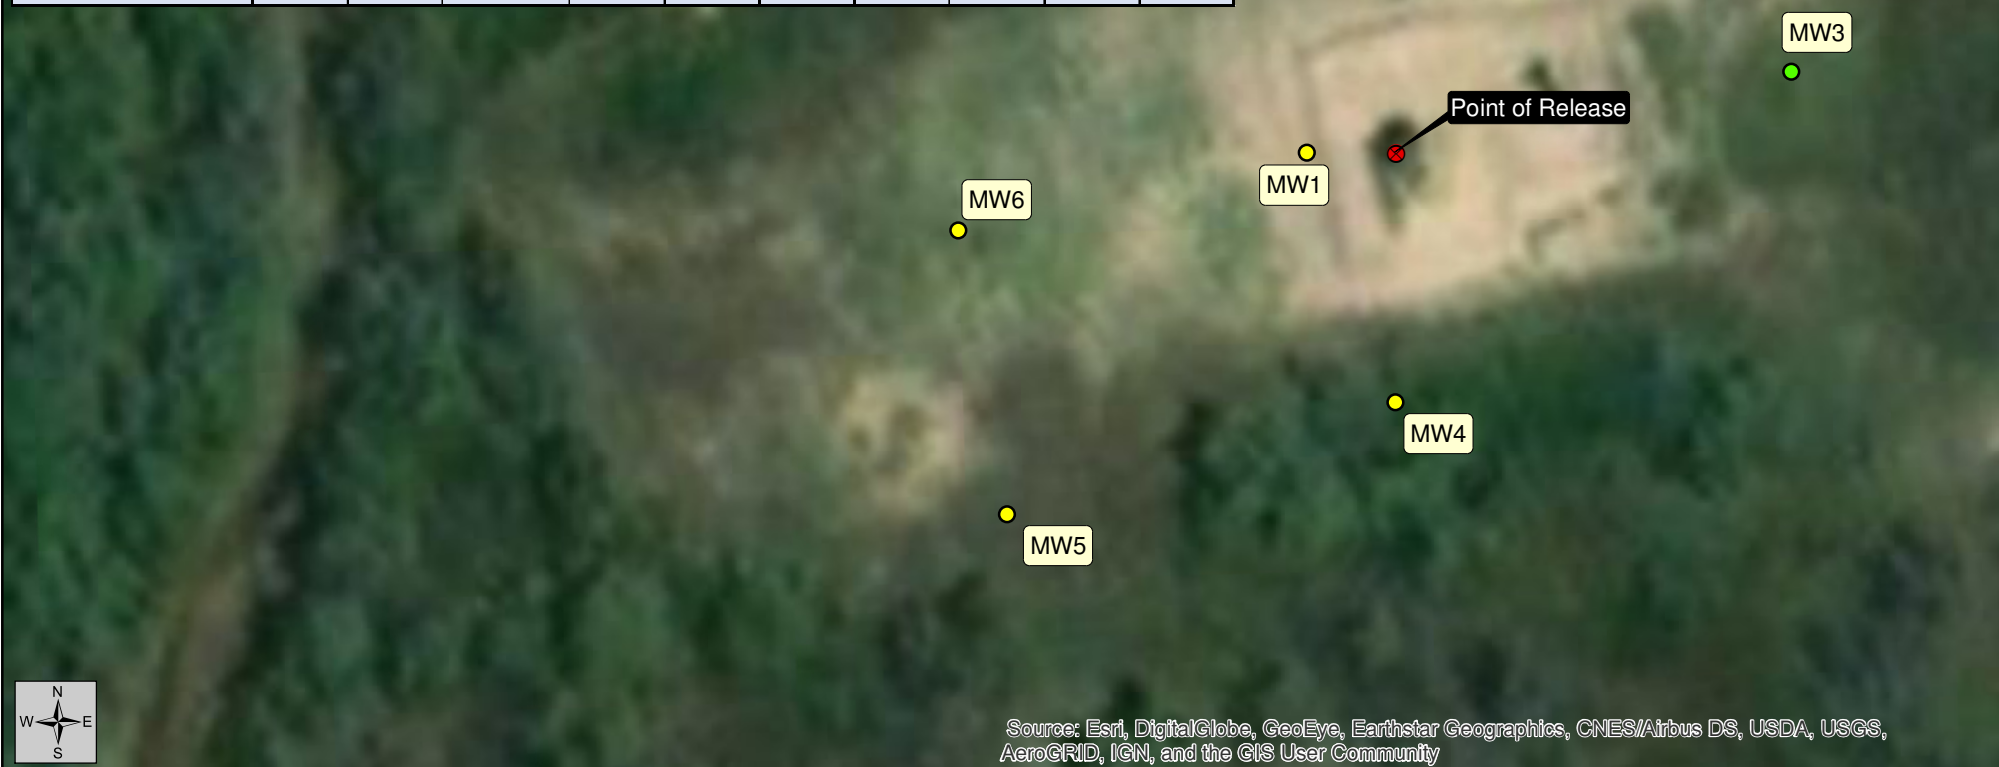
Figure 5
Site Characterization -
Sample Location Map

At least two intervals were selected from each boring for laboratory analysis. The selected samples included the depth interval exhibiting the highest PID reading, groundwater interface and/or boring terminus. Sample locations from the initial assessment are presented in Figure 4; soil borings installed during the site characterization are shown in Figure 5.

Sample ID	Date	Volatile Organic Compounds (mg/kg)				Total BTEX (mg/kg)	Chloride (mg/kg)	TPH-DRO (mg/kg)	TPH-MRO (mg/kg)	TPH-GRO (mg/kg)	Total TPH (mg/kg)
		Benzene	Toluene	Ethylbenzene	Xylenes						
MW1 2.5-3.5'	01/15/19	0.96	22	7	92	121.96	< 30	600	< 49	1,200	1,800
MW1 4.5-5.5'	01/15/19	< 0.025	< 0.049	< 0.049	0.12	0.12	< 30	31	< 46	< 4.9	31
MW1 6.5-7.5'	01/15/19	< 0.023	< 0.046	< 0.046	< 0.092	< 0.0092	< 30	20	48	4.7	72.7
MW1 14-15'	01/15/19	< 0.025	< 0.05	< 0.05	< 0.1	< 0.1	< 30	< 9.3	< 47	< 5.0	< 47
MW2 5'	01/14/19	< 0.024	< 0.048	< 0.048	< 0.096	< 0.096	< 30	< 9.2	< 46	< 4.8	< 46
MW2 6.5-7.5'	01/14/19	< 0.024	< 0.048	< 0.048	< 0.096	< 0.096	< 30	18	< 49	< 4.8	18
MW3 5.0-5.5'	01/14/19	< 0.024	< 0.049	< 0.049	< 0.098	< 0.098	< 30	< 9.8	< 49	< 4.9	< 49
MW3 6.5-7.5'	01/14/19	< 0.024	< 0.049	< 0.049	< 0.097	< 0.097	< 30	< 9.4	< 47	< 4.9	< 47
MW4 5-6'	01/15/19	< 0.024	< 0.048	< 0.048	< 0.096	< 0.096	< 30	< 9.8	< 49	< 4.8	< 49

MW4 8-9'	01/15/19	< 0.024	< 0.047	< 0.047	< 0.094	< 0.094	< 30	130	< 50	< 4.7	130
MW5 4.5-5.5'	01/15/19	< 0.024	< 0.048	< 0.048	< 0.097	< 0.097	< 30	< 9.8	< 49	< 4.8	< 49
MW5 8-9'	01/15/19	< 0.024	< 0.049	< 0.049	< 0.098	< 0.098	< 30	86	< 47	29	115
MW5 14.5-15.5'	01/15/19	< 0.023	< 0.046	< 0.046	< 0.093	< 0.093	< 30	< 9.5	< 47	< 4.6	< 47
MW6 5.0-5.5'	01/14/19	< 0.025	< 0.05	< 0.05	< 0.099	< 0.099	< 30	10	< 49	10	20
MW6 7.5-8.5'	01/14/19	< 0.025	0.057	< 0.05	< 0.1	< 0.1	< 30	110	< 49	120	230
Regulatory Criteria		10	--	--	--	50	600	--	--	--	100

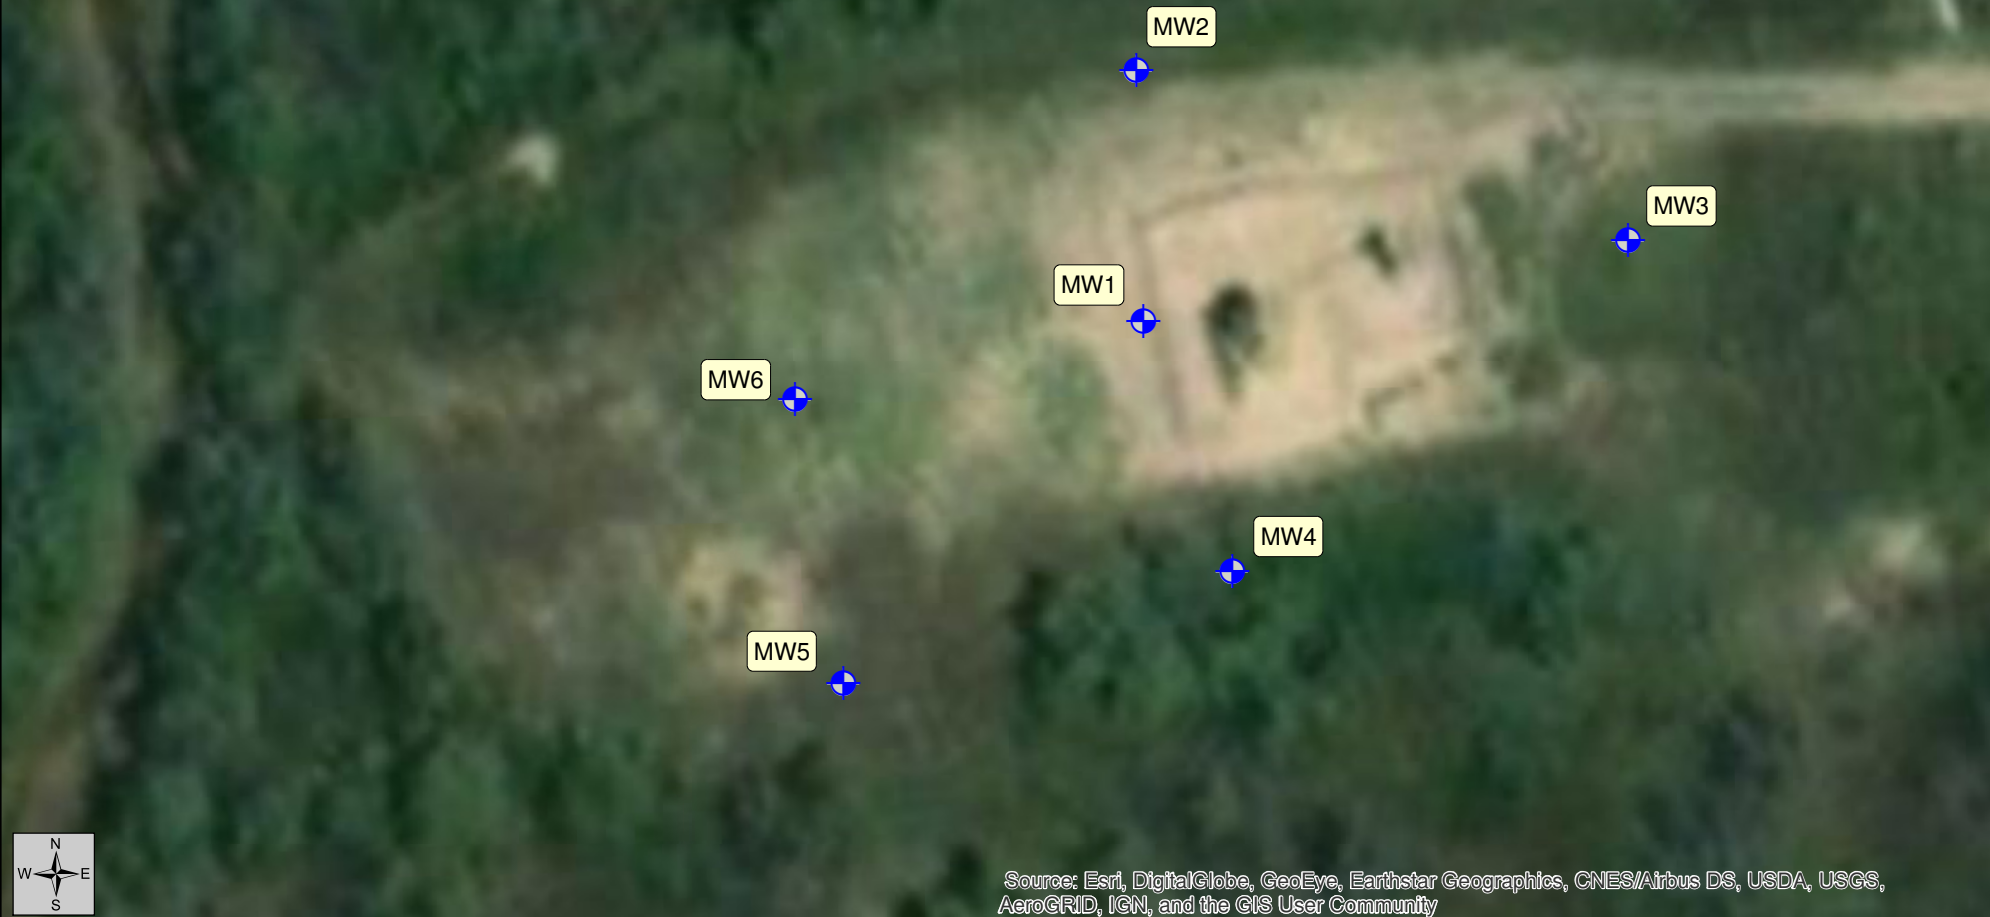
Figure 6
Monitor Well Location Map

Sample ID	Date	Volatile Organic Compounds (mg/L)				Chloride (mg/L)	TPH-GRO (mg/L)	TPH-DRO (mg/L)	TPH-MRO (mg/L)	Total TPH (mg/L)
		B	T	E	X					
MW1	01/18/19	0.074	0.35	0.027	0.33	130	2.0	< 1.0	< 5.0	2.0
MW2	01/17/19	< 0.001	< 0.001	< 0.001	< 0.0015	150	< 0.05	< 1.0	< 5.0	< 5.0
MW3	01/17/19	< 0.001	< 0.001	< 0.001	< 0.0015	140	< 0.05	< 1.0	< 5.0	< 5.0
MW4	01/17/19	< 0.001	< 0.001	< 0.001	< 0.0015	140	< 0.05	< 1.0	< 5.0	< 5.0
MW5	01/17/19	< 0.001	< 0.001	< 0.001	< 0.0015	130	0.32	< 1.0	< 5.0	0.32
MW6	01/18/19	< 0.001	< 0.001	< 0.001	< 0.0015	180	1.1	< 1.0	< 5.0	1.1
Regulatory Criteria		0.01	0.75	0.75	0.62	250	--	--	--	--

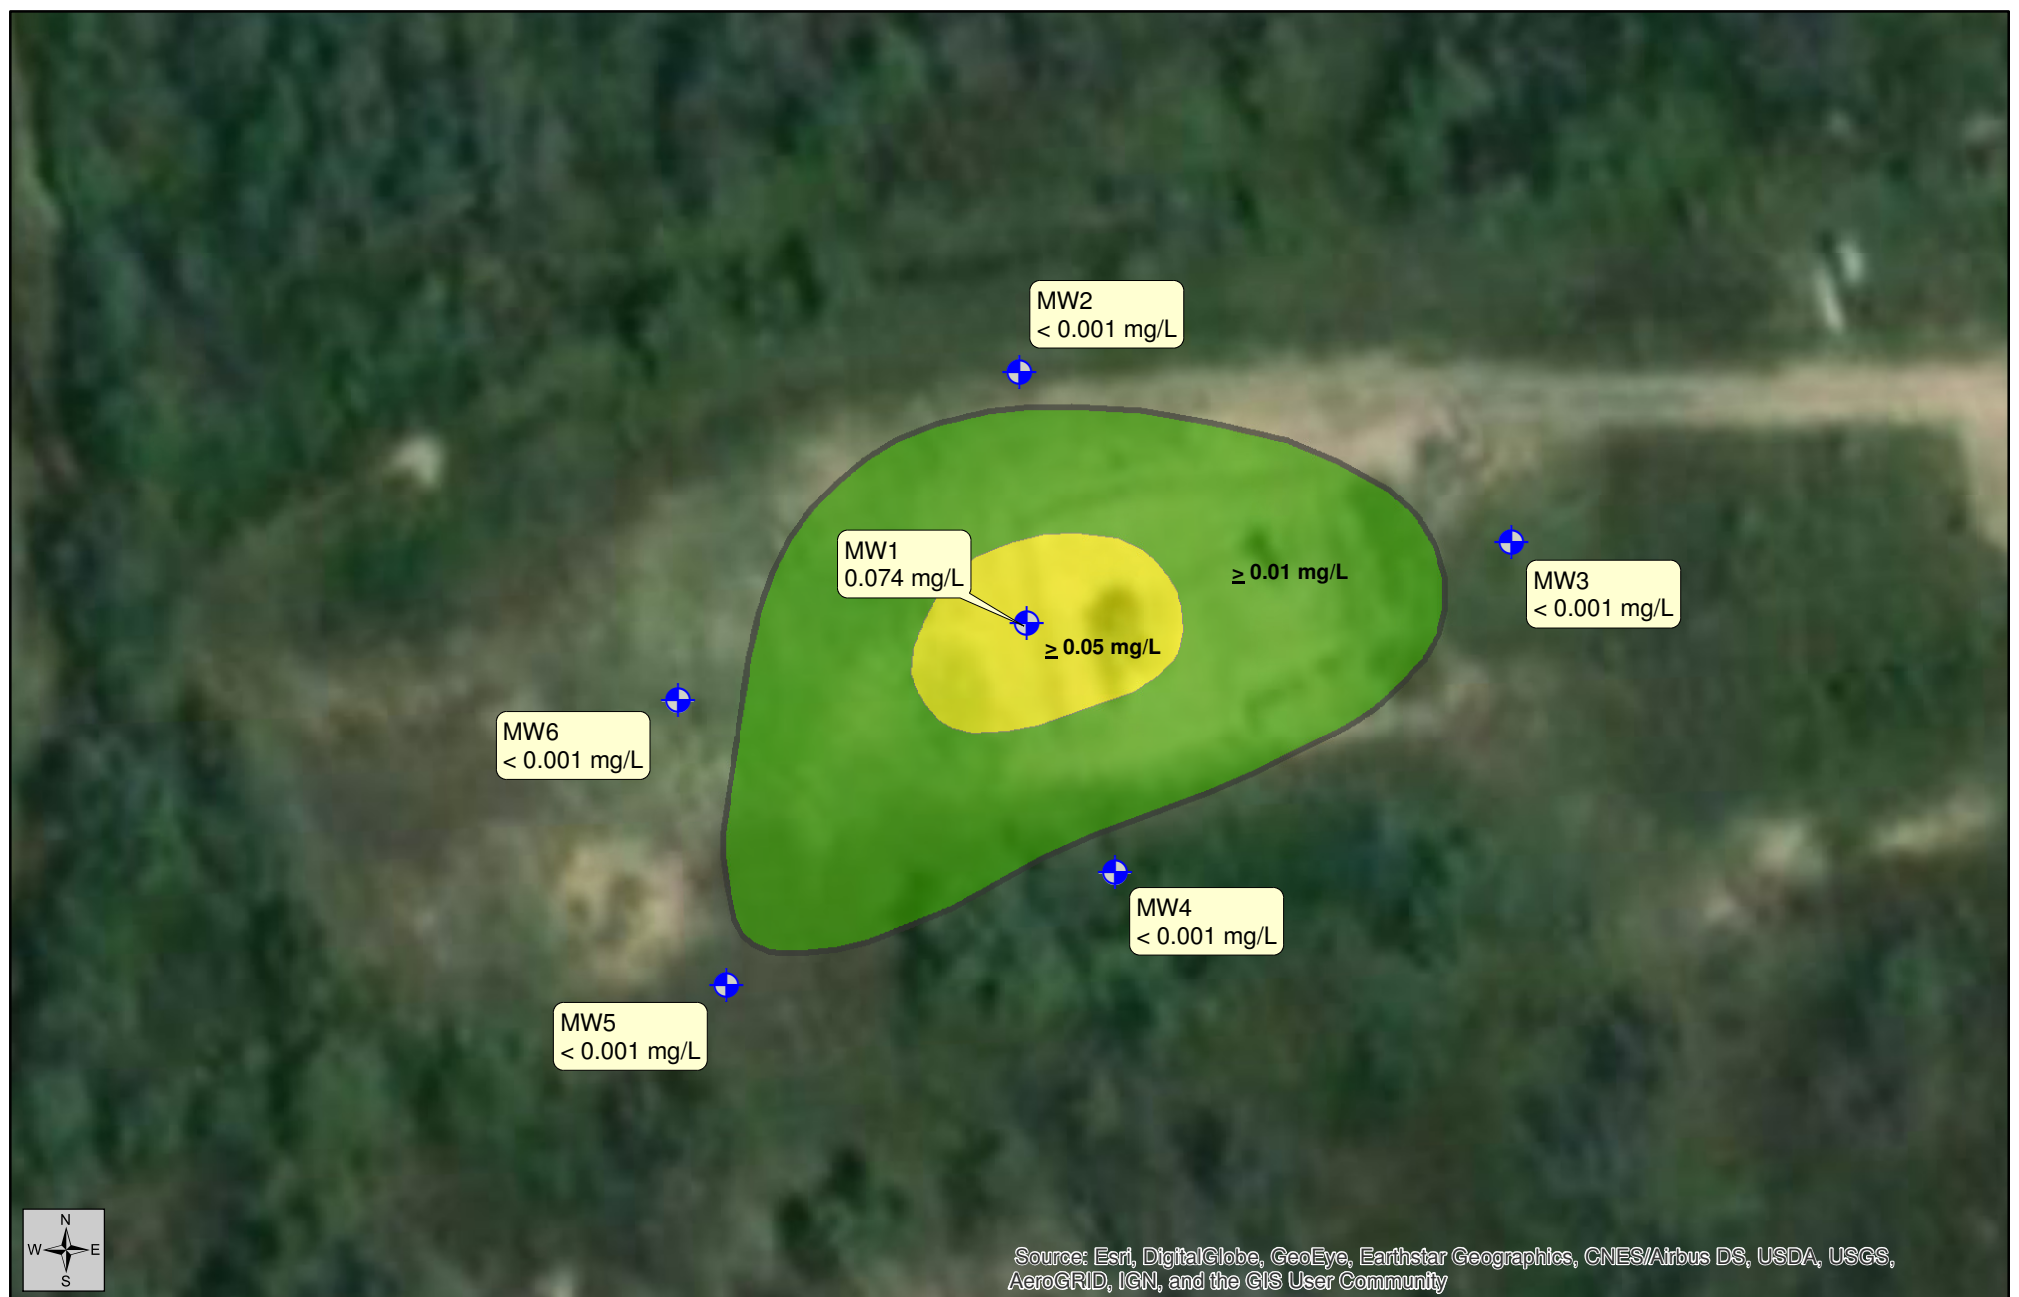
Figure 7
Bezene Plume Map

Benzene was the only COC identified within Site groundwater. Benzene was observed in only 1 well (i.e., MW1) situated immediately adjacent and downgradient of the point of release. Benzene was horizontally delineated. A benzene plume map is provided in Figure 7. Groundwater samples collected from MW5 and MW6 exceeded laboratory detection limits for GRO (i.e., 0.32 mg/L and 1.1 mg/L, respectively); however, neither the NMOCD nor NMDEQ has established criteria for petroleum hydrocarbons (i.e., TPH) in groundwater.

Benzene: ≥ 0.05 mg/L

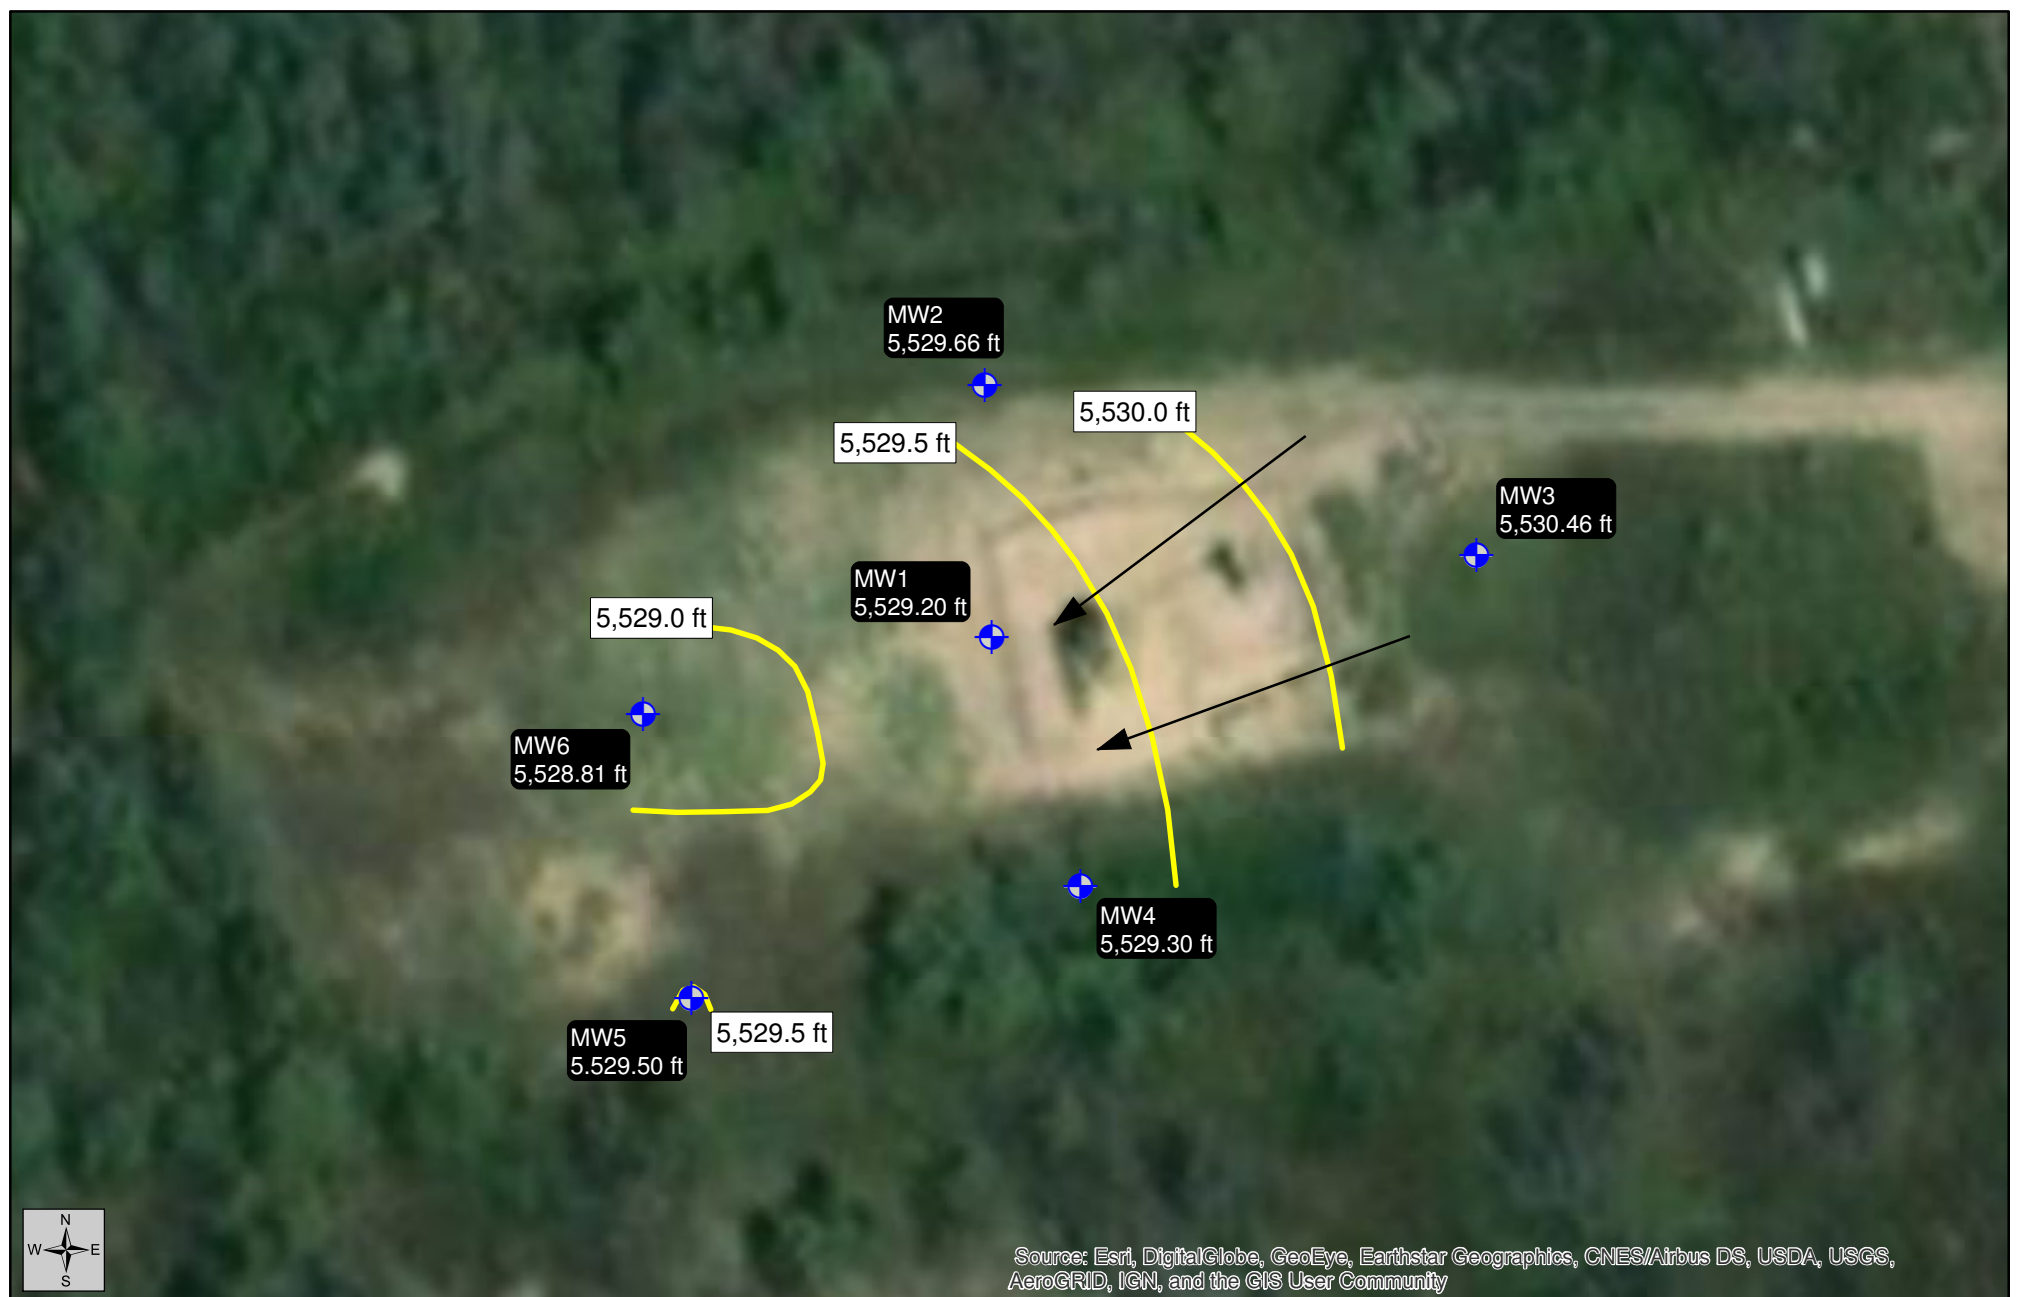
Figure 8
Potentiometric Surface Map

Each well was gauged to determine the depth to water using an oil-water interface probe capable of measuring to the nearest one-hundredth foot. No phase separated hydrocarbons (PSH) were observed. An elevation survey was conducted on the tops of monitor well casings using a survey rod and laser level transit. Depths to groundwater were subtracted from the corresponding monitor well elevation to determine the depth of groundwater above mean sea level in each well.

- Monitor Well
- Groundwater Gradient
- Groundwater Flow

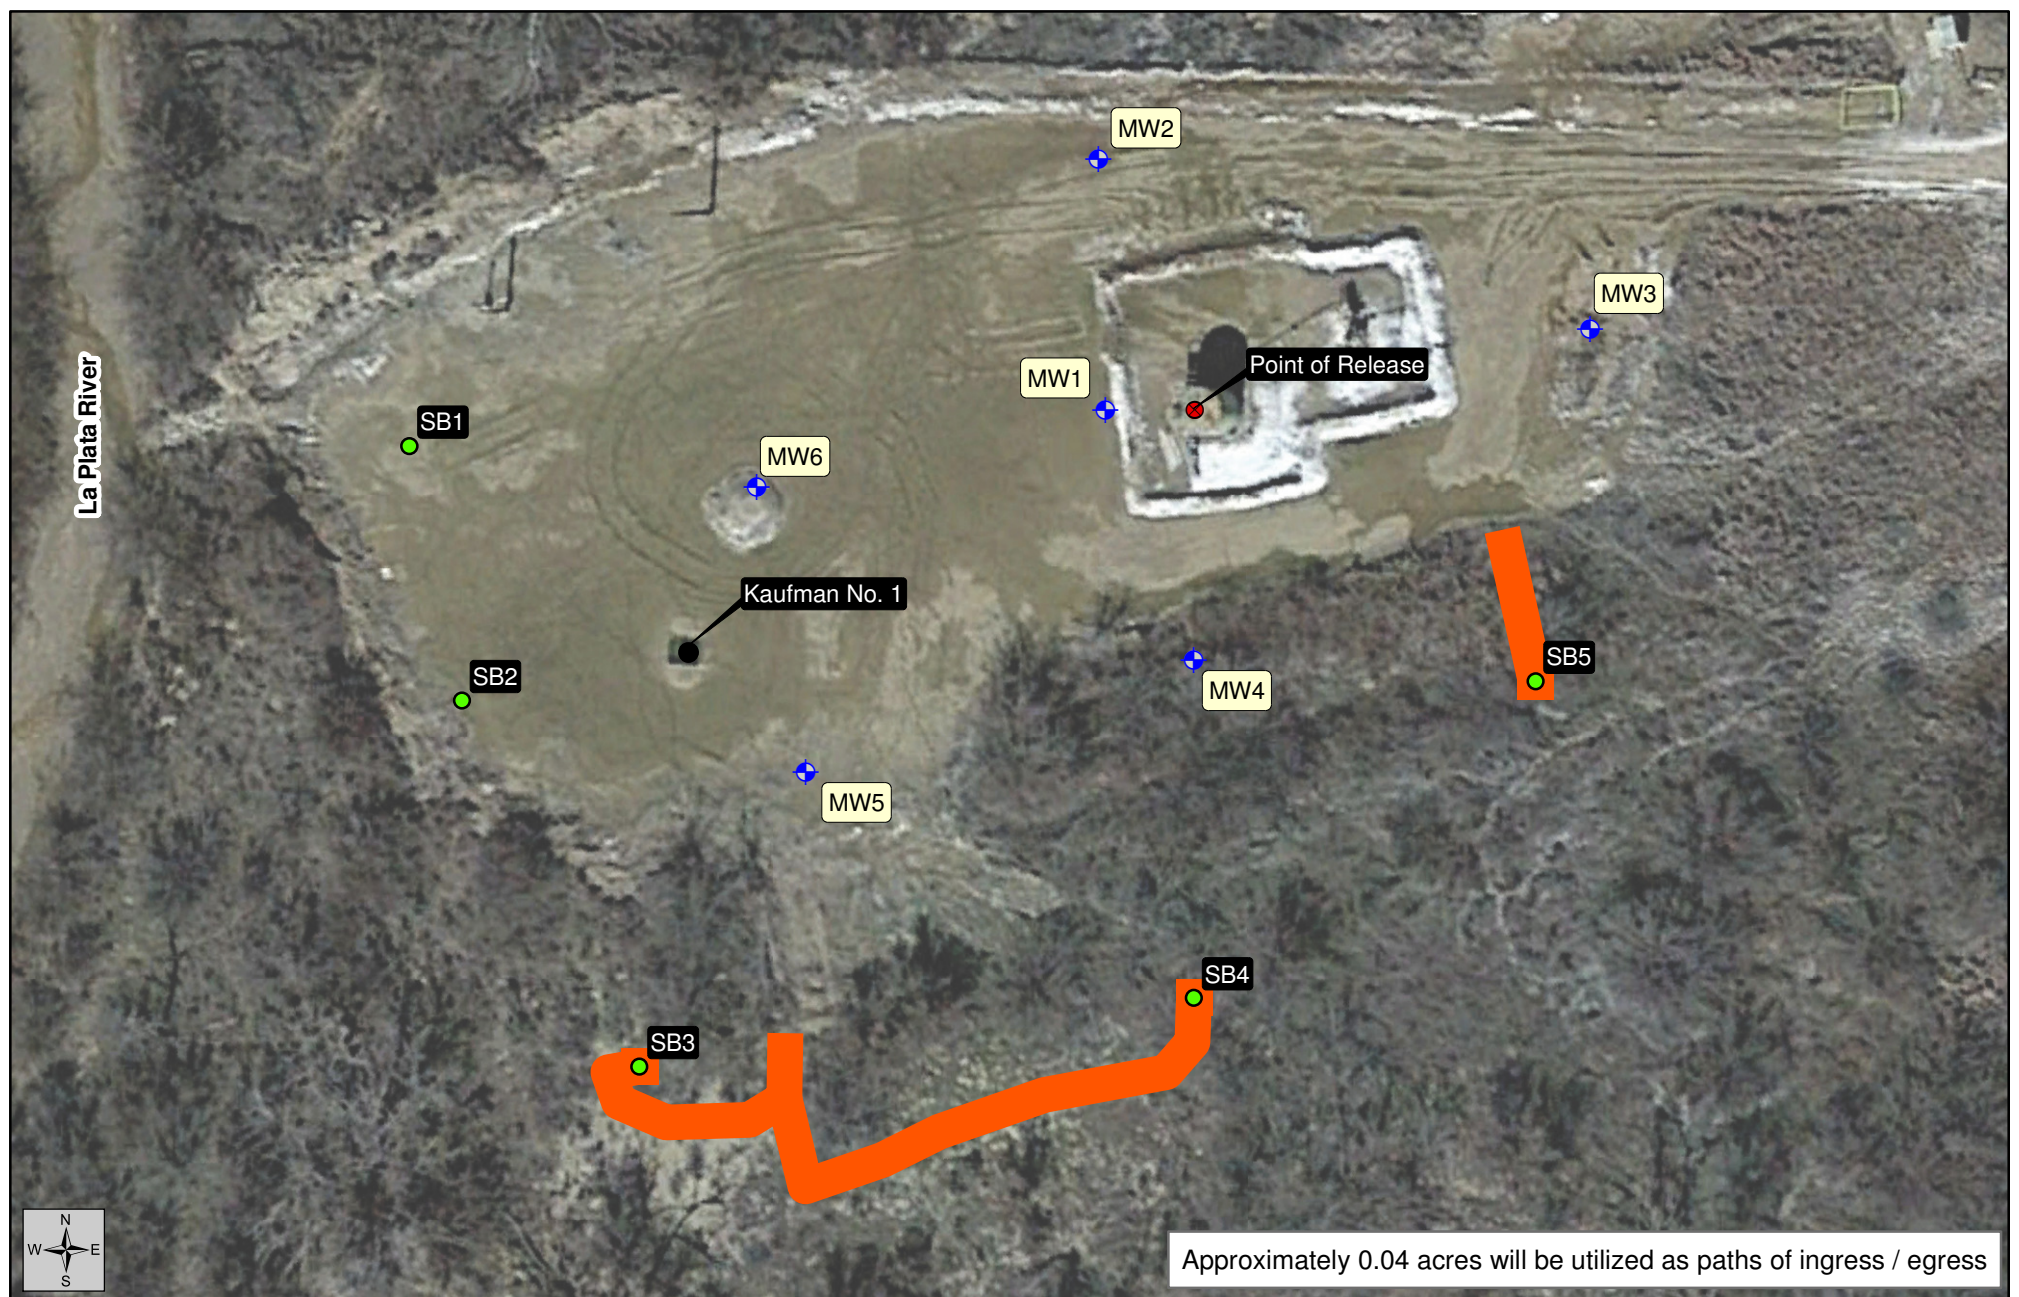
Figure 9
Proposed Soil Boring Locations

- Point of Release
- ◆ Monitor Well
- Proposed Soil Boring
- Kaufman No. 1 Well Head
- Paths of Ingress / Egress

- 1) horizontally delineate historical soil impacts located south, southwest, and west of the former tank battery
- 2) assess of the vadose zone to determine the leachability of Site soil
- 3) conduct an ecological risk assessment to ensure that risk to area threaten and endangered species is mitigated
- 4) conduct additional groundwater sampling and analysis to determine if elevated total dissolved solids (TDS) observed in a monitor well located near the point of release is a native condition of Site groundwater or is related to the release
- 5) conduct a receptor survey to identify water wells within a one-mile radius of the Site and sensitive features within a quarter-mile of the Site
- 6) conform with New Mexico Administrative Code (NMAC) 19.15.30 Remediation and provide sufficient data to present a stage 2 abatement plan
