Closure

CLOSURE REPORT

**Canyon Largo 147 Drip Line Release
NW ¼, S2 T25N R6W
Rio Arriba County, New Mexico**

August 8, 2019
Ensolum Project No. 05A1226044

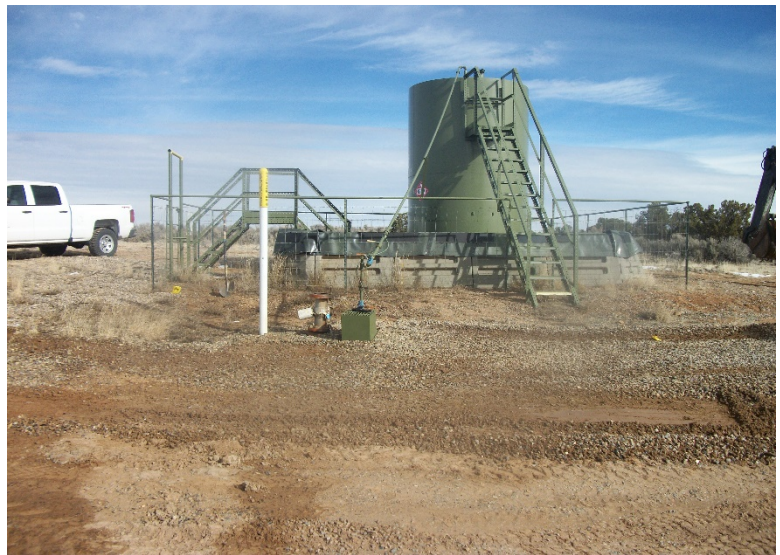
Photograph 1

Photograph Description: View of the release area.

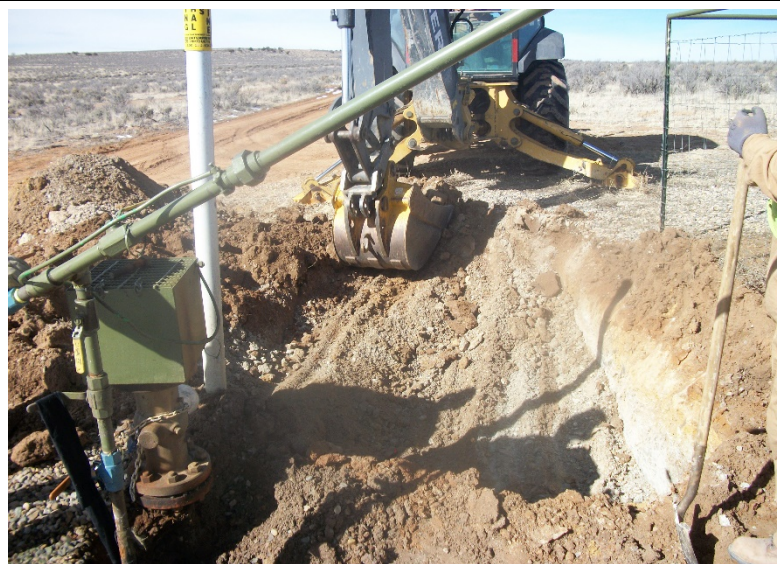
Photograph 2

Photograph Description: View of the in process excavation activities.

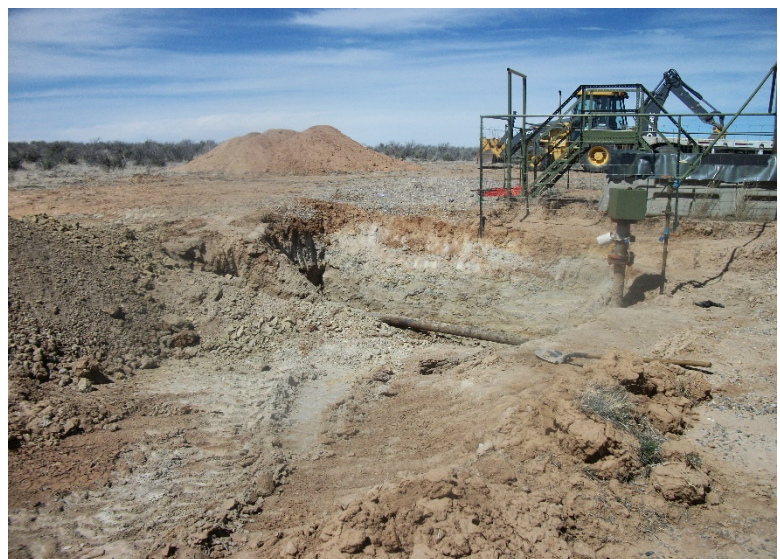
Photograph 3

Photograph Description: View of the in process excavation activities.

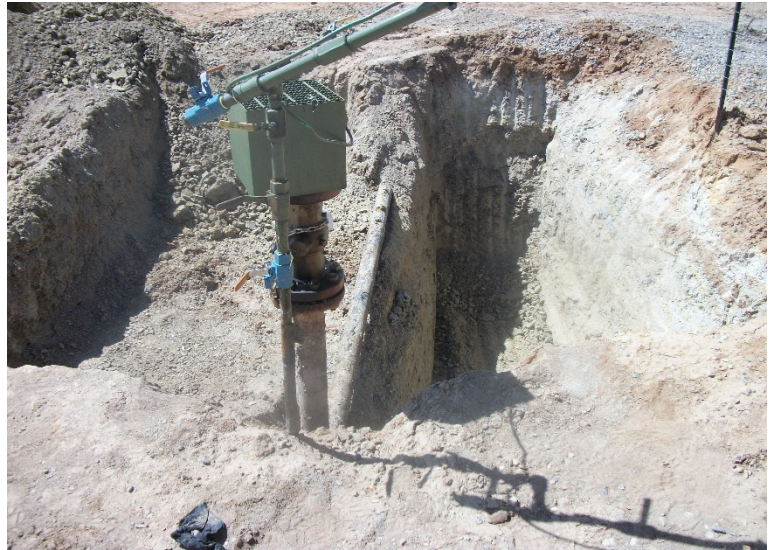
Photograph 4

Photograph Description: View of the in process excavation activities.

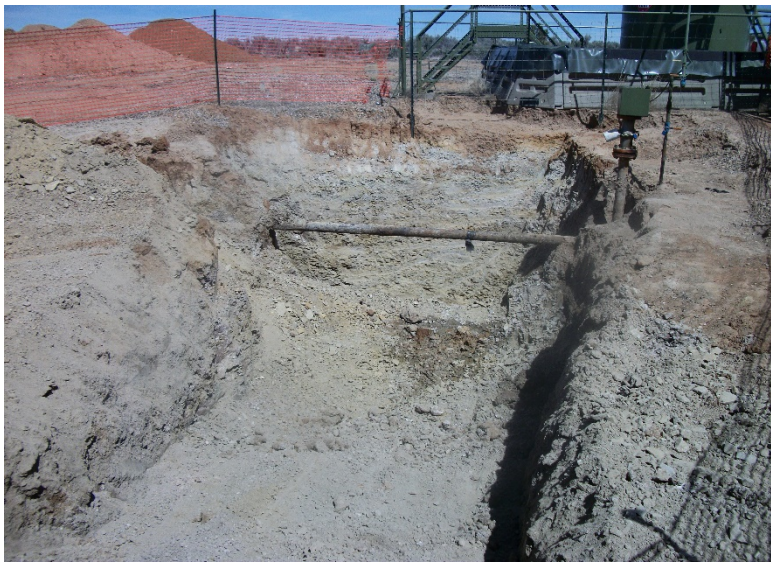
Photograph 5

Photograph Description: View of the in process excavation activities.

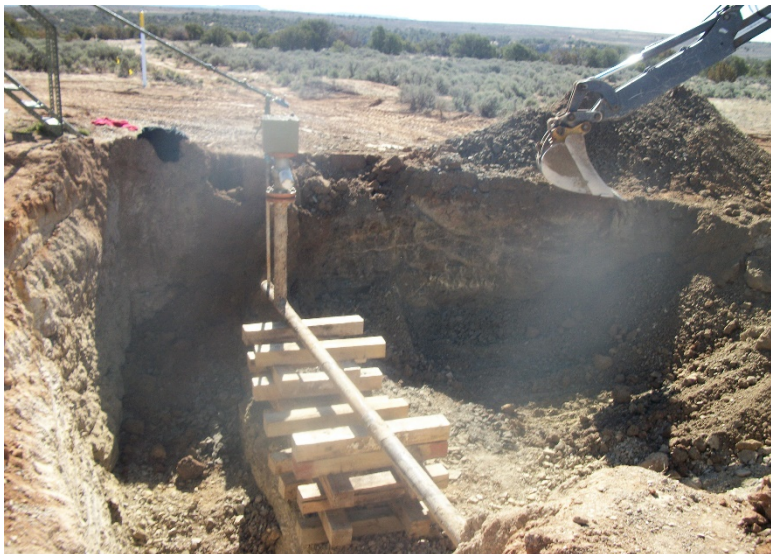
Photograph 6

Photograph Description: View of the in process excavation activities.

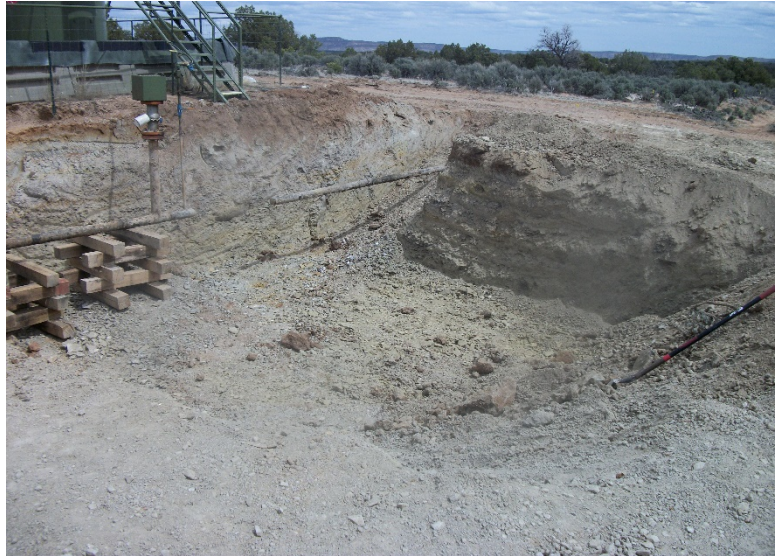
Photograph 7

The final excavation measured approximately 34 feet long and 38 feet wide at the maximum extents. The maximum depth of the excavation measured approximately 8 feet bgs, with some areas as shallow as 0.5 feet bgs.

Photograph Description: View of the final excavation.

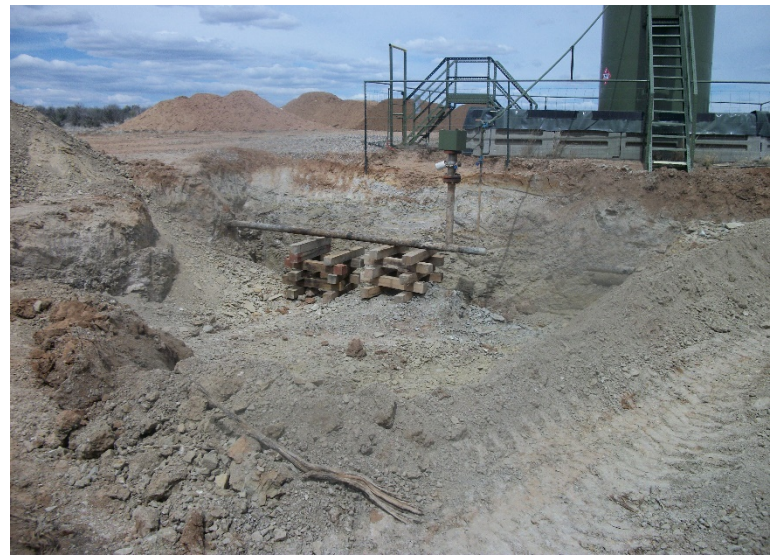
Photograph 8

Photograph Description: View of the final excavation.

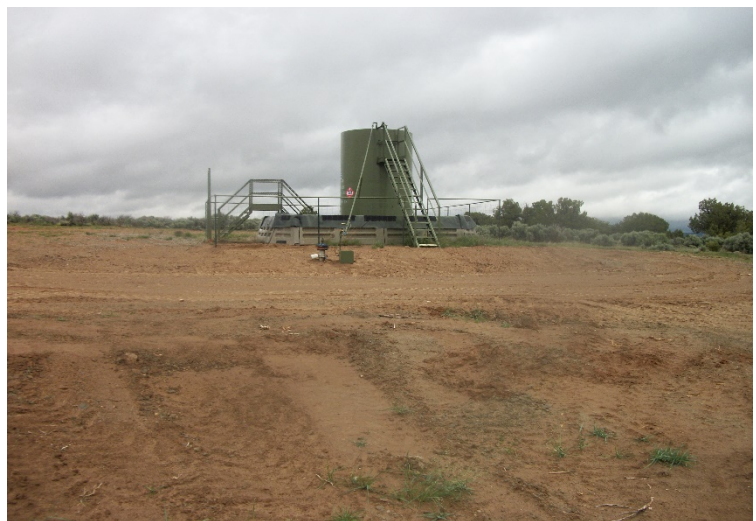
Photograph 9

Photograph Description: View of the final excavation after restoration.

The excavation was backfilled with imported fill and then contoured to the surrounding grade. The area will continue to be utilized as a driving surface.
