## Release Notification

Site Name	El Cedro Tank Battery	Site Type	Tank Battery
Date Release Discovered	6/21/2019	API# (if applicable)

Historic tank leak encountered during site work.

**NMOCD Site Assessment/Characterization, Remediation & Closure**

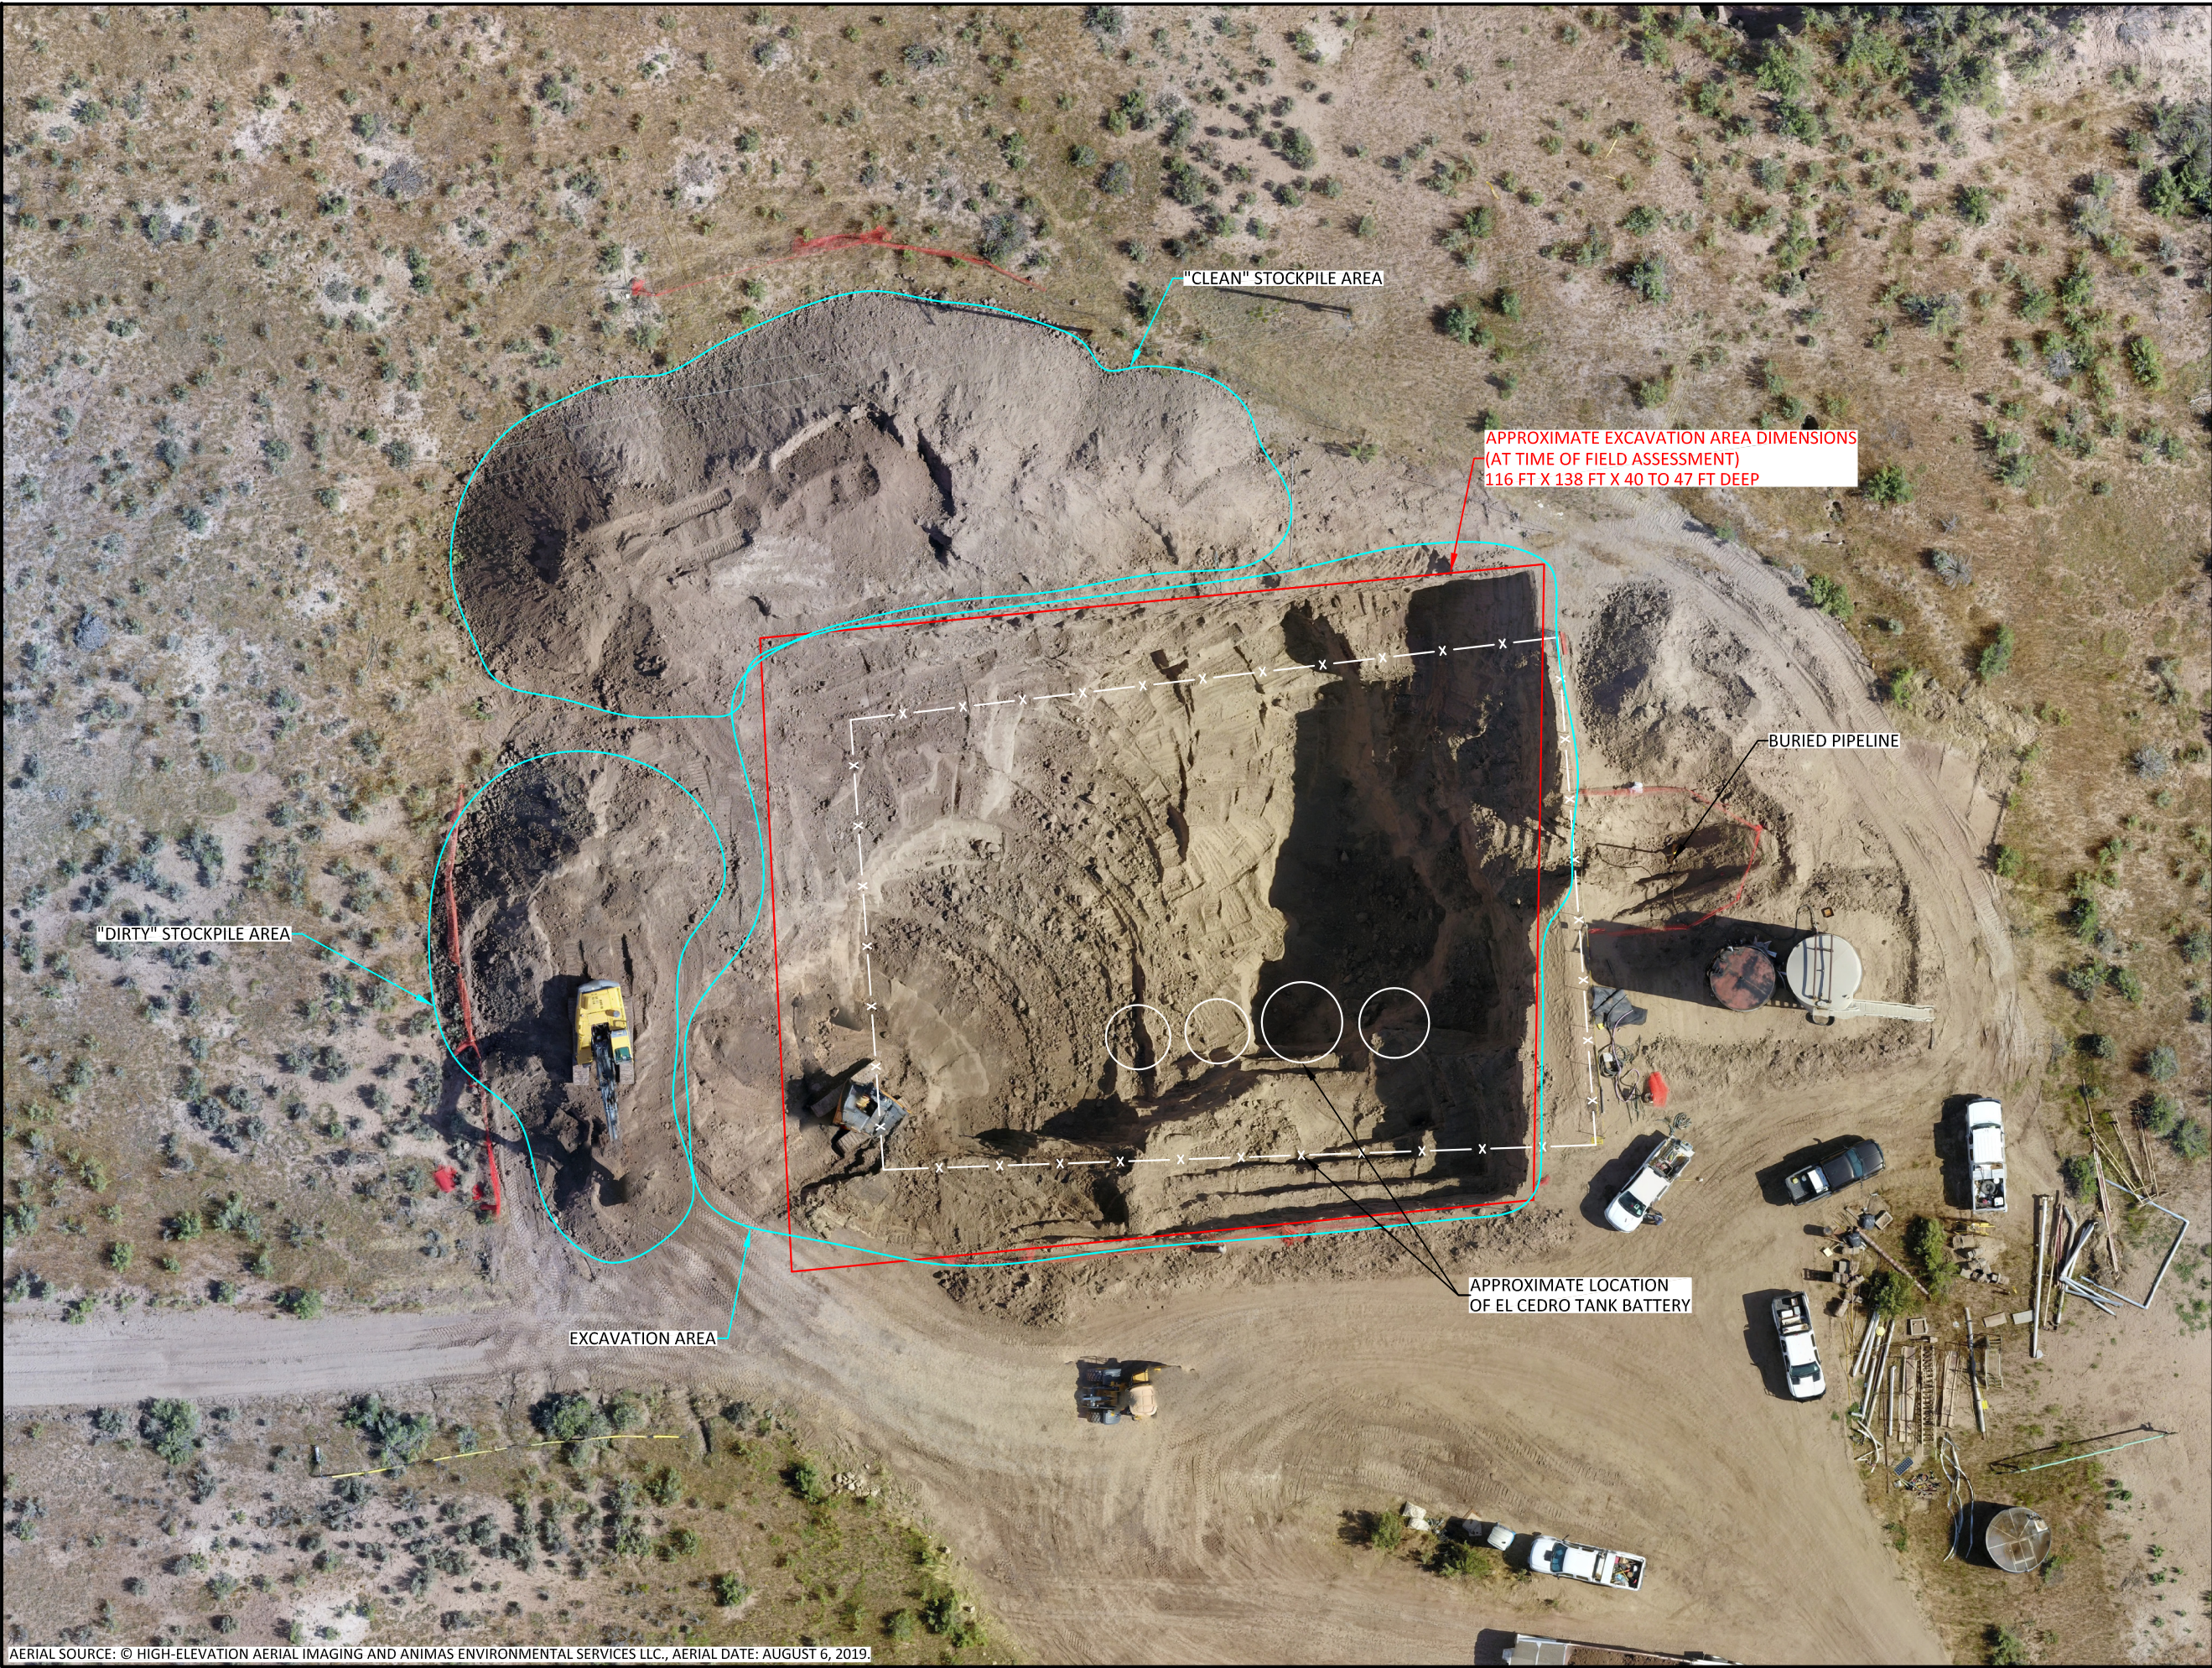
FIGURE 3

INITIAL EXCAVATION AERIAL MAP  
AUGUST 6, 2019  
HARVEST MIDSTREAM  
EL CEDRO TANK BATTERY  
INCIDENT NUMBER:  
SE¼ NW¼, SECTION 31, T29N, R5W  
RIO ARriba COUNTY, NEW MEXICO  
N36.68536, W107.40181

Excavation and disposal of PCS started on June 26, 2019 and continues to date - 2 confirmation sampling events have been conducted with results submitted to NMOCD on 8/22/19 and 9/4/19. To date, approximately 18,000 cy of soil have been transported to Industrial Ecosystems, Inc. (IEI) for disposal.
