CLOSURE

NMOCD Case No. : 1RP-5140

Site Name: Anderson Lease

Remediation Work Performed

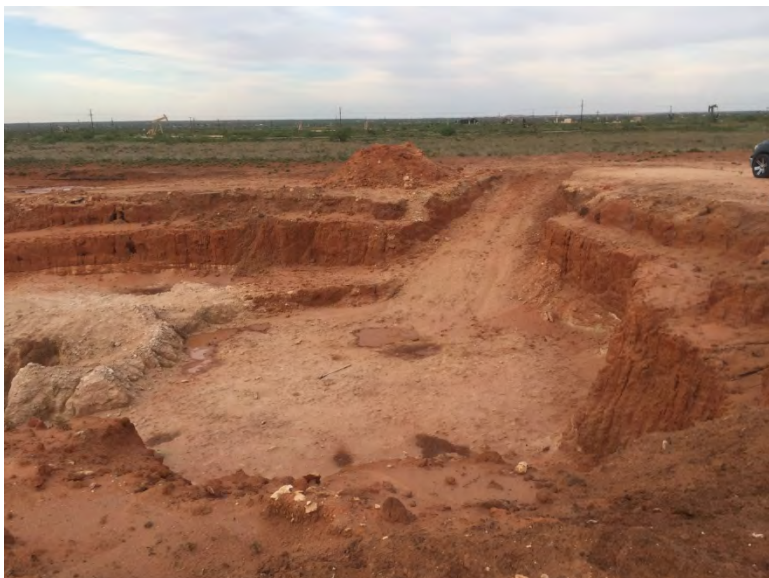
Photo #1: Pit excavation facing southeast prior to addition and mixing of chemical oxidants into grids M-N-O-P (7/1/19)

- On July 1, 2019, the upper 4-ft of soil in grids M-N-O-P at the south end of the pit excavation were loosened and homogenized with a trackhoe.
- Starting with the first treatment area, one supersack (2,240 lbs) of sodium persulfate ($\text{Na}_2\text{S}_2\text{O}_8$) was placed in the south half of grid cell M, followed by approximately 1,125 lbs of calcium hydroxide ($\text{Ca}(\text{OH})_2$).

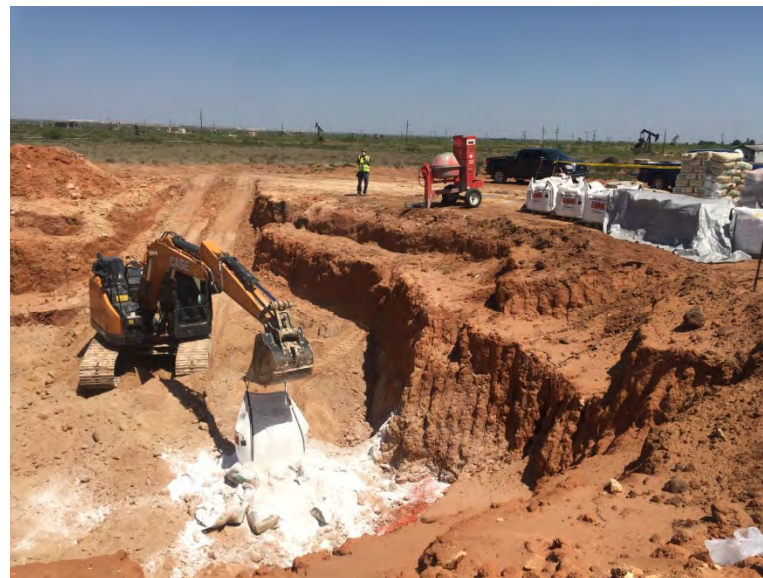
Photo #2: Addition of sodium persulfate into soil while still in dry state (grid M; 7/1/19)

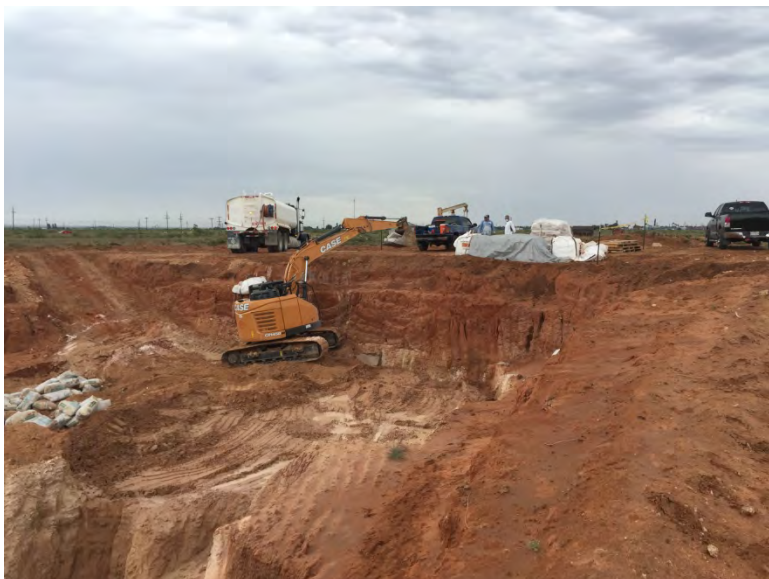
Photo #3: Adding calcium hydroxide on top of sodium persulfate prior to mixing into soil (grid P; 7/2/19)

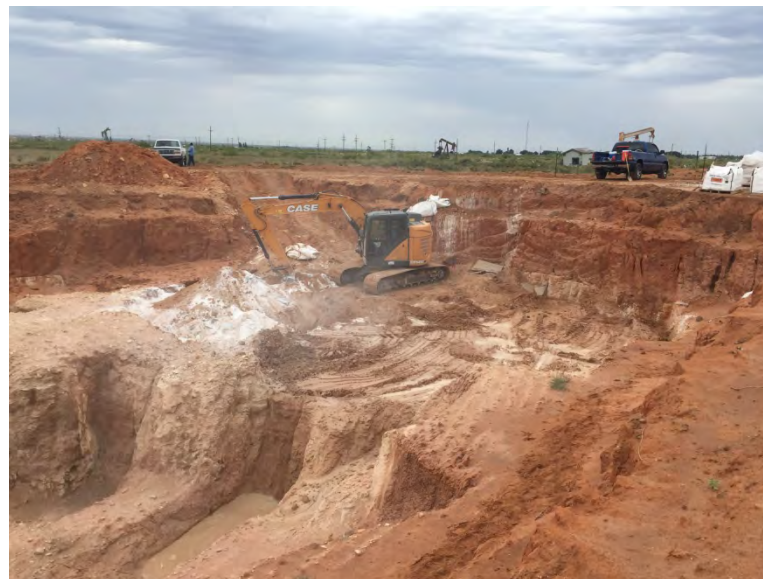
Photo #4: Dry-blending chemical oxidants (sodium persulfate and calcium hydroxide) into soil (grid P; 7/2/19)

- The chemical oxidants were then dry-blended with the upper 4-ft of soil such that it was well homogenized.
- Approximately 1,500 - 2,000 gallons of freshwater was then gradually added into the blend, and again homogenized to maximize contact between the oxidants and the impacted soil.

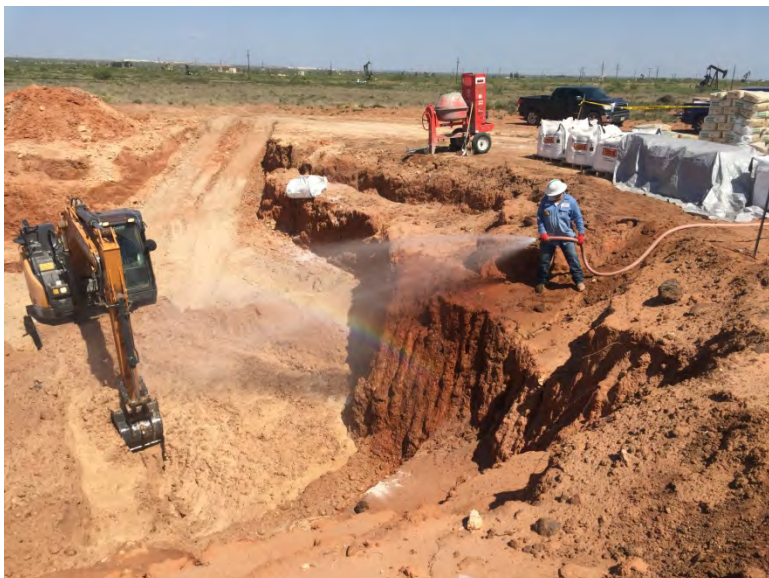
Photo #5: Blending chemical oxidants (sodium persulfate and calcium hydroxide) and freshwater with soil (grid M; 7/1/19)

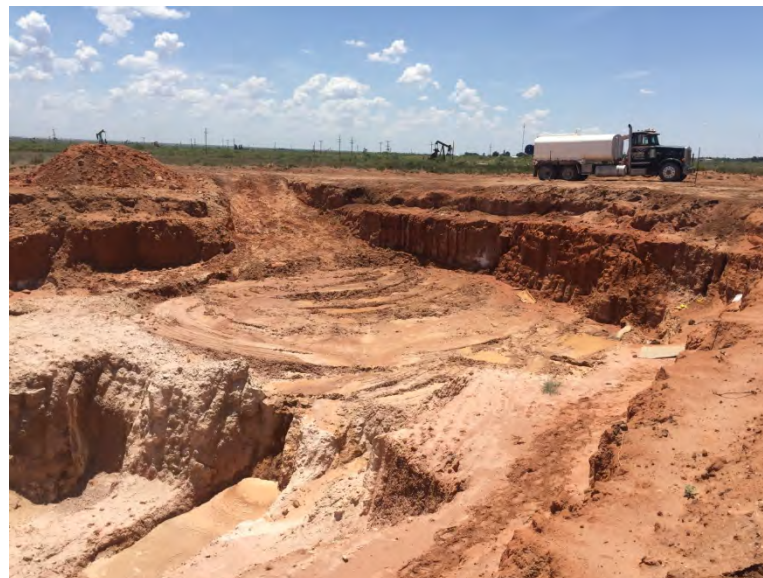
Photo #6: Pit excavation facing southeast after completion of chemical oxidation treatment in grids M-N-O-P (7/2/19)

- The above-described procedure was repeated for each cell until the entire M-N-O-P gridded area was treated over the two day period (July 1-2, 2019).
- A total of 17,920 lbs of sodium persulfate, approximately 9,000 lbs of calcium hydroxide, and 12,000 gal of freshwater were evenly and homogeneously blended within about 8,160 ft^3 of impacted soil at the base of the pit excavation in grid cells M-N-O-P.

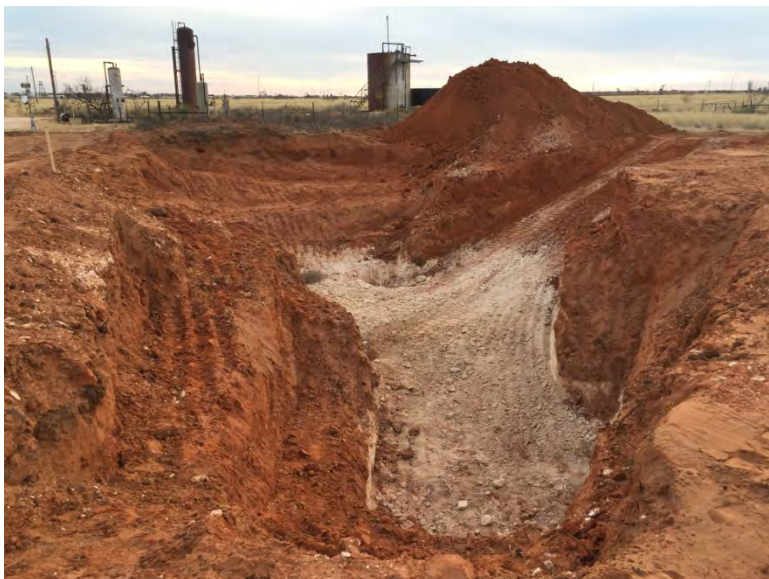
Photo #7: Vent excavation facing south prior to chemical oxidation treatment (01/10/19)

- The same basic procedures were performed within the smaller vent excavation on July 3rd, in which a total of 4,480 lbs of sodium persulfate, approximately 3,500 lbs of calcium hydroxide, and 3,000 gal of freshwater were blended within about 3,000 ft^3 of impacted soil at the base of the vent excavation.

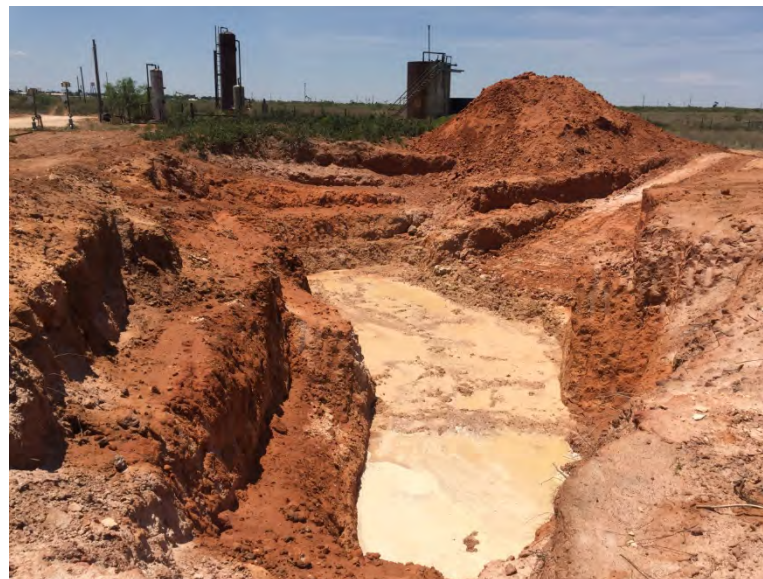
Photo #8: View facing south at vent excavation after completion of chemical oxidation treatment (7/3/19)

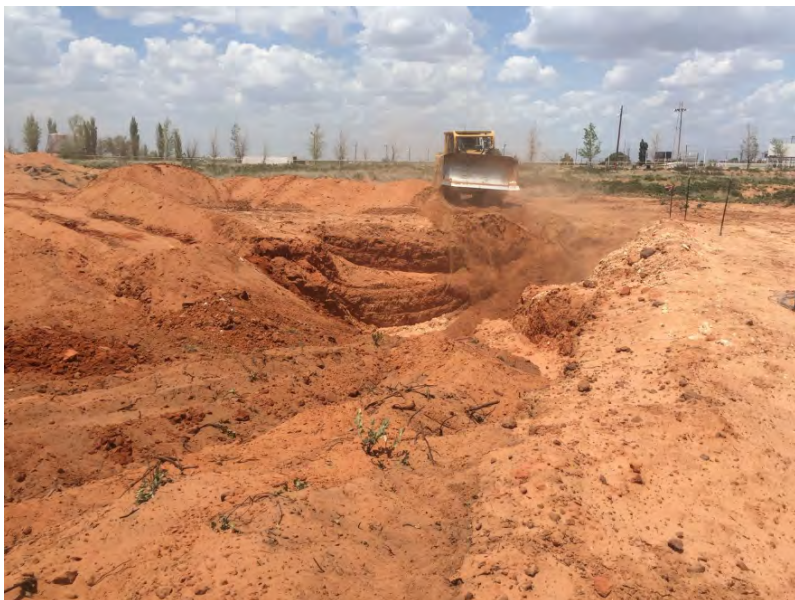
Photo #9: View facing northeast showing backfilling clean soil into vent excavation (7/31/19)

Both excavations were backfilled with clean native soil obtained from adjacent non-impacted areas of the property, per agreement with the private landowner, and gently sloped towards the east-southeast direction which is consistent and proportional to the pre-existing grade.

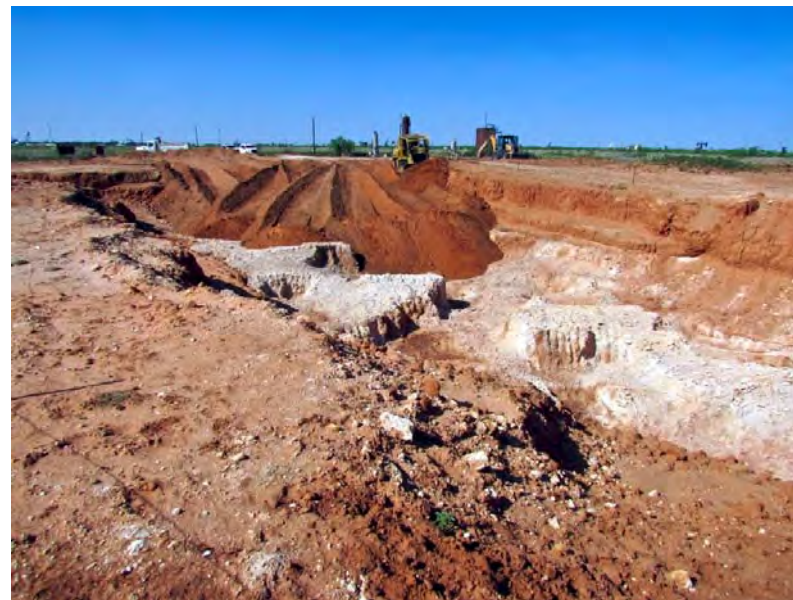
Photo #10: View facing southwest showing backfilling clean soil into pit excavation (8/1/19)

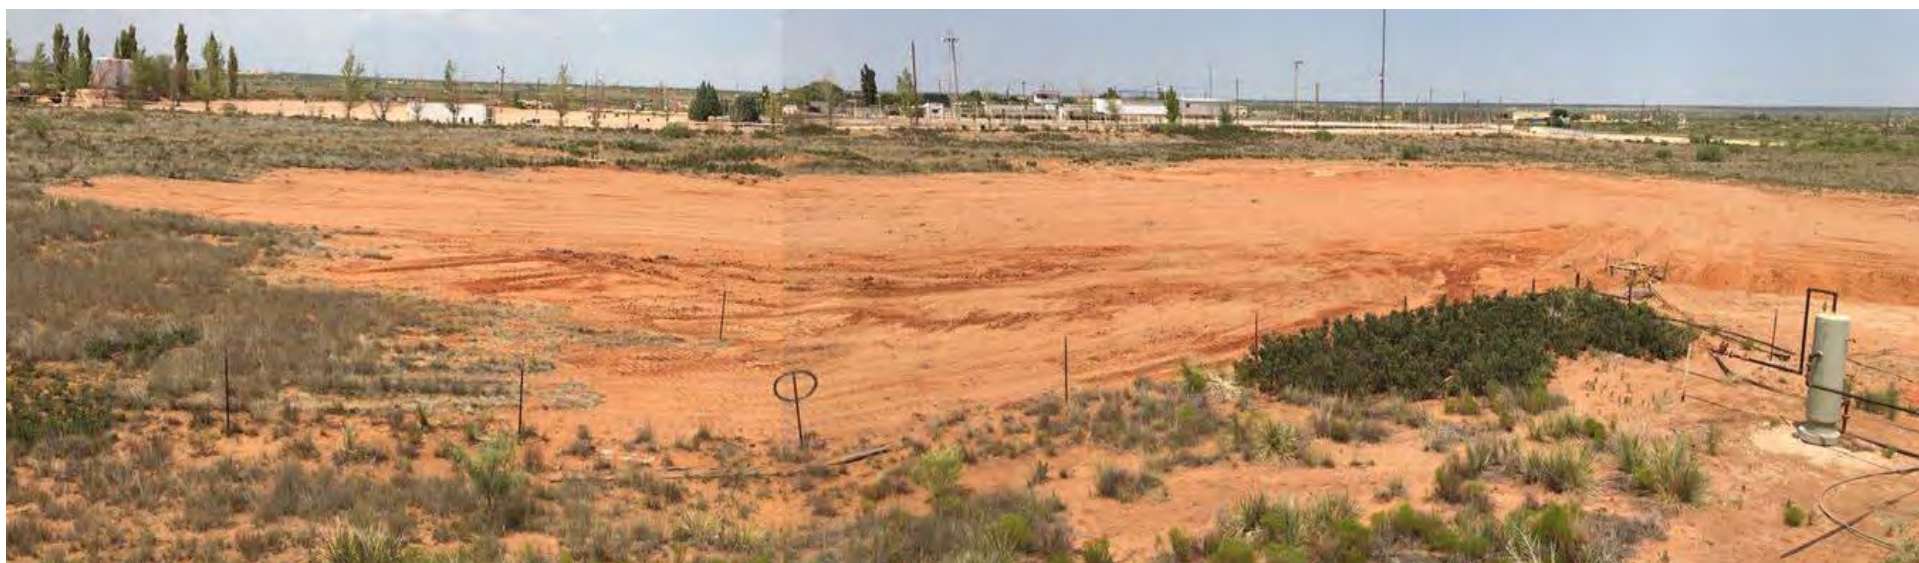
Photo #11: Panoramic view facing northeast showing final backfill of both vent and pit excavation areas (8/6/19)

Clean top soil containing plenty of grass and seed that had been set aside was applied over the entire excavated area for final cover to re-establish the native vegetation. Photographs of backfilling activities are included at the end of Attachment A.
