1Q 2020

Status Report

AP-138

Re: Status Report – 1st Quarter 2020
Kaufman No. 1
San Juan County, New Mexico
OCD No.: AP-0138

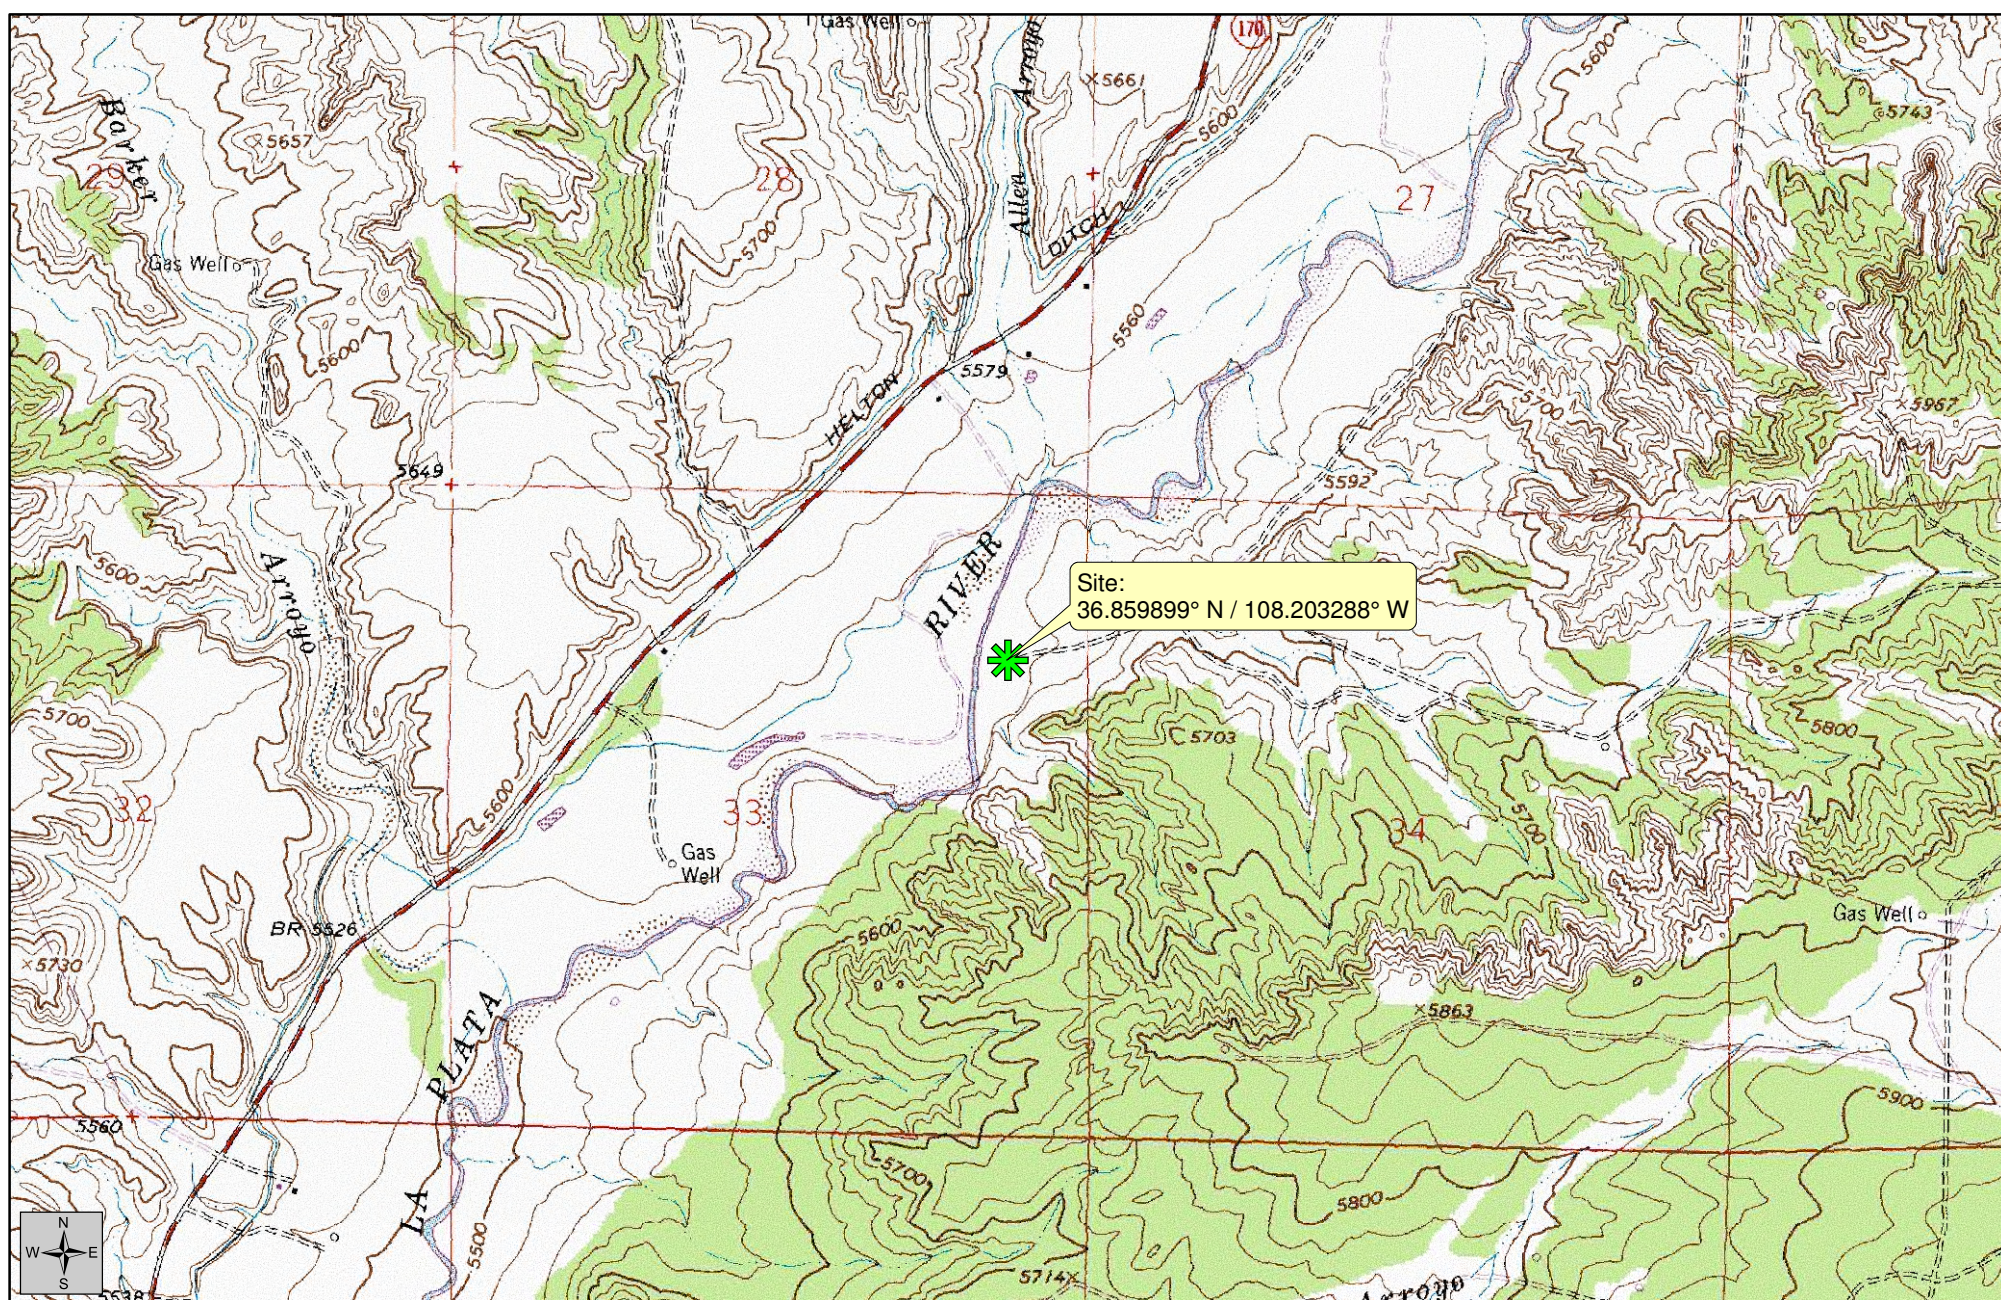
Figure 2
Topographic Map

The Site is situated on Federal land (managed by the Bureau of Land Management (BLM)) and is immediately east of the La Plata River (Figures 2 and 3). The Site is comprised of approximately 1 acre, all of which is located within the La Plata River flood plain and adjacent to riparian zones or wetlands.

The average elevation at the Site is approximately 5,537 feet above mean sea level. Area topography is flat with a slight dip west, toward the La Plata River.

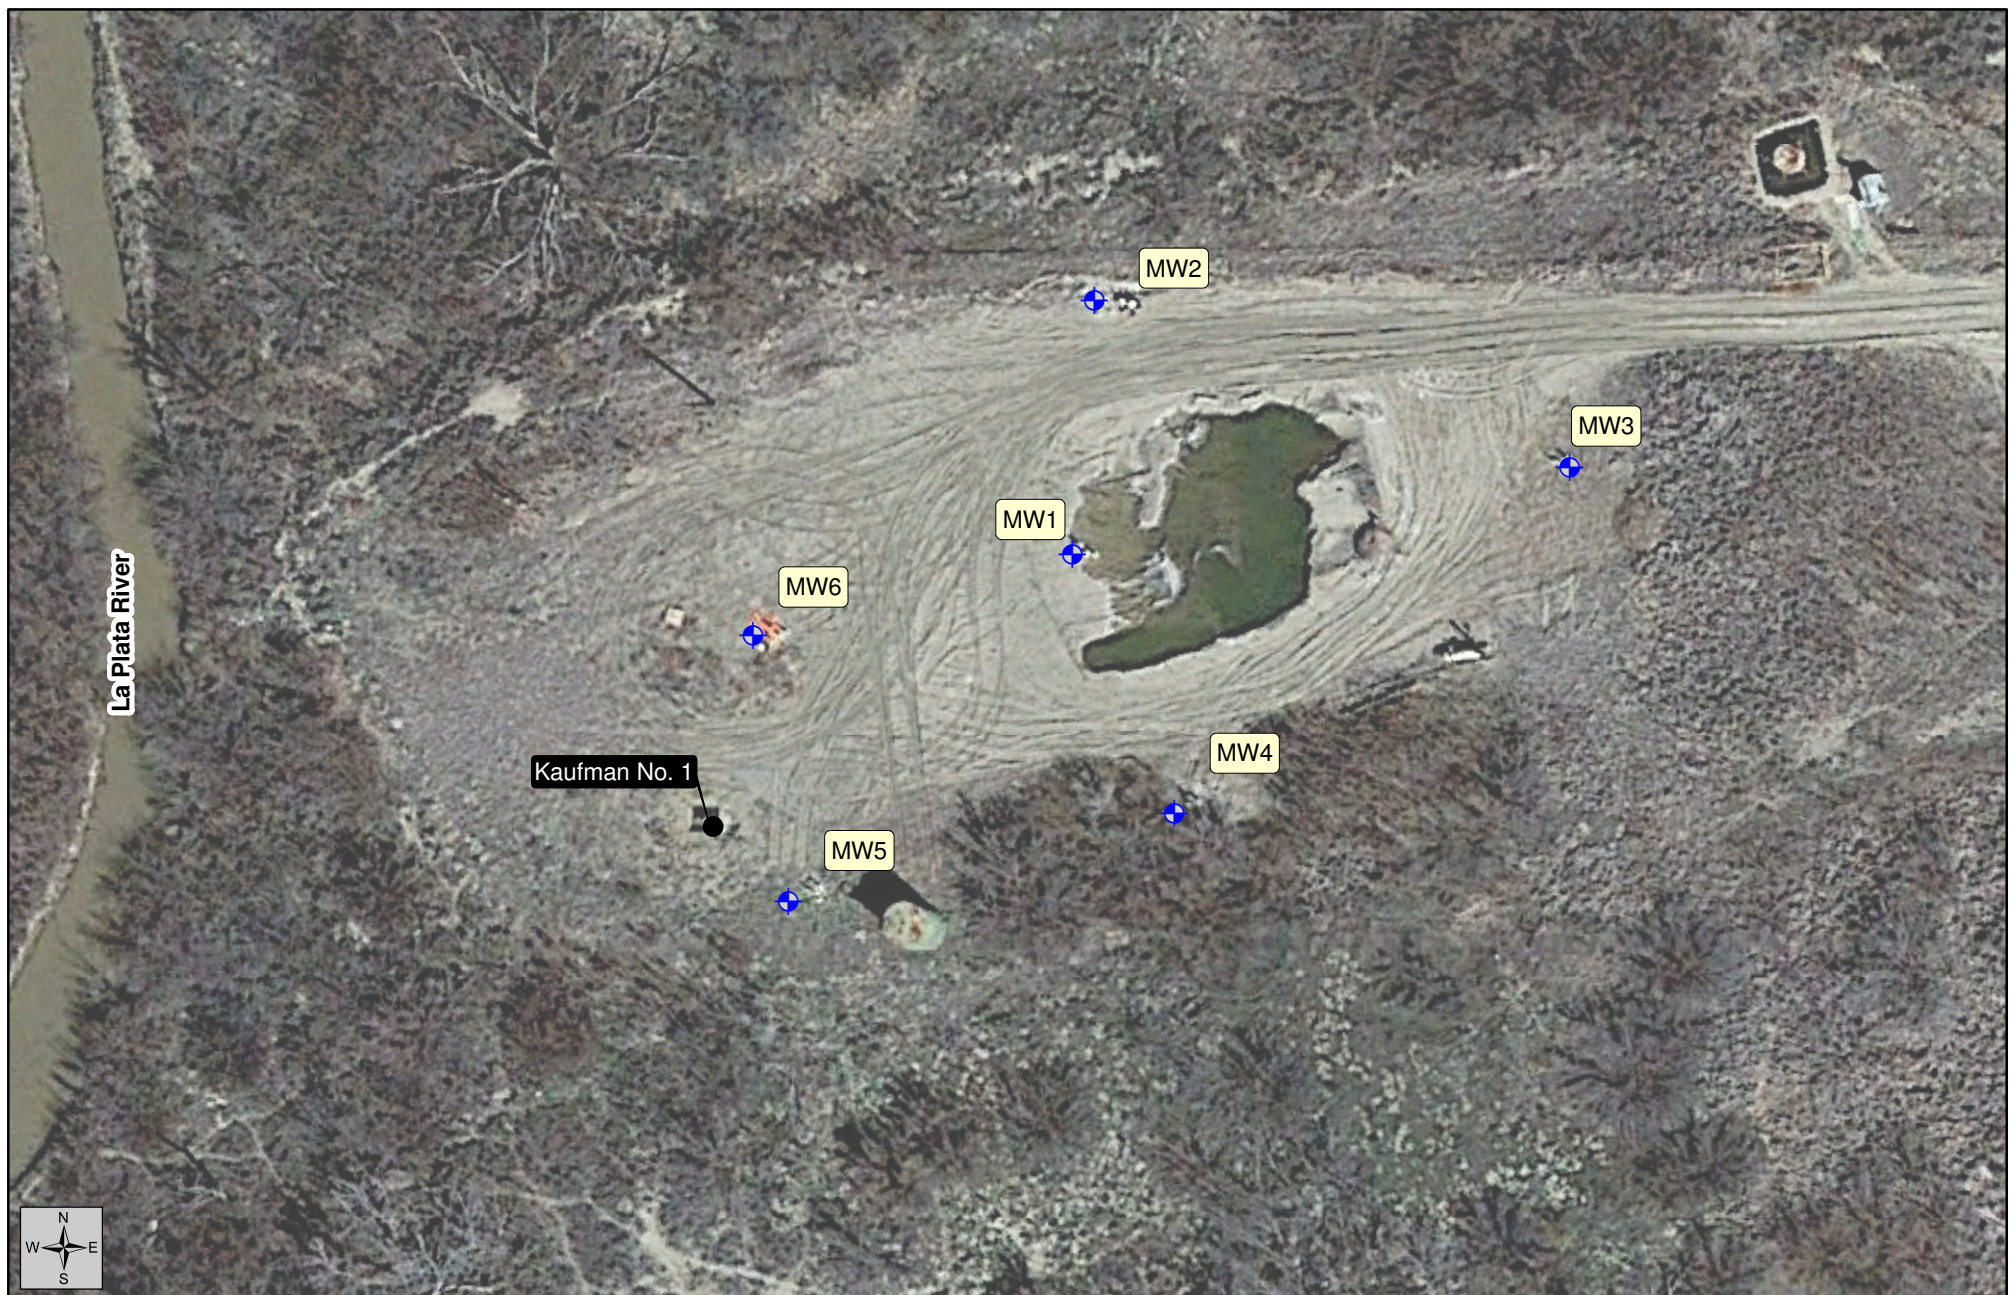
Figure 4
Monitor Well Location Map

On 01/16/20, Timberwolf conducted the 1Q20 groundwater monitoring event at the Site. Groundwater and surface water gauging, groundwater sample collection and analytical results are documented below. Monitor well locations are shown in the attached Figure 4.

- ◆ Monitor Well
- Kaufman No. 1 Well Head

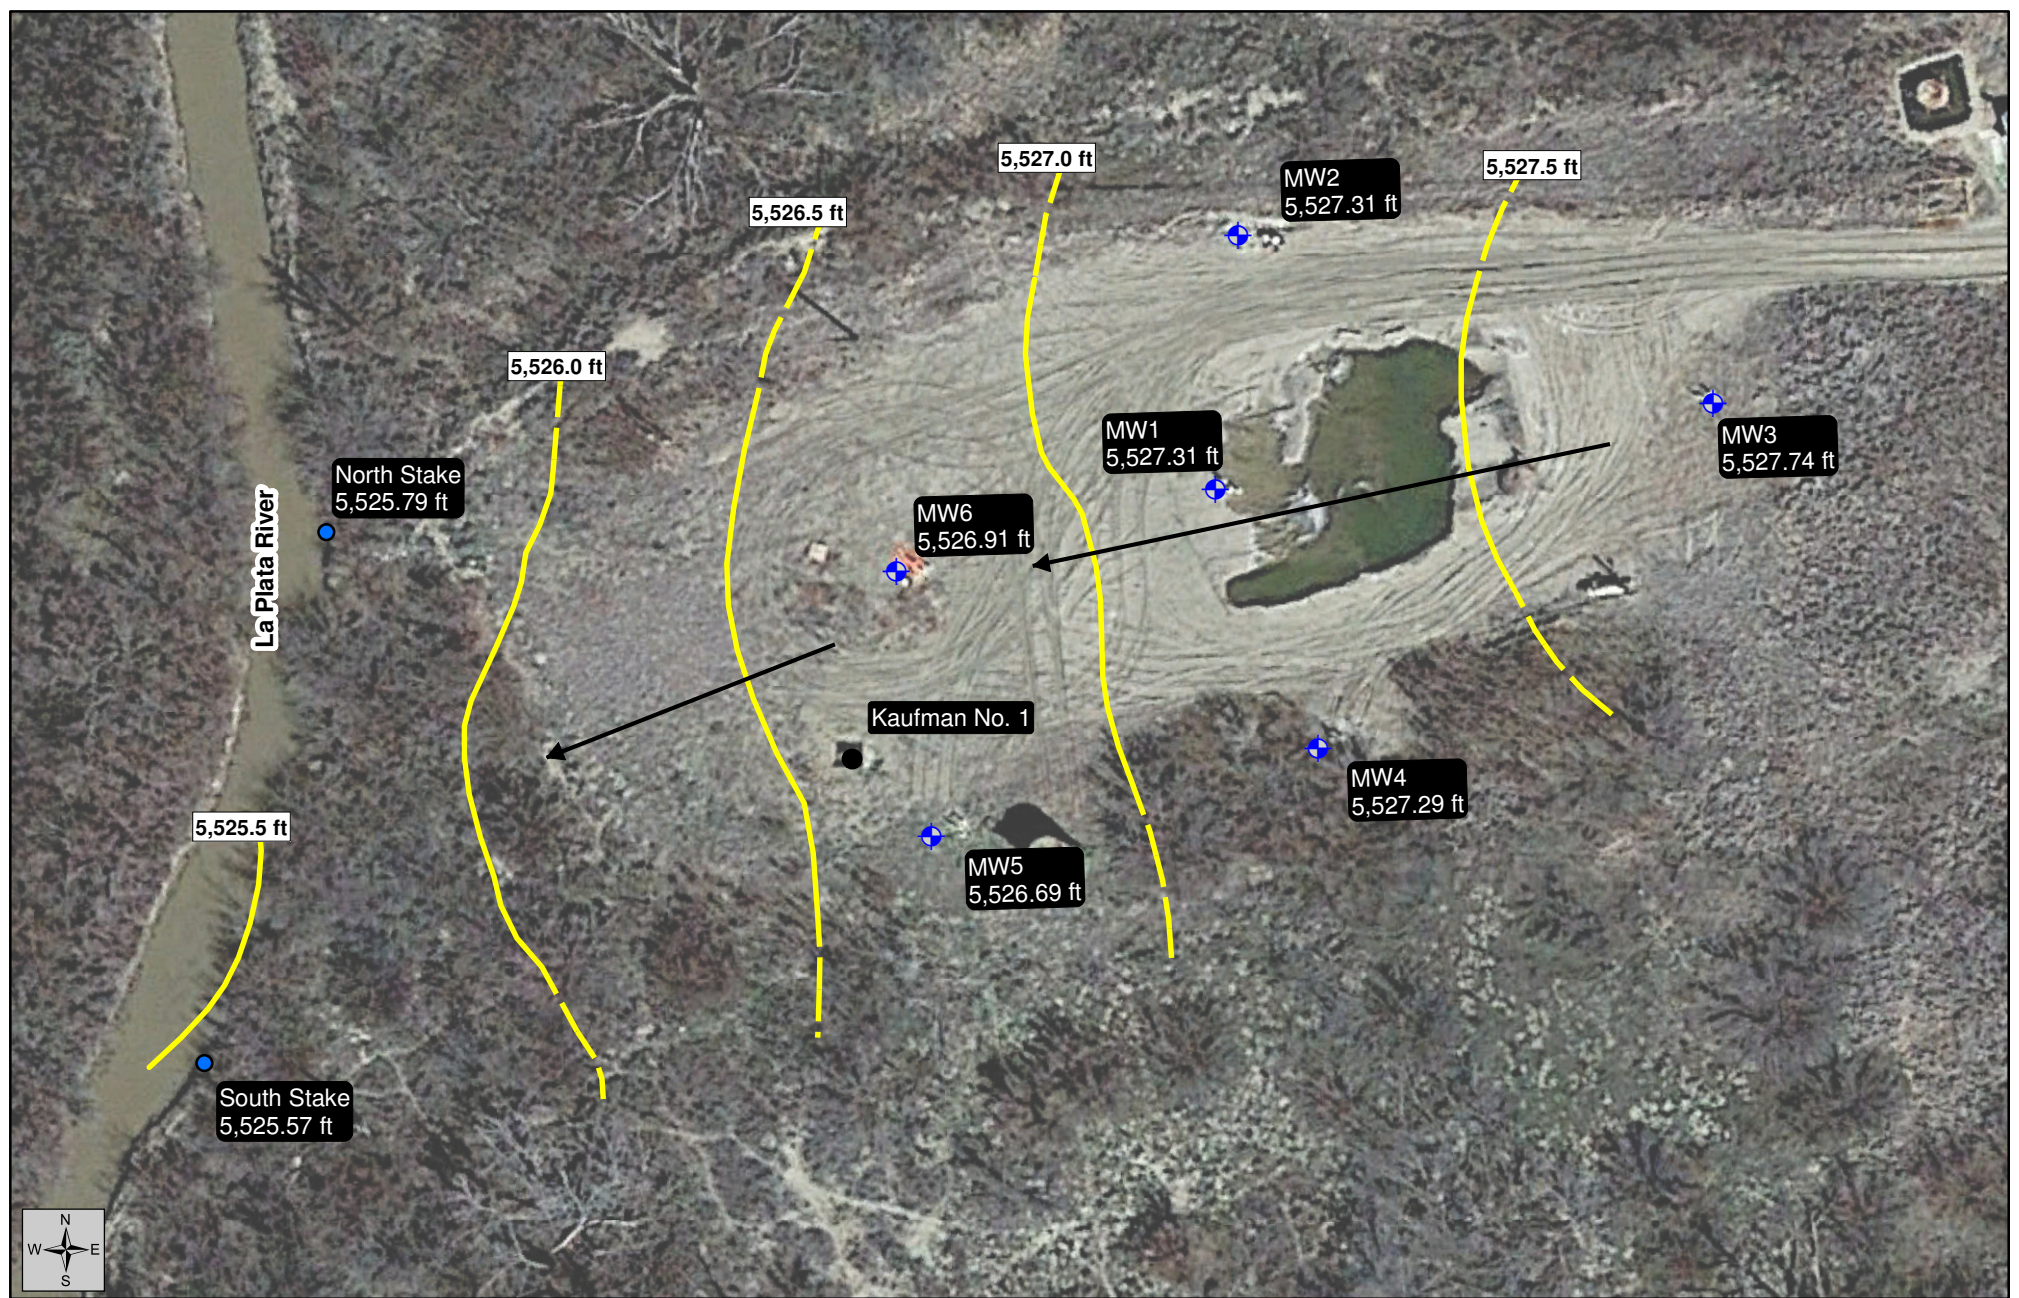
Figure 5
Potentiometric Surface
Elevation Map

Gauging data are recorded in Table A-1 (attached). Depth to groundwater measurements were subtracted from the corresponding monitor well elevations to determine the depth of groundwater relative to mean sea level in each well. Likewise, river elevations were calculated by subtracting the measured depth to water from the top of each steel rod. Timberwolf prepared a potentiometric surface elevation (PSE) map as shown in Figure 5. The 1Q20 PSE map revealed that groundwater flow across the Site was west-southwest towards the La Plata River.

- Monitor Well
- Surveyed Stake
- Kaufman No. 1 Well Head
- Groundwater Gradient
- Direction of Flow

- BTEX concentrations were below regulatory criteria in all samples (i.e., MW1 – MW6)
 - Concentrations of BTEX were below human health criteria and laboratory detection limits in five samples (i.e., MW1 – MW4 and, MW6)
 - Benzene concentration in MW5 exceeded laboratory detection limits but remains below the New Mexico human health criteria for drinking water
- Groundwater flow across the Site is west-southwest towards the La Plata River

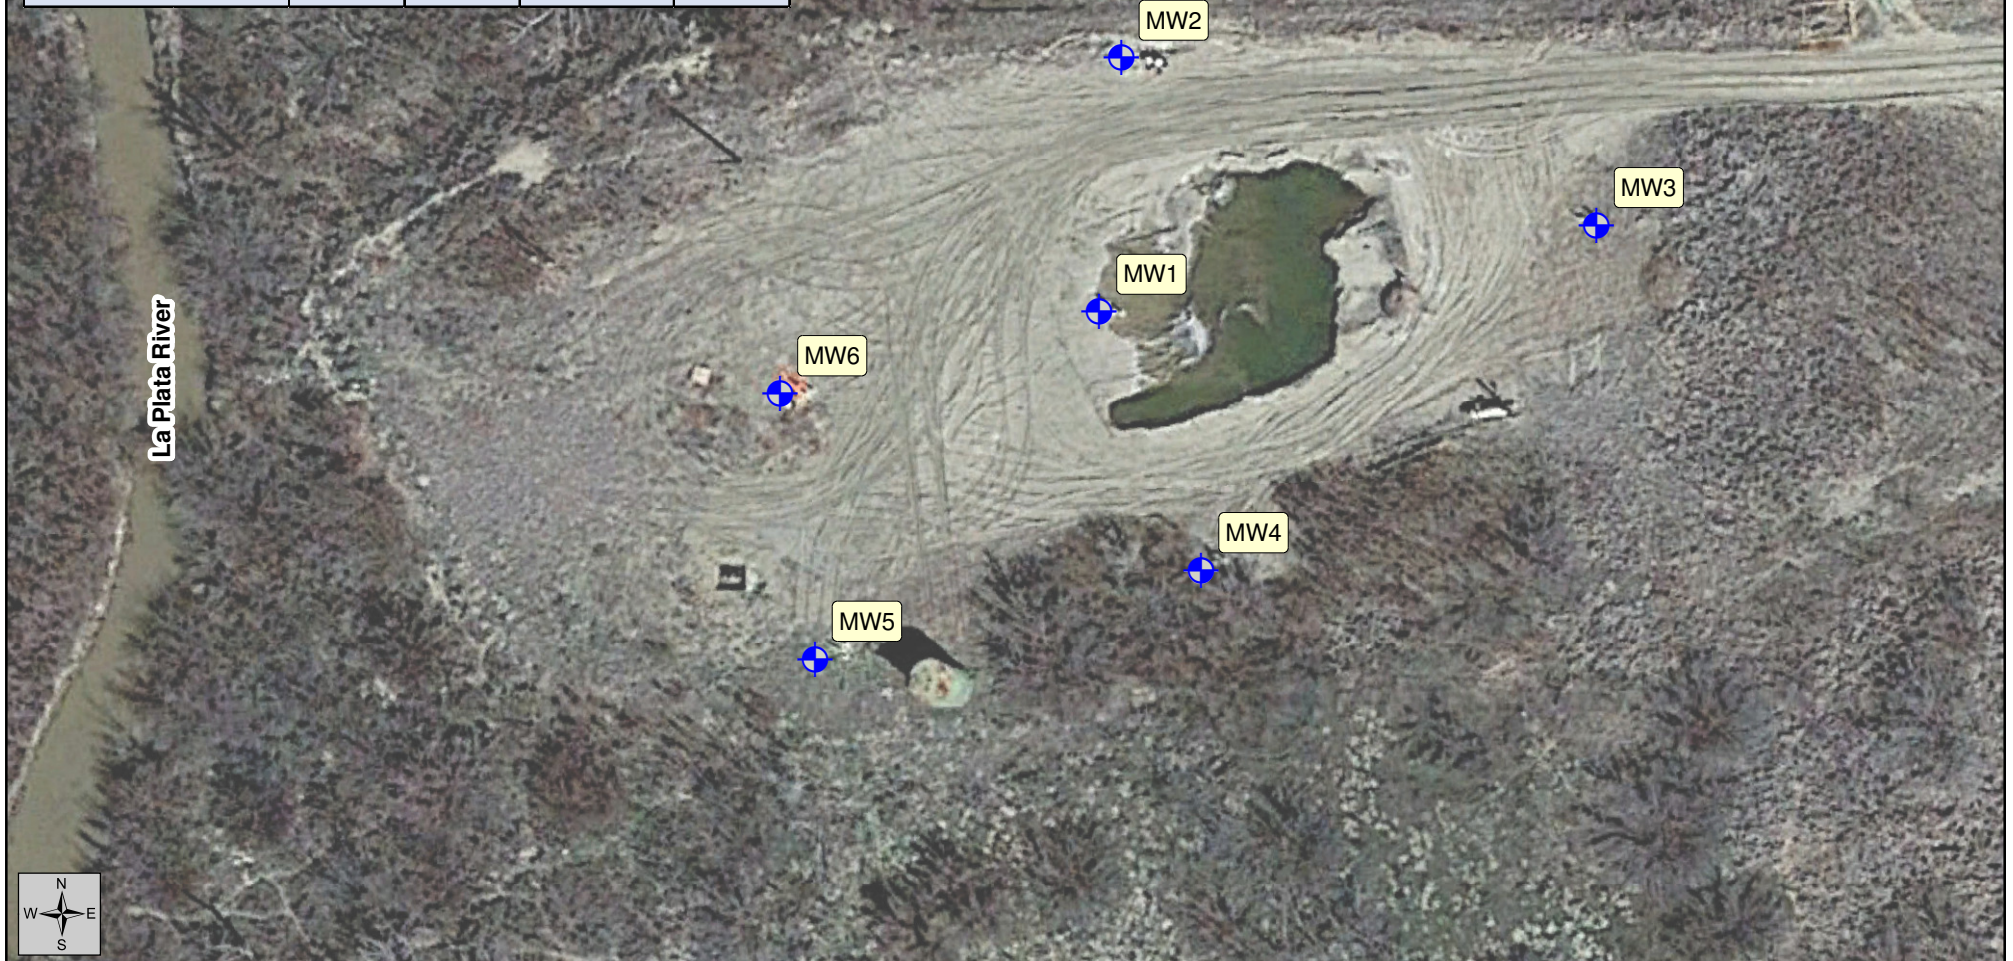
Figure 6
BTEX Results - 1Q20

Groundwater samples were analyzed for the following constituents: benzene, toluene, ethylbenzene, and xylenes (BTEX) by EPA Method 8260. Cumulative analytical results from each groundwater sampling station is documented in Table A-3 (attached). Analytical results for the 1Q20 groundwater monitoring event are summarized in Table 2 below and shown in Figure 6.

Sample ID	Date	Volatile Organic Compounds (mg/L)			
		B	T	E	X
MW1	01/16/20	< 0.001	< 0.001	< 0.001	< 0.002
MW2	01/16/20	< 0.001	< 0.001	< 0.001	< 0.002
MW3	01/16/20	< 0.001	< 0.001	< 0.001	< 0.002
MW4	01/16/20	< 0.001	< 0.001	< 0.001	< 0.002
MW5	01/16/20	0.0012	< 0.001	< 0.001	< 0.002
MW6	01/16/20	< 0.001	< 0.001	< 0.001	< 0.002
Regulatory Criteria		0.01	0.75	0.75	0.62

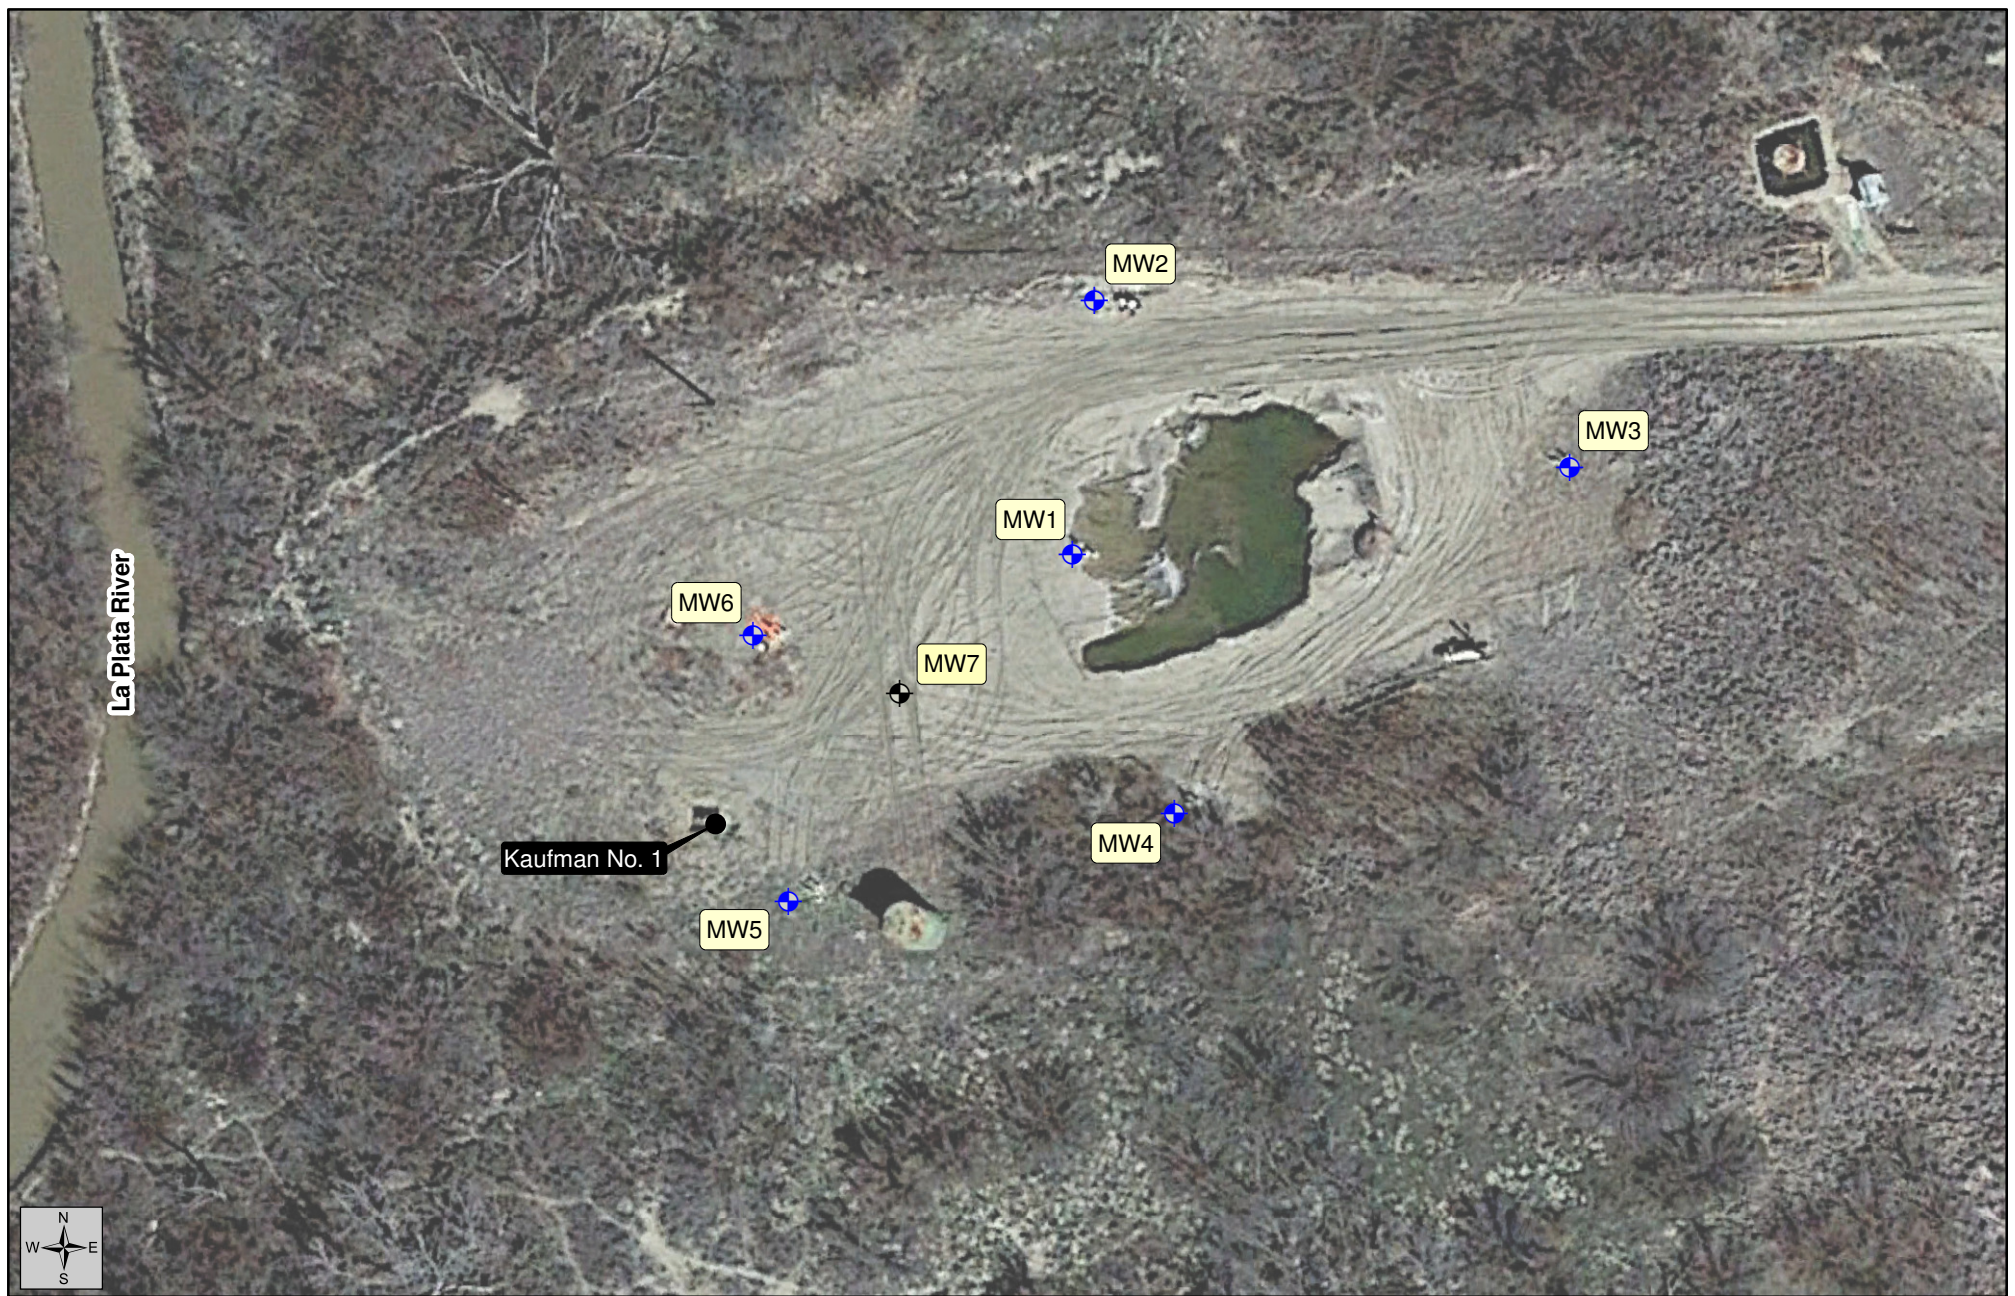
Figure 7
Proposed Monitor Well
Location Map

- ◆ Monitor Well
- ◆ Proposed Monitor Well
- Kaufman No. 1 Well Head

- Conduct a quarterly groundwater monitoring event
- Begin a threatened and endangered specie surveys for the *Southwestern willow flycatcher* and *Western yellow-billed cuckoo*
- Contingent upon OCD approval of Stage 2 Abatement Plan, Timberwolf will conduct the following activities at the Site during the 2nd quarter of 2020:
 - Install an additional monitoring well between MW1 and MW5. The proposed well (i.e., MW7) will be installed by a licensed driller and constructed of 2-inch PVC. The well will be permitted as required by the New Mexico Office of State Engineer. The Proposed location of MW7 is shown in (Figure 7)
 - Develop MW7 and sample for BTEX
 - Survey the top of casing elevation for MW7
