Release Notification

Site Name: Northeast Blanco Unit 605 002H	Site Type: Natural Gas Production Well Pad
Date Release Discovered: November 11, 2019	API#: 30-045-35857

NEBU 605 2H
Water Release
11/11/2019
API#30-045-35857
P-11-31N-7W

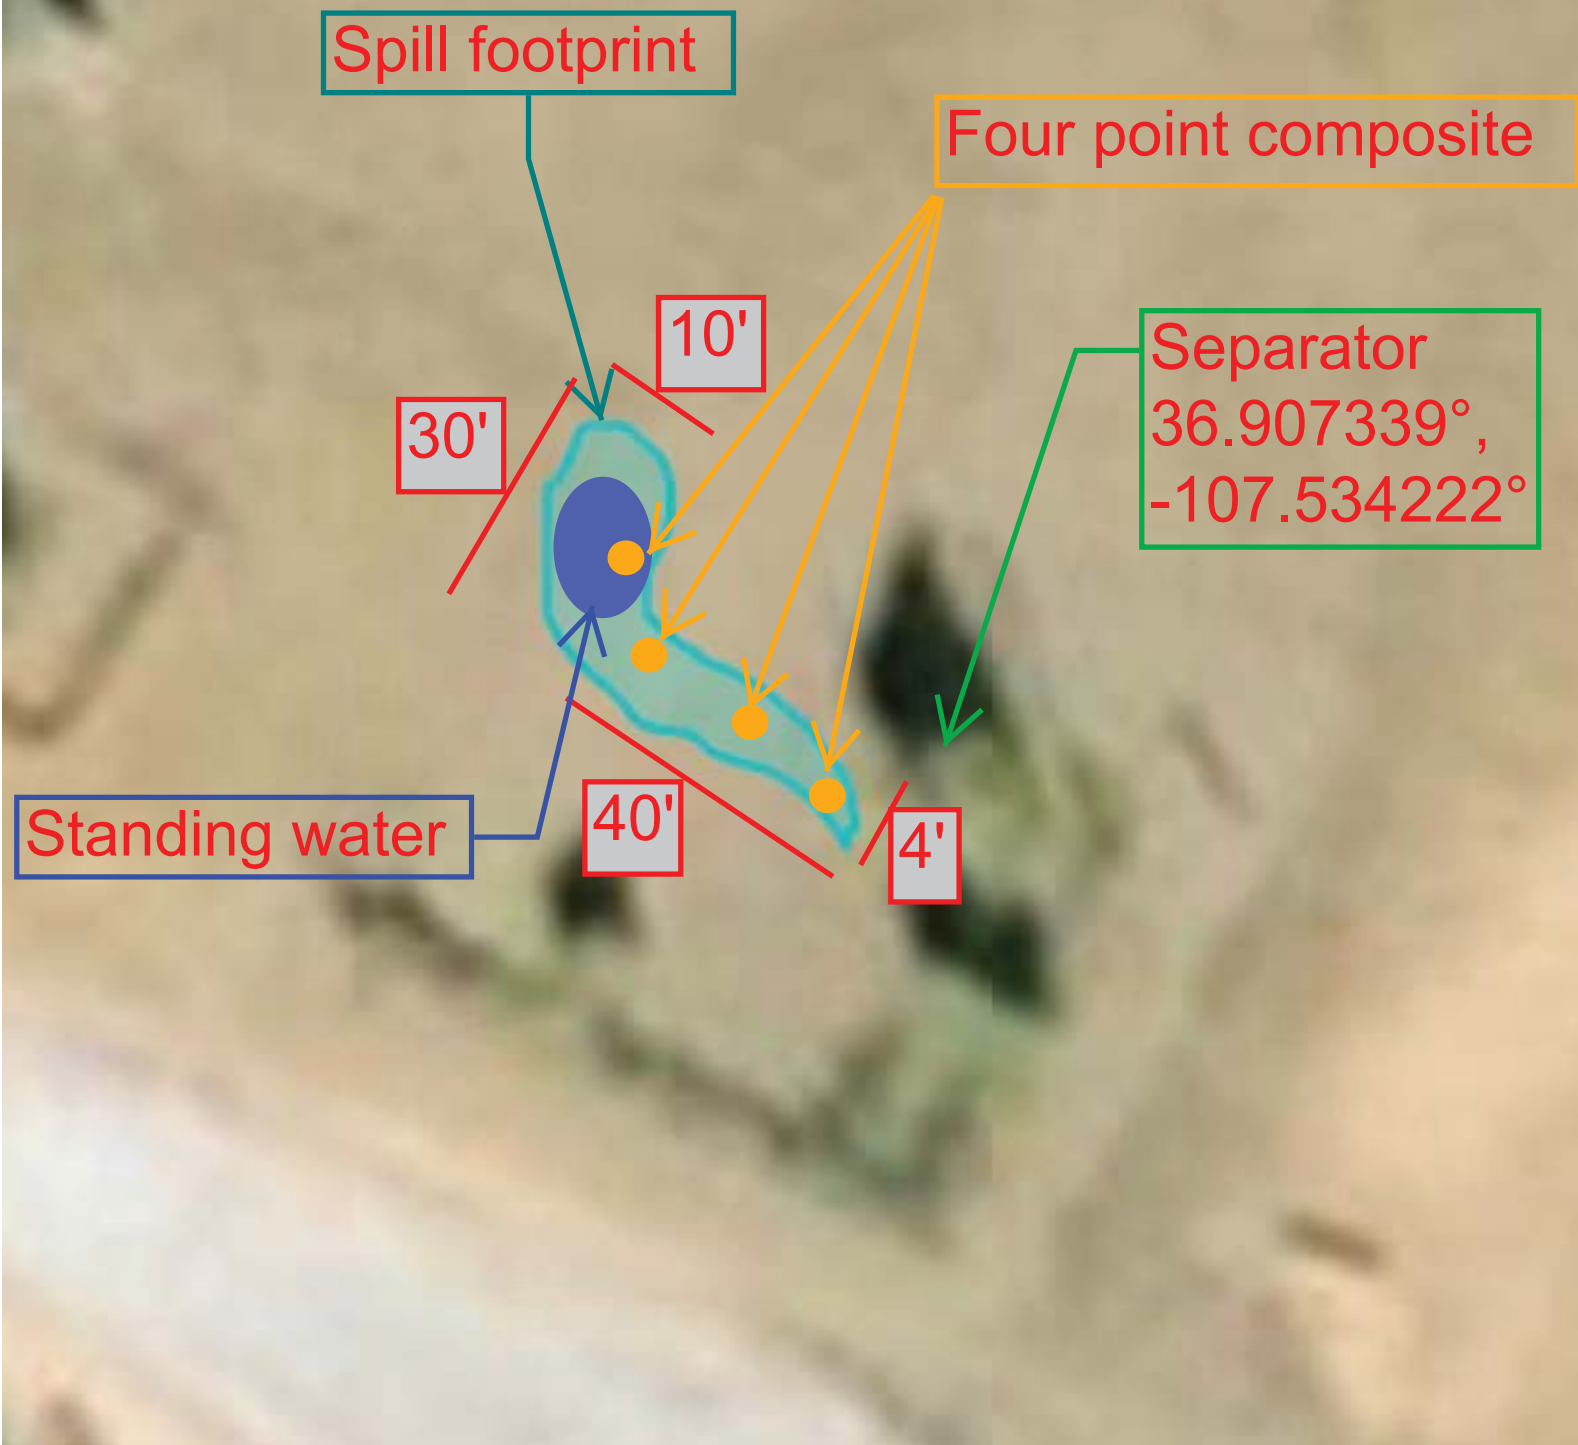
Spill footprint

Four point composite

Separator
36.907339°,
-107.534222°

Standing water

30'

10'

40'

4'

Based on site assessment and sample results, no remedial action is necessary based on the site ranking. No remedial action was performed. Attached are the lab results, sampling photos and site ranking criteria.

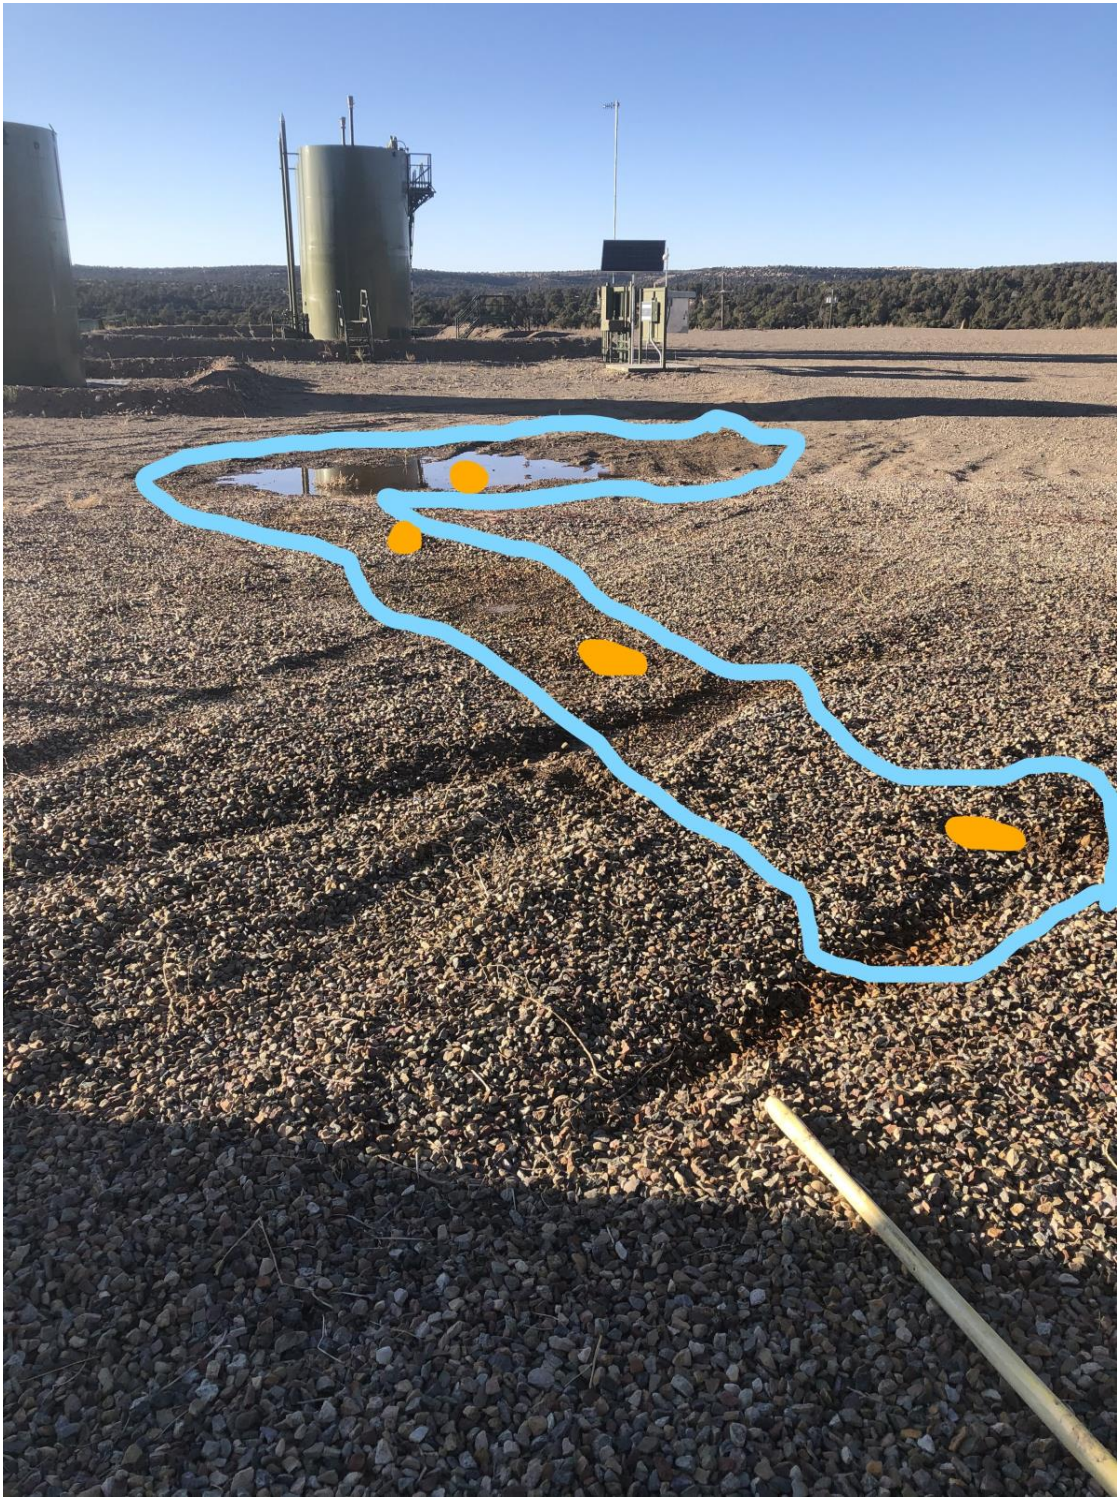
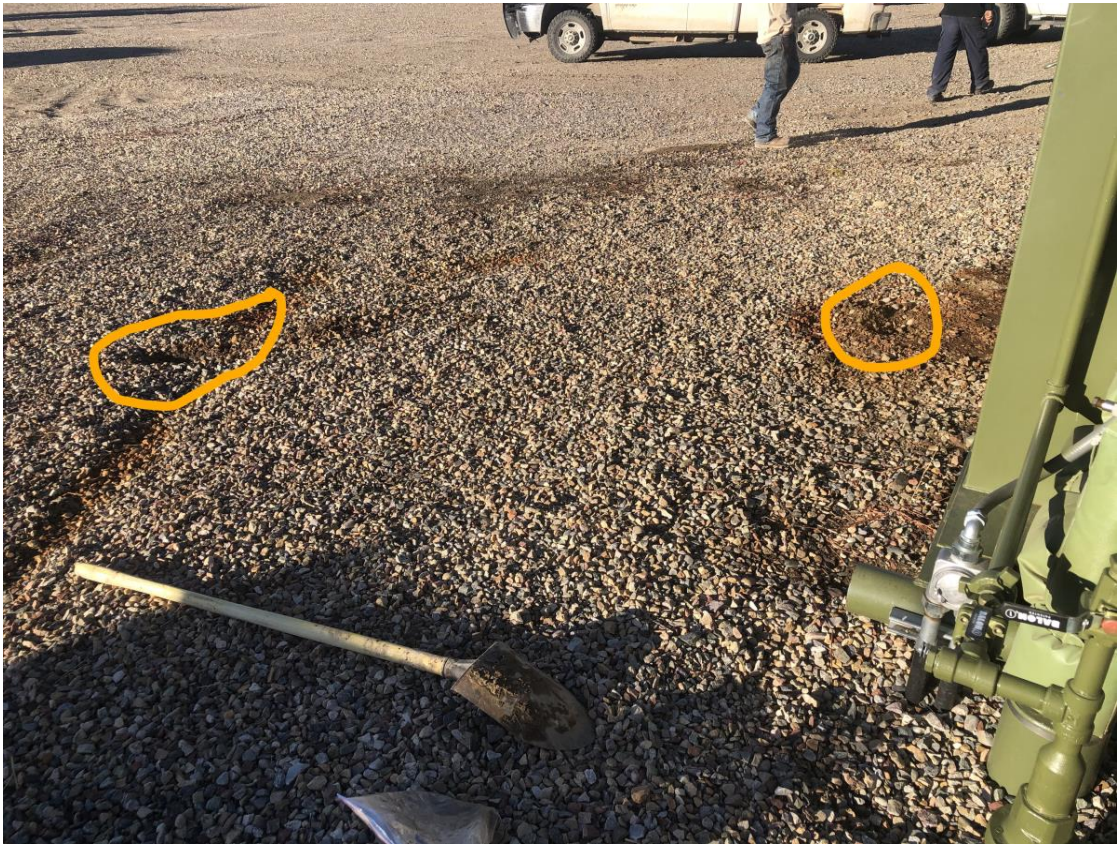
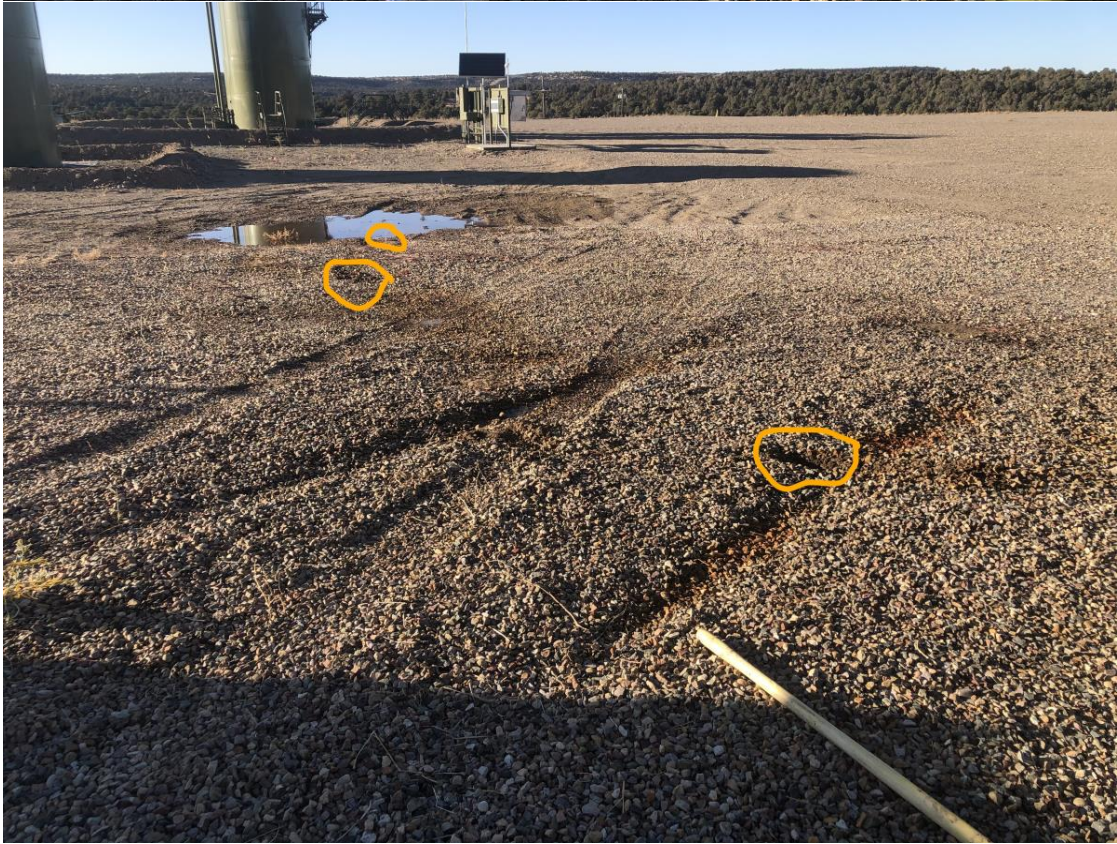
As discussed over the phone this morning, BP discovered a spill due to a hole in a separator dump valve yesterday, 11/11/2019. I was notified of the release and conducted a site visit/assessment. I was able to collect a 4-point composite from the impacted area. The area measured 10'x30' in pooling segment and 40'x4' along the flow path, totaling about 380 sq. ft., but more likely less as the 40' section and 10' section overlapped a bit. Total release volume is estimated to be 15.8 bbls. All water released remained well within the footprint of the pad.

Release of produced water associated internal erosion of dump valve body. The water was release from a small hole on the valve body, only when the hump was opened. The valve body was replaced.
