**Lateral L-11 Valve Release:
Release Assessment and Final Remediation Report**

Latitude 36.333375°, Longitude -107.213957°

Section 1, T24N, R4W

**Lateral L-11 Valve Release
Final Remediation Report
Rio Arriba County, New Mexico**

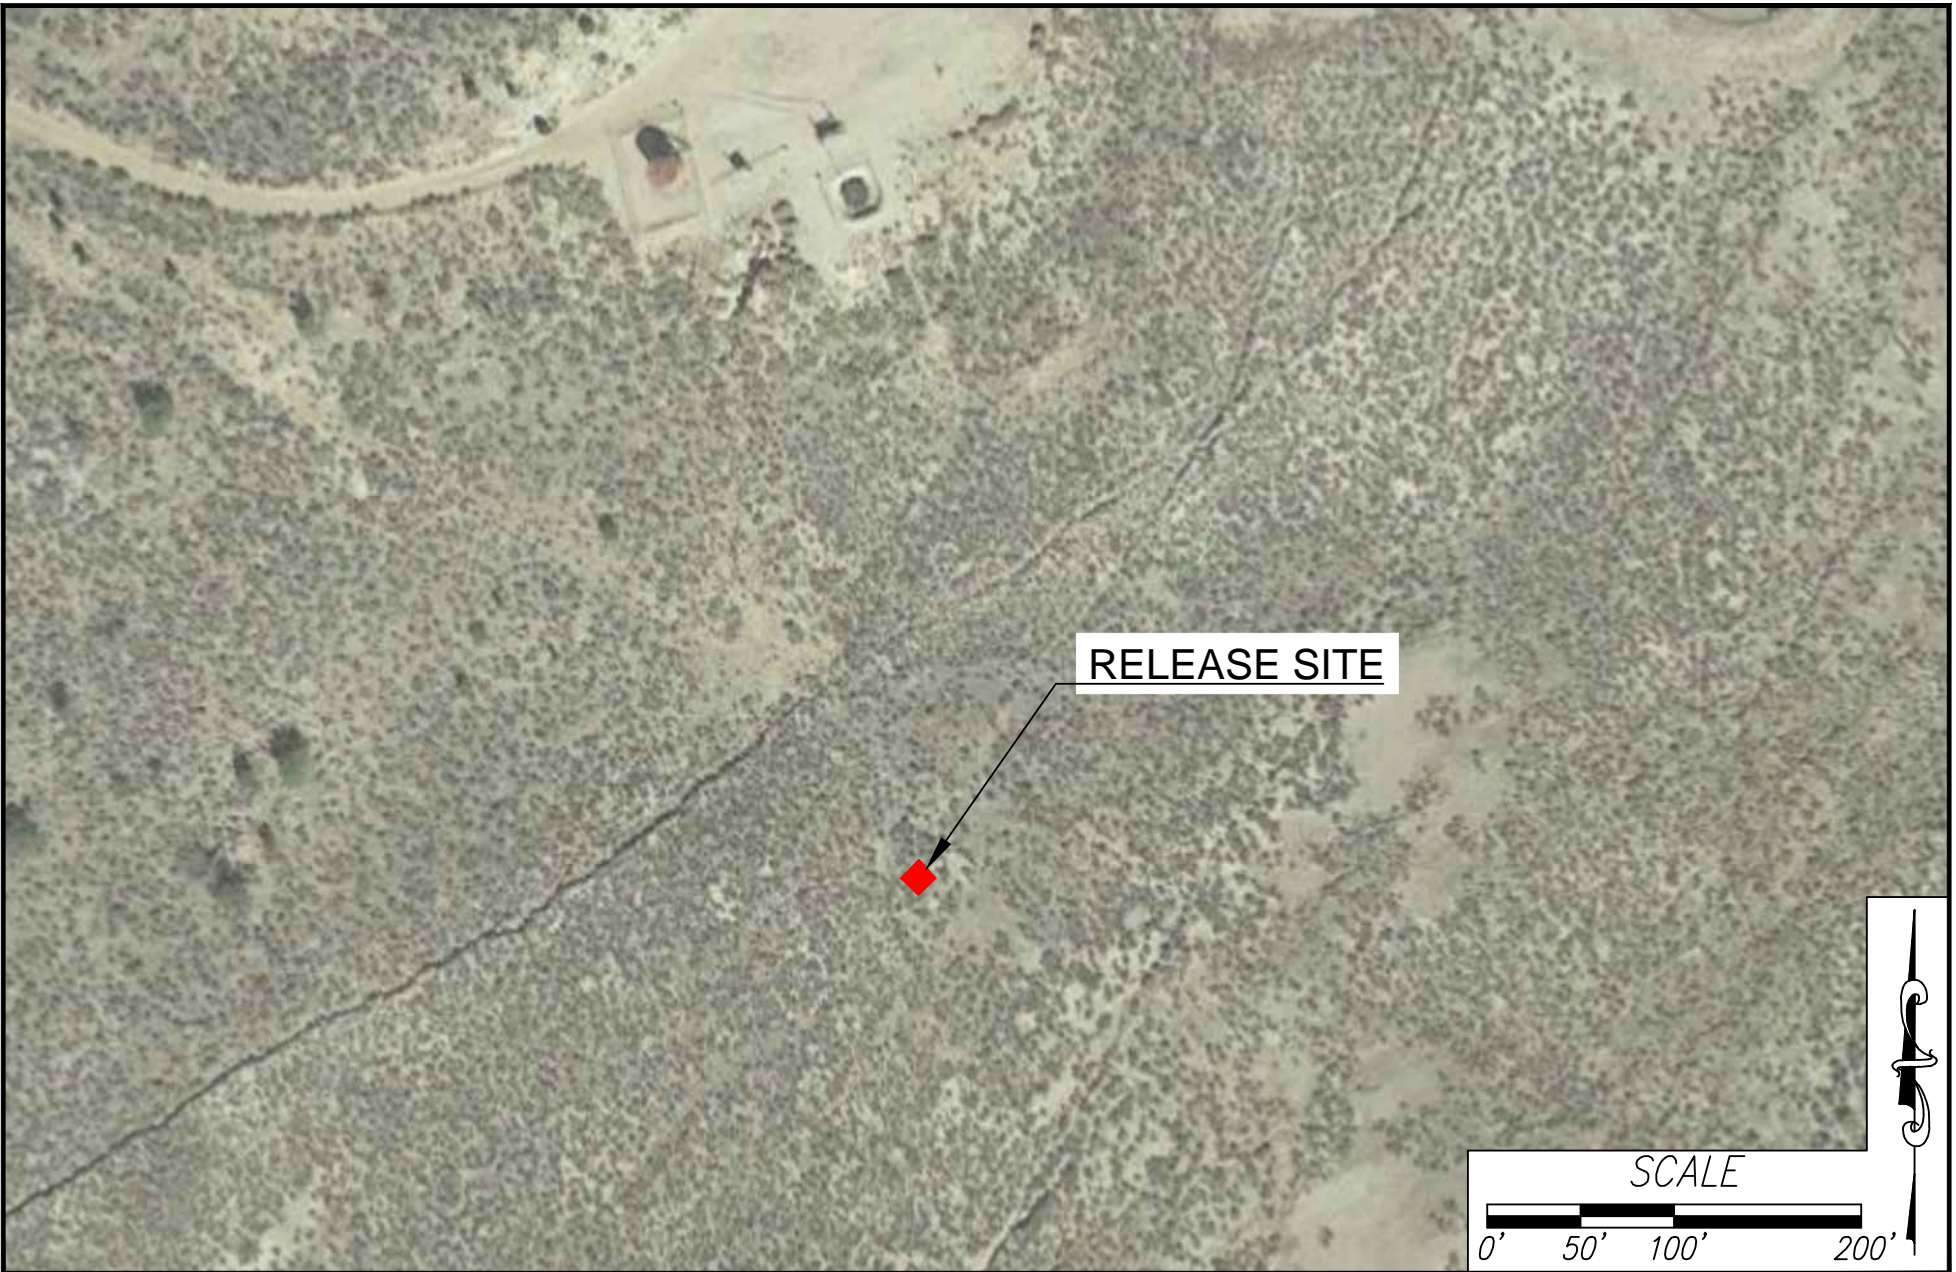
SITE MAP
LATERAL L-11 VALVE RELEASE
SECTION 1, T24N, R4W

source elimination. Figure 1 illustrates the vicinity and site location, Figure 2 illustrates the release location.

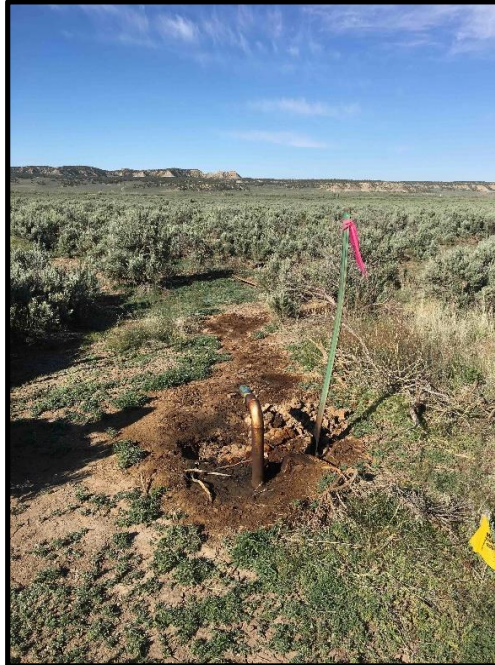
Figure 1. View of surface stained area prior to excavation.

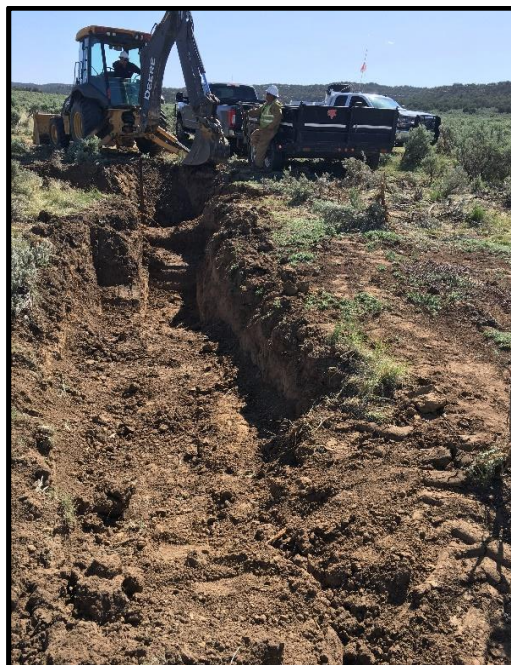
Figure 2. View facing north of final excavation.

On May 31, 2019 and June 4, 2019, SMA conducted confirmation sampling of the excavation, which measured, at the widest points, approximately 26 feet by 12 feet and ranged in depth from 1 foot to 5 feet in depth.

Confirmation samples were comprised of five-point composites of the excavated area. The base of the excavation measured 197 ft². The sidewalls ranged in depth from 1 to 5 feet with a total surface area measurement of 167 ft². Sample SC-1 was collected from the base of the excavation and sample SC-2 was collected from the sidewalls of the excavation. Analytical results demonstrated that SC-2, a side wall composite sample, exceeded Closure Criteria and was therefore further excavated and resampled (SC-3).

Contaminated soils were removed and replaced with clean backfill material to return the surface to previous contours. Twenty-eight (28) cubic yards of contaminated soil was transported and disposed of at Envirotech Landfarm, Bloomfield, New Mexico, an NMOCD permitted disposal facility.
