Release Notification

Site Name Serendipity #3R	Site Type Gas Well
Date Release Discovered September 3, 2019	API# (if applicable) 30-045-30811

SUBJECT: Deferral Request for the Serendipity 3R Release (NCS1926052330), Farmington, New Mexico

Serendipity 3R Remediation Plan (NCS1926052330)
October 25, 2019

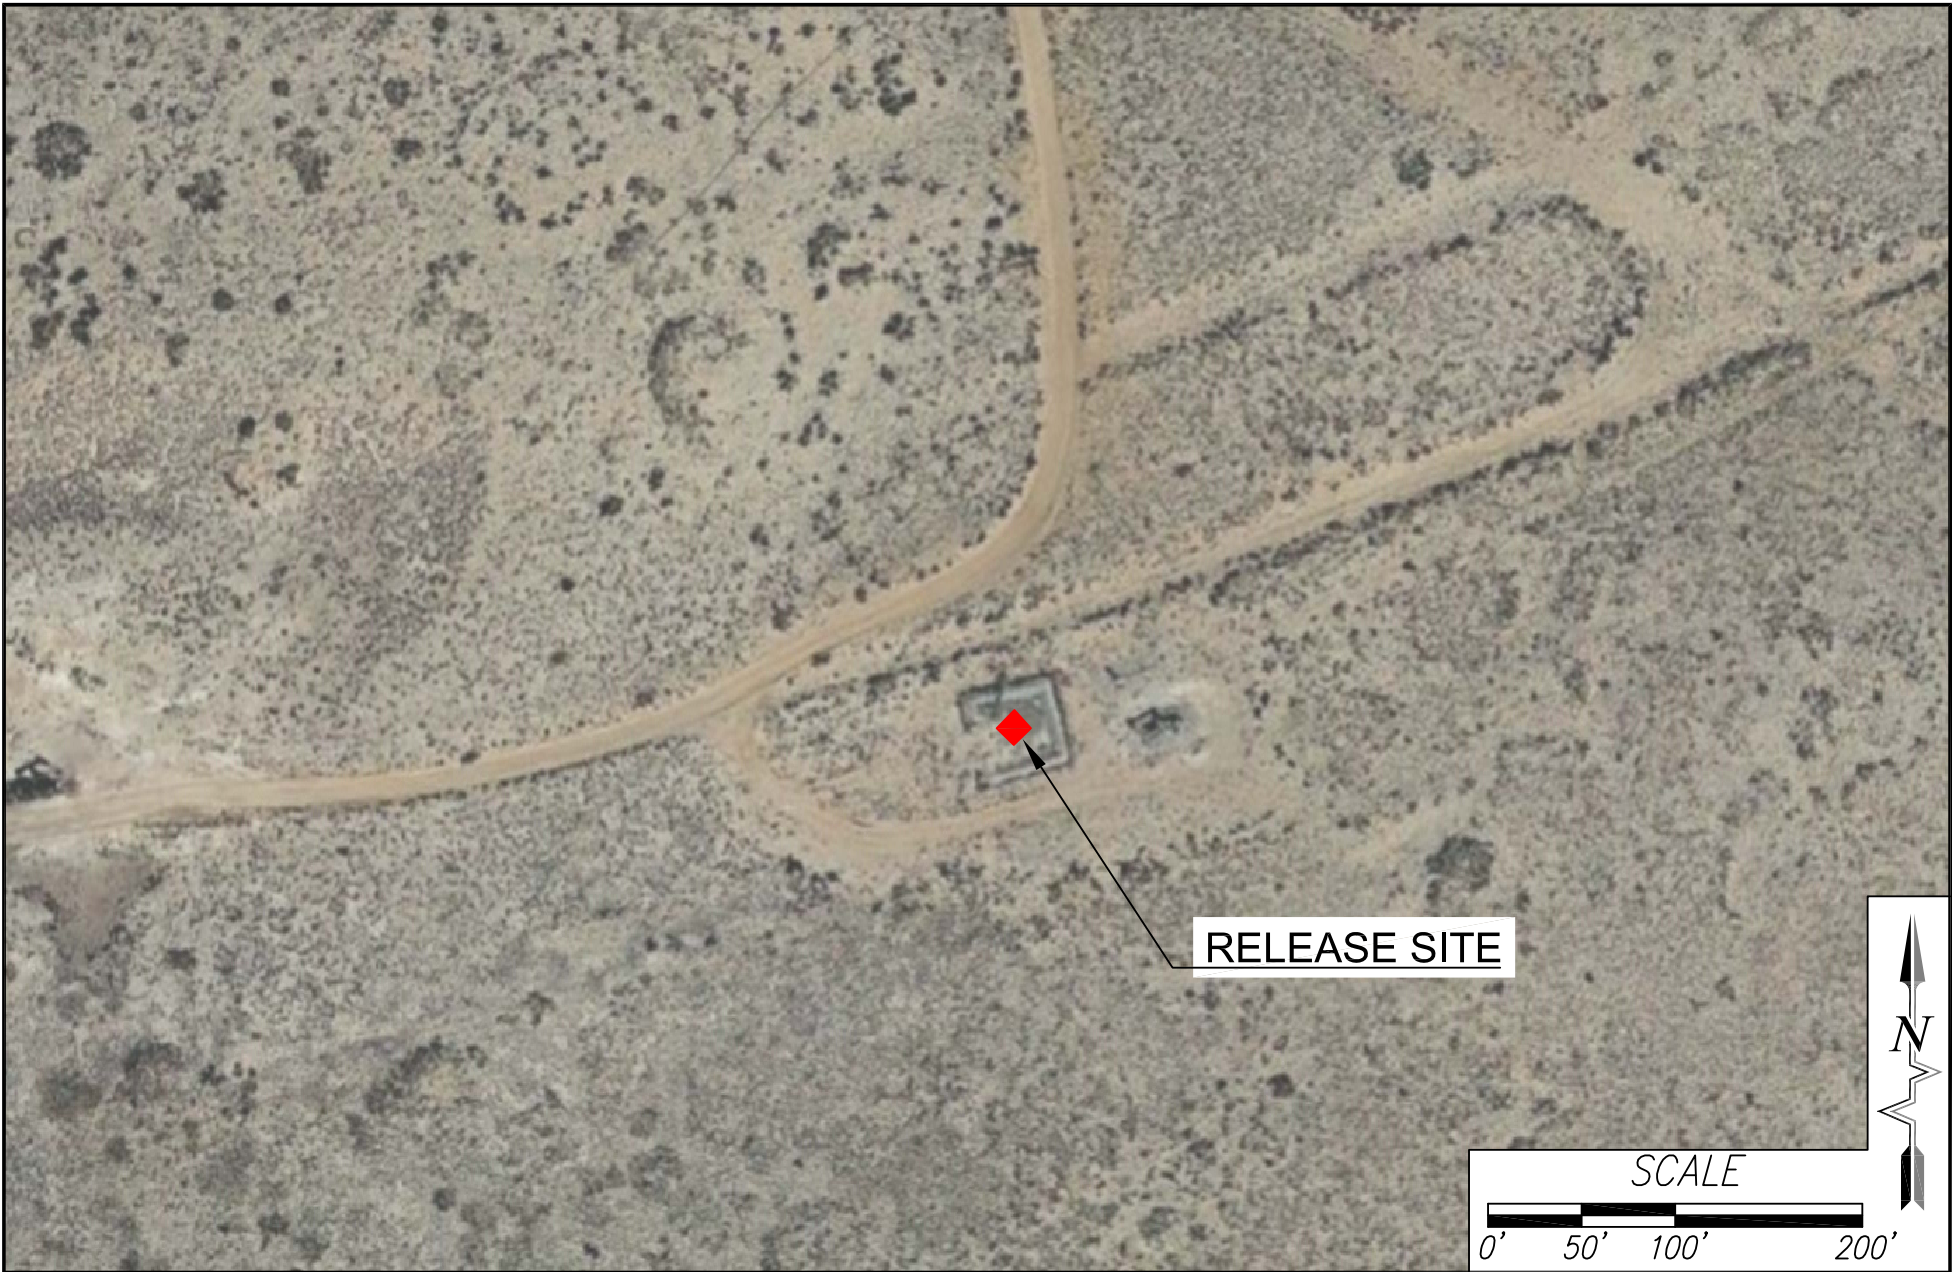
Figure 2: Surface Water Radius Map

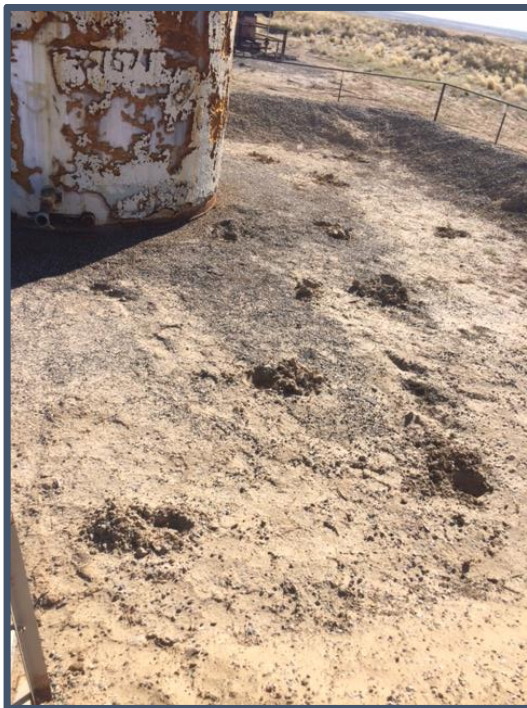
As summarized in Table 3, results indicate that an area approximately 14 feet by 11 feet by 6 inches deep has been impacted (sample location SC2) by chlorides above the reclamation requirement but remain below the Closure Criteria. Locations for all samples are depicted on Figure 3.

Photo 1: Sample area SC2.

SMA proposes the application of gypsum to the impacted area of SC2 as in situ remediation, and temporary deferral of closure sampling. SMA proposes to collect closure samples from the area of SC2 within one year of the deferral approval.

In accordance with 19.15.29.12.B(2), a deferral is being requested in the area identified as SC2 , As described above, the contamination has been delineated and does not cause an imminent risk to human health, the environment, or groundwater.

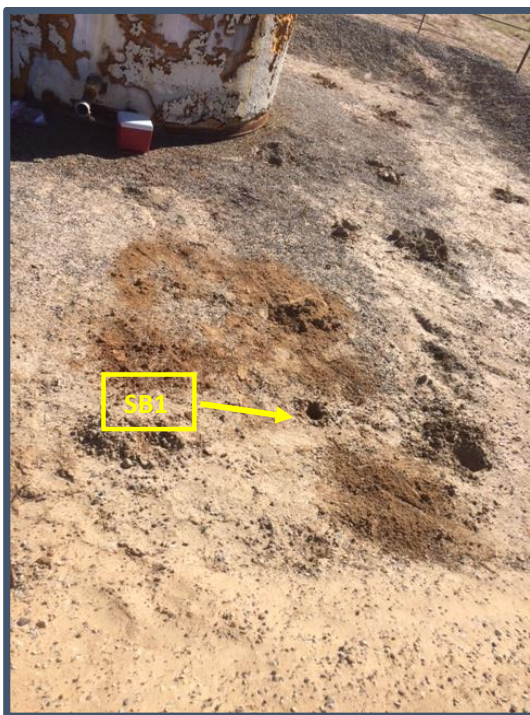
At the request of Cory Smith, NMOCD Environmental Specialist, SMA returned to site on October 2, 2019 conduct chloride delineation via soil boring and sampling activities. A single soil boring, measuring from surface to four (4) bgs, was completed in the low spot within the sample location of SC2. A total of four (4) samples were collected, one from each foot of the boring, for laboratory analysis for total chloride using EPA Method 300.0.

As summarized in Table 3, results from soil boring activities indicate that the impacted area of SC2 is limited to the surface. Locations for all samples are depicted on Figure 3.

Photo 2: Location of SB1 in sample area SC2.
