Release Notification

CLOSURE REPORT

**Trunk MD (2018) Pipeline Release
SE ¼, S17 T31N R10W
San Juan County, New Mexico**

September 30, 2019
Ensolum Project No. 05A1226017

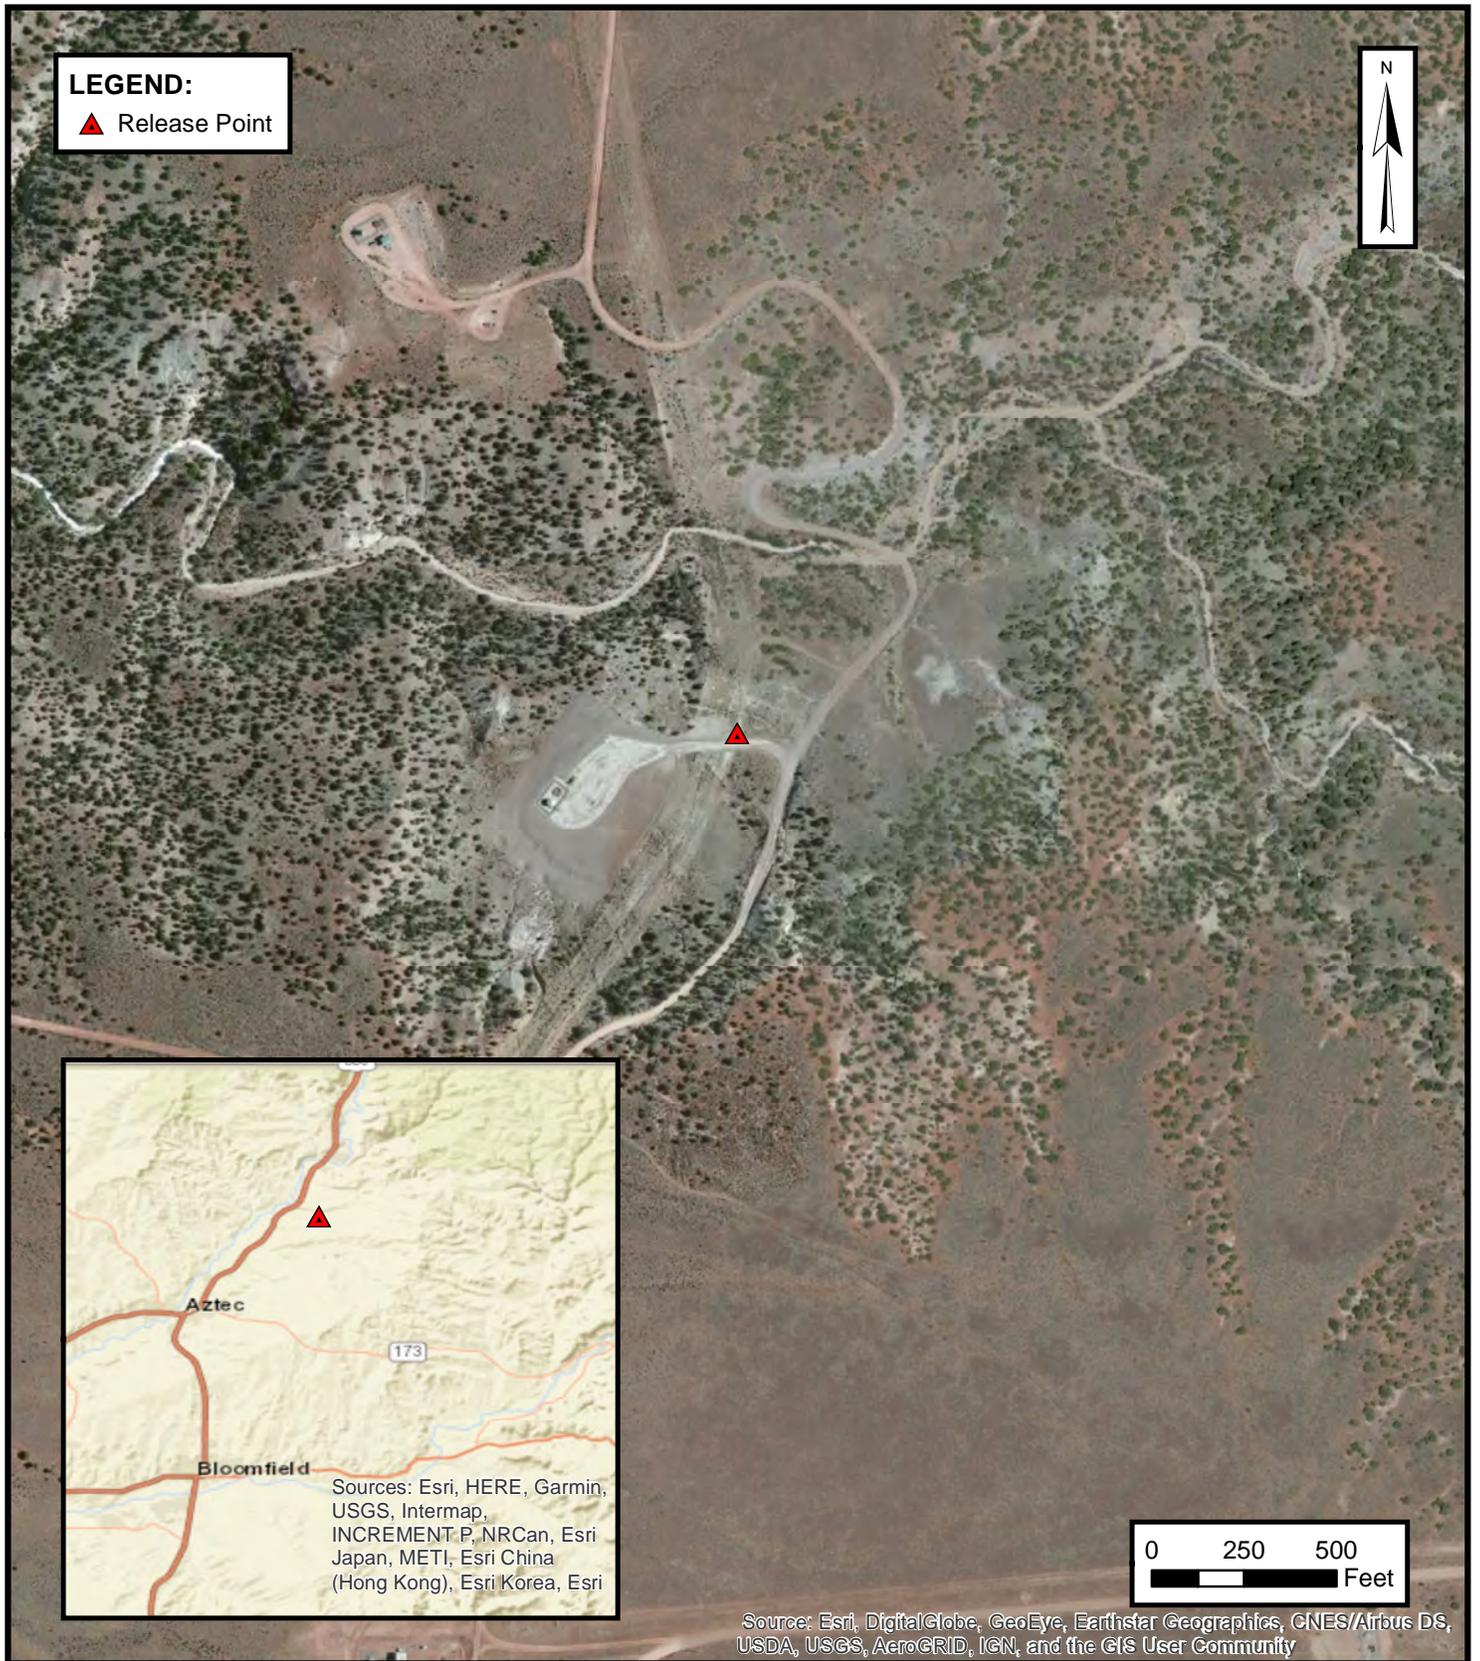
FIGURE
1

The **Topographic Map** depicting the location of the Site is included as **Figure 1**, and the **Site Vicinity Map** is included as **Figure 2** in **Appendix A**.

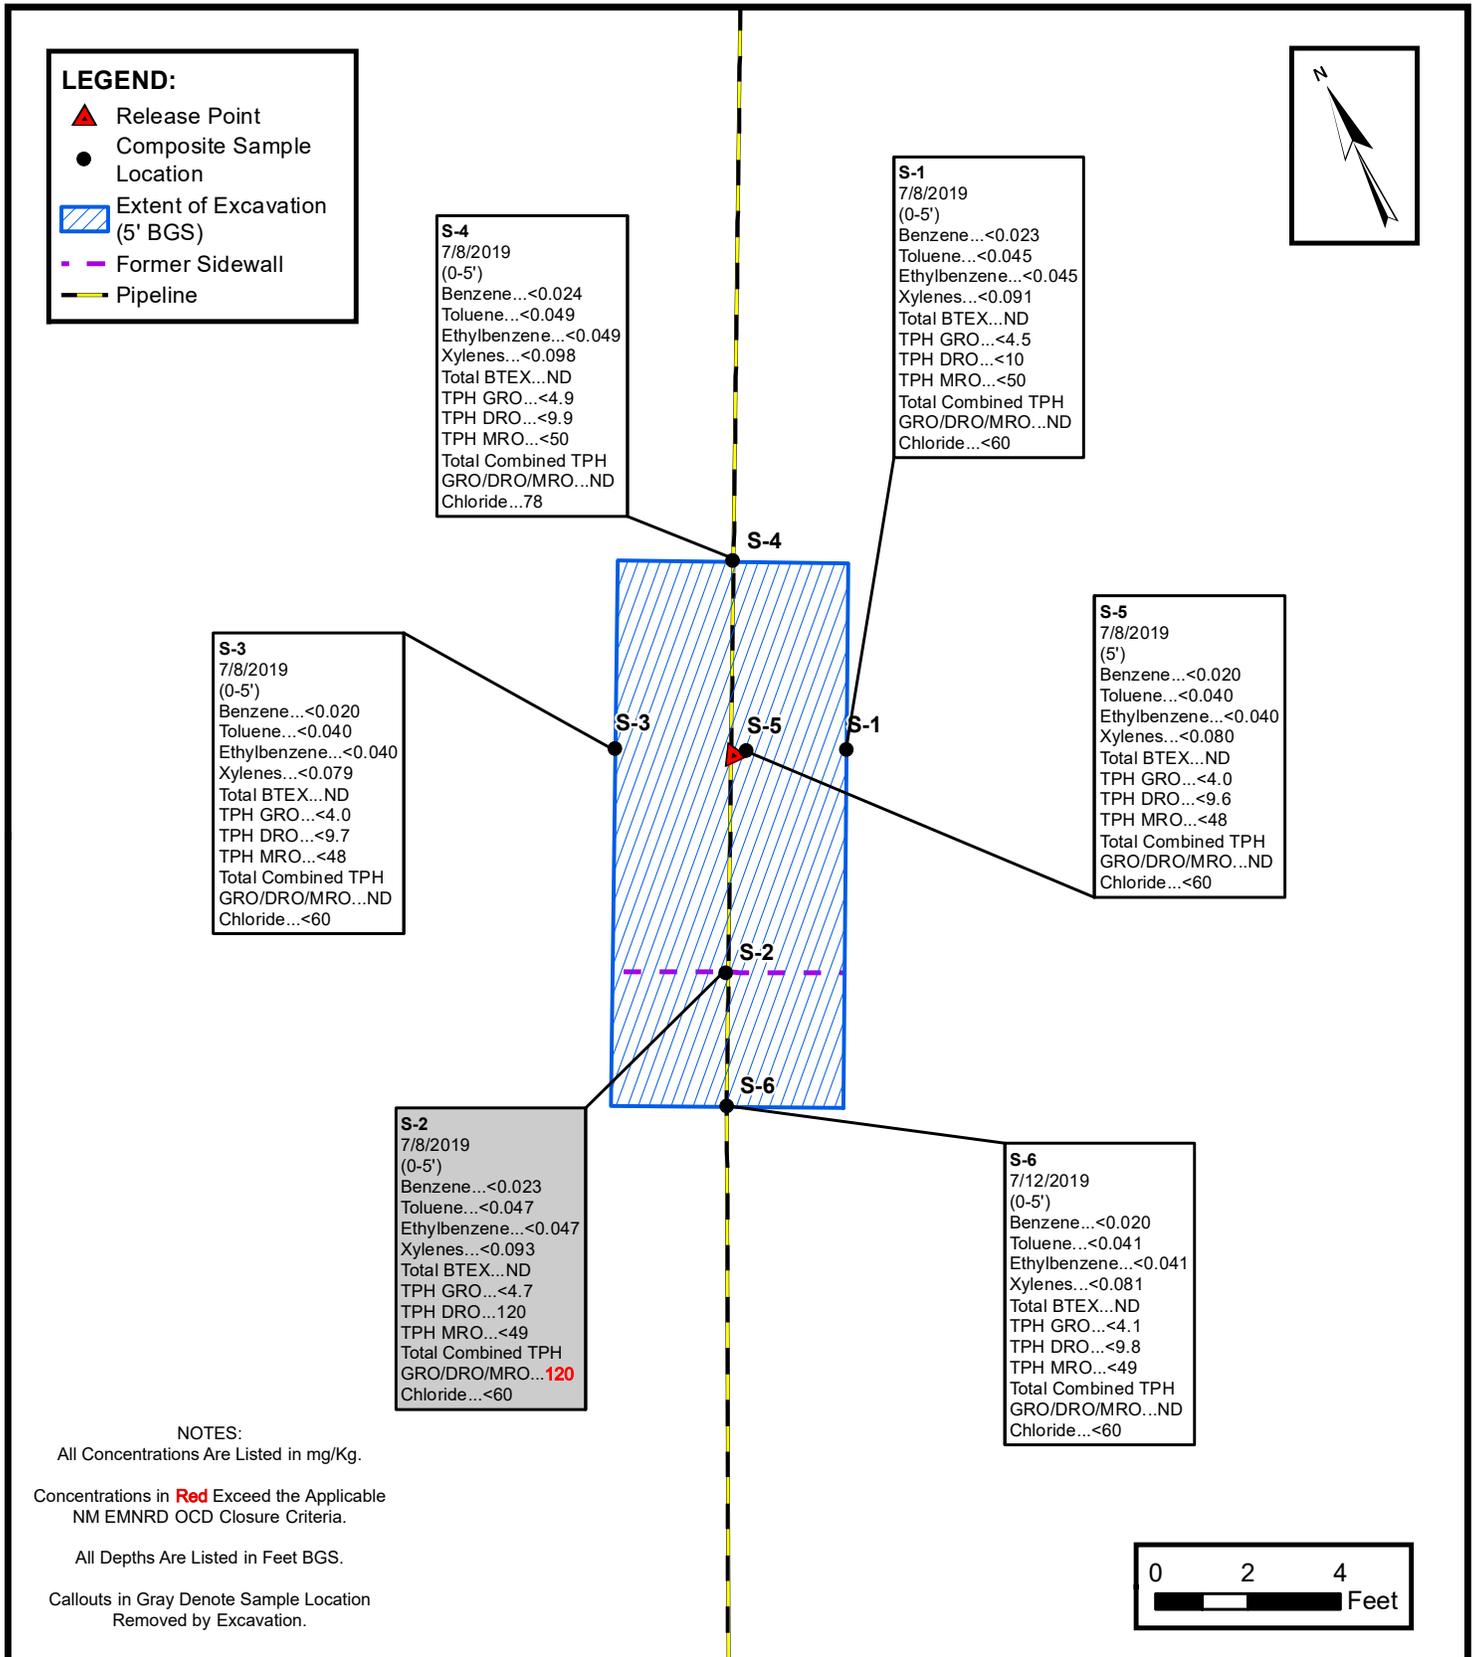
FIGURE
3

Figure 3 is a map that identifies approximate soil sample locations and depicts the approximate dimensions of the excavation with respect to the pipeline (**Appendix A**). Photographic documentation of the field activities is included in **Appendix C**.

SITE MAP
 ENTERPRISE FIELD SERVICES, LLC
 TRUNK MD (2018) PIPELINE RELEASE
 SE ¼, S17 T31N R10W, San Juan County, New Mexico
 36.893767° N, 107.898126° W
 PROJECT NUMBER: 05A1226017

The final excavation measured approximately 11 feet long and five (5) feet wide. The maximum depth of the excavation measured approximately five (5) feet bgs.

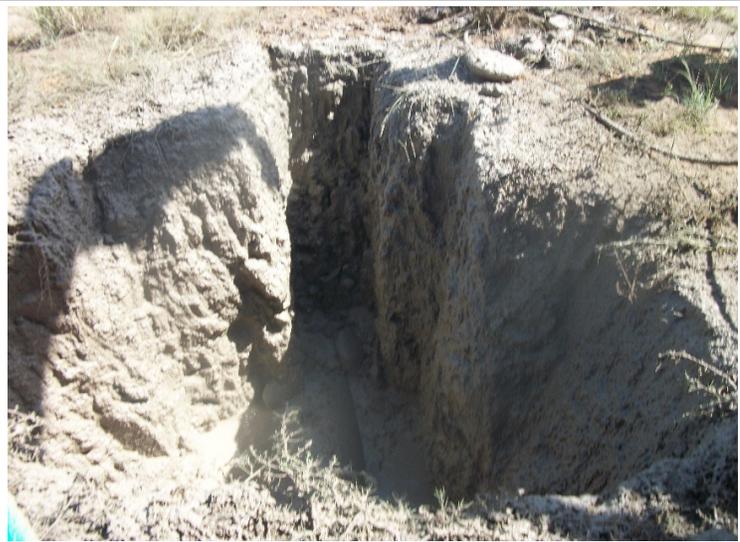
Photograph 1

Photograph Description: View of the initial excavation.

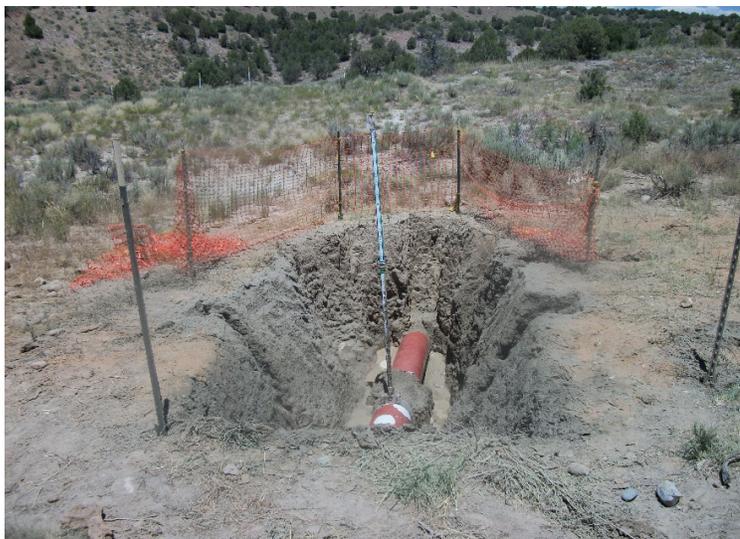
Photograph 2

Photograph Description: View of the final excavation.

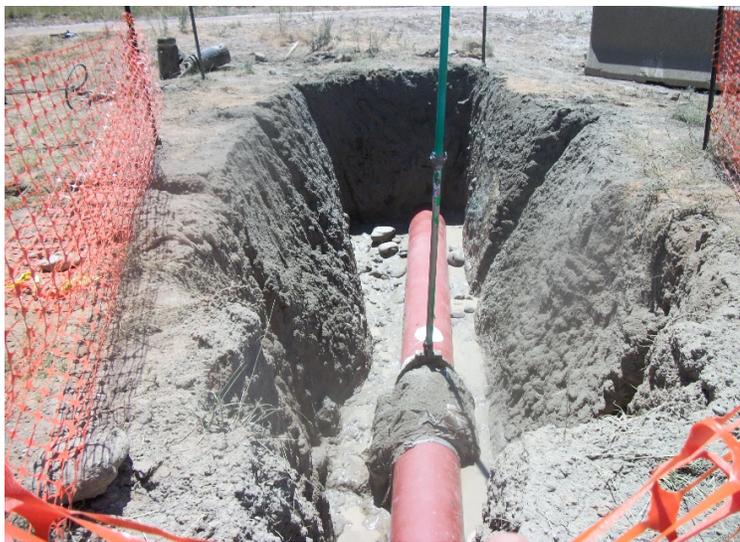
Photograph 3

Photograph Description: View of the final excavation.

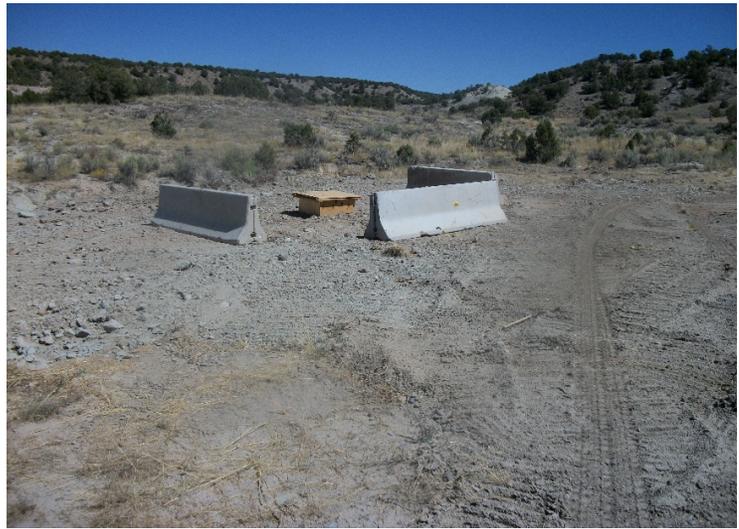
Photograph 4

Photograph Description: View of the final excavation after initial restoration. A cellar box was placed in the excavation to access the Petro-sleeve until final pipeline repairs can be conducted.

The excavation was partially backfilled with imported fill and then contoured to the surrounding grade. Enterprise will fully backfill the excavation once permanent pipeline repairs are completed. Enterprise will re-seed the Site with an approved seeding mixture if requested by the landowner.

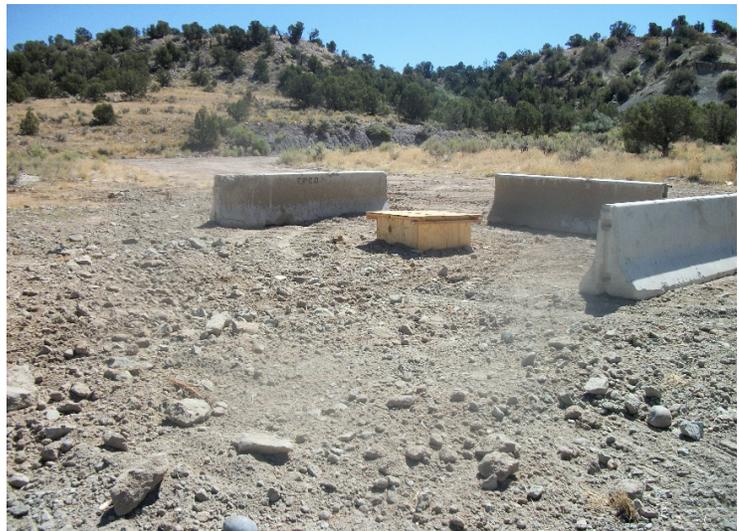
Photograph 5

Photograph Description: View of the final excavation after initial restoration. A cellar box was placed in the excavation to access the Petro-sleeve until final pipeline repairs can be conducted.
