## Release Notification

## Riddle F LS 001

### Summary Record of Stockpile Soils Remediation

## Stockpile Vadose Zone Closure Sampling Test Results

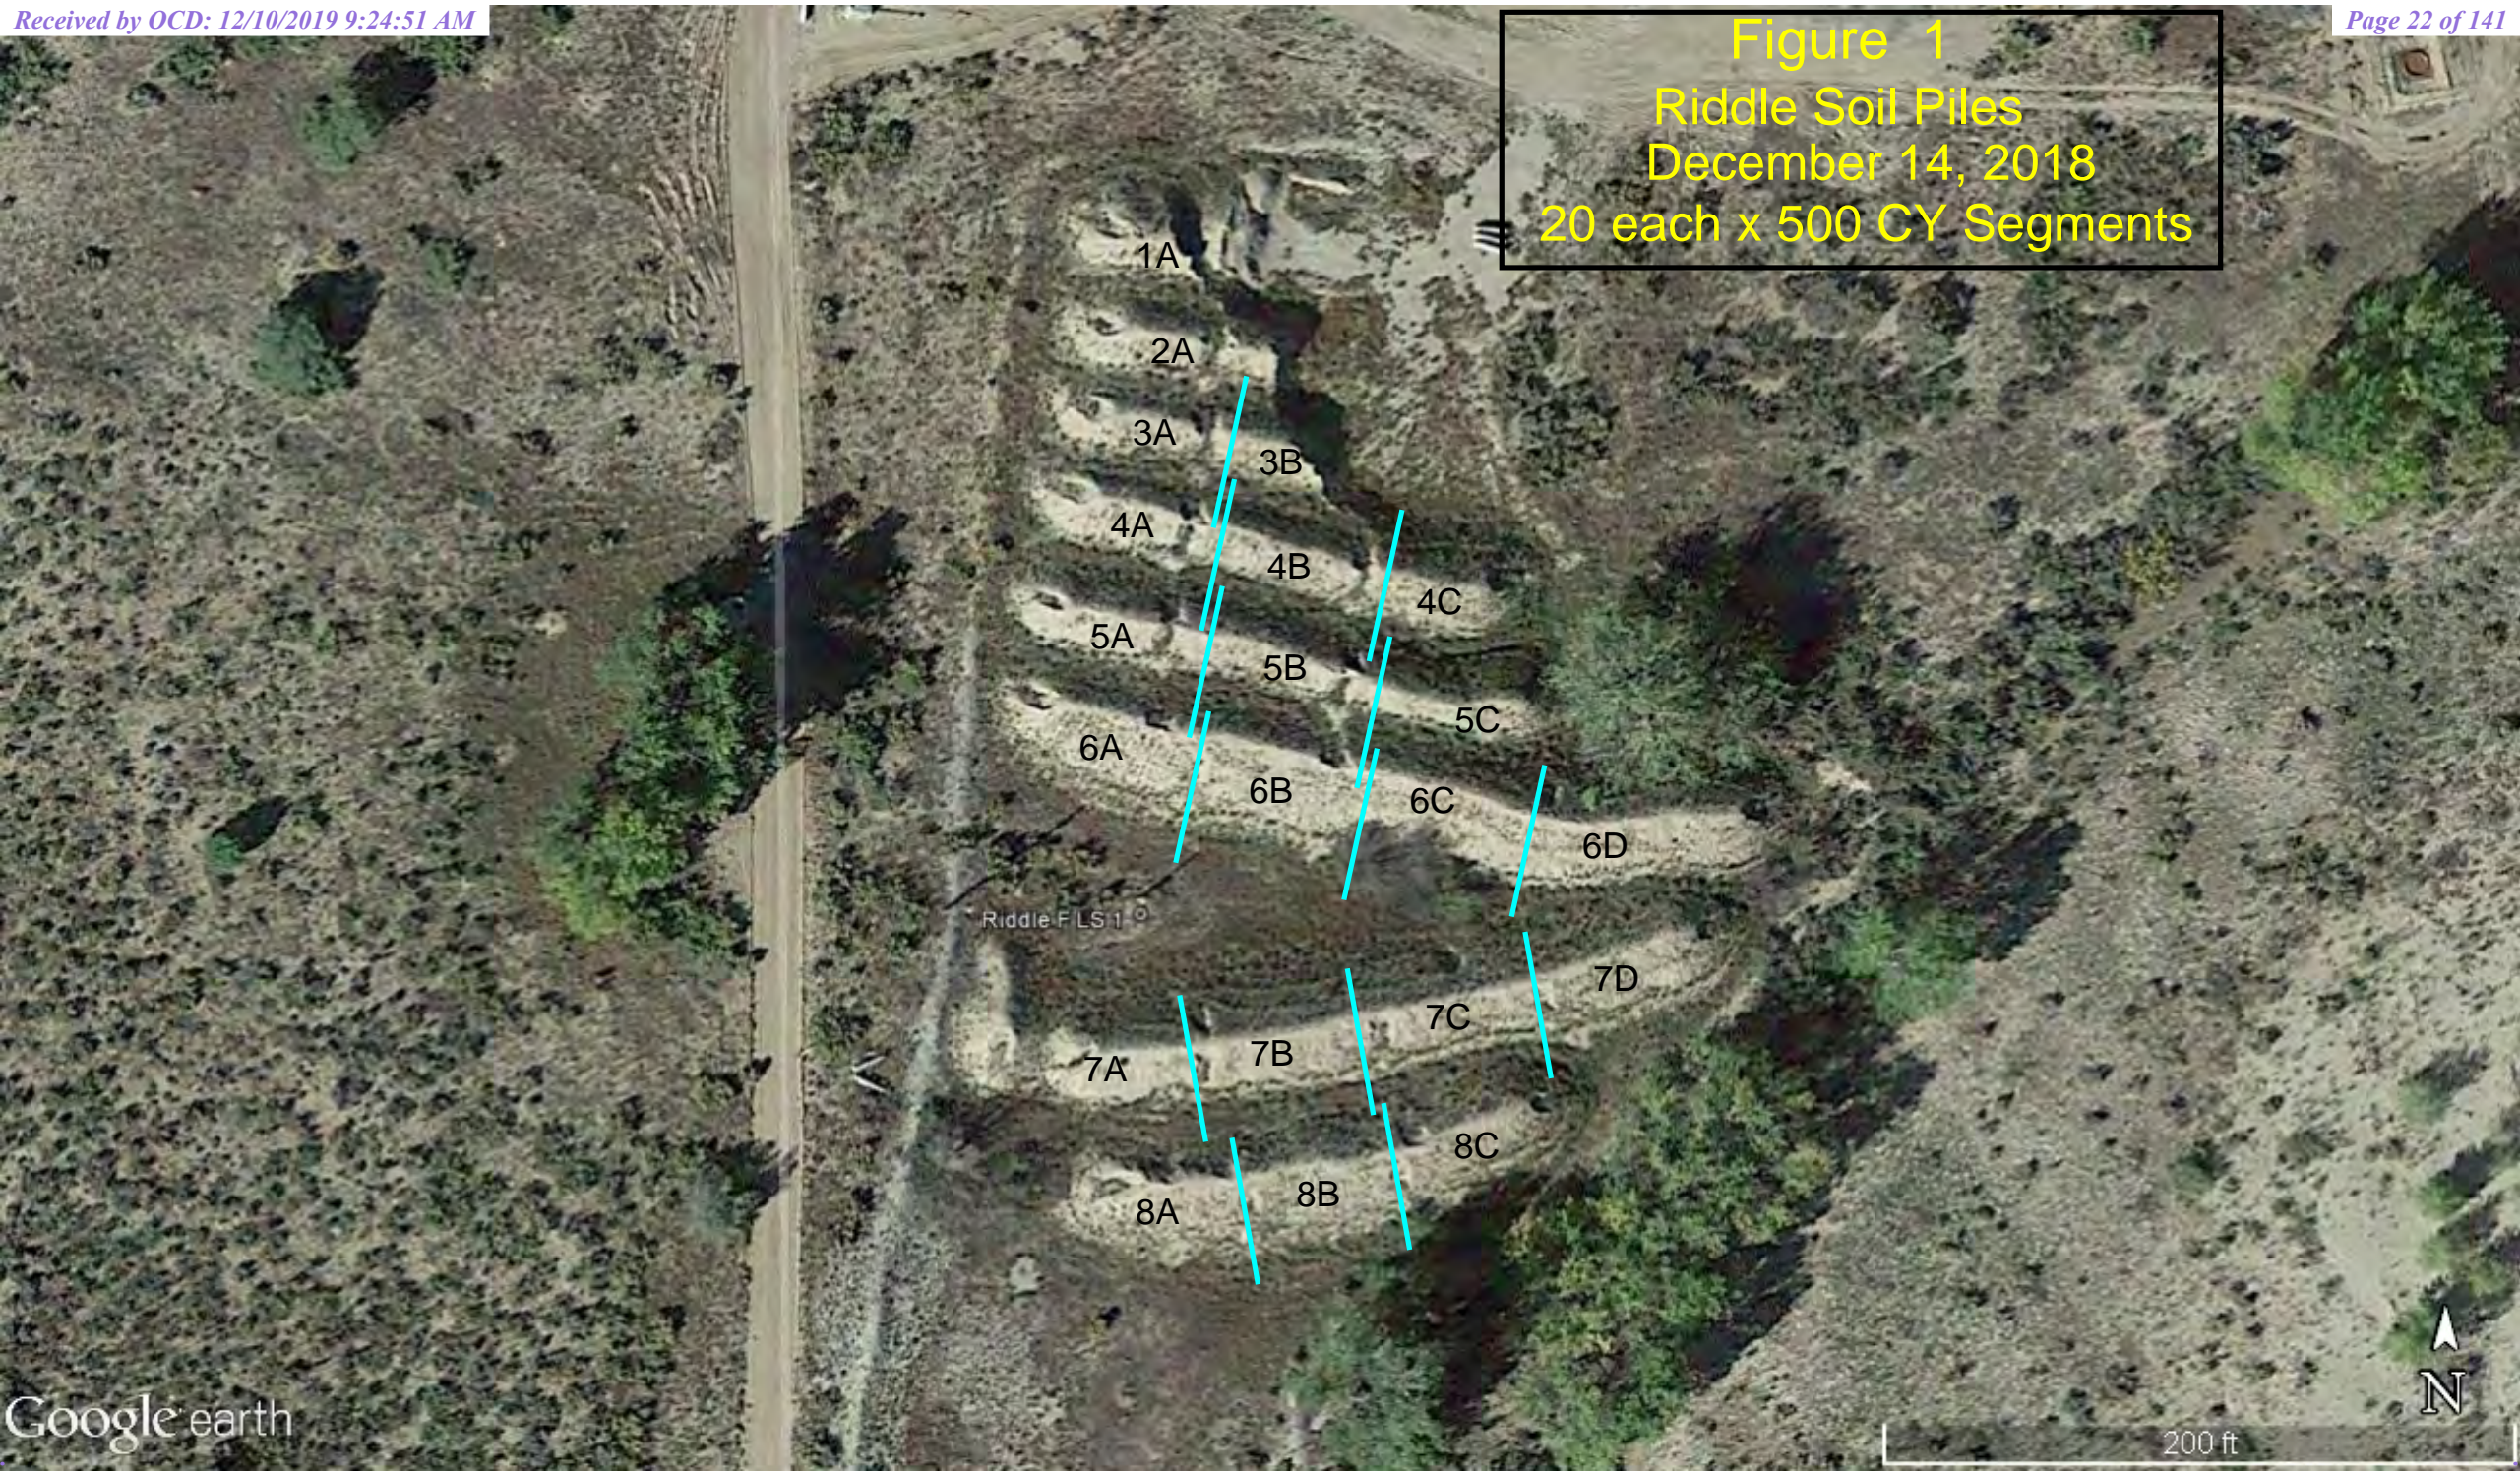
Figure 1  
Riddle Soil Piles  
December 14, 2018  
20 each x 500 CY Segments

A second round of stockpile sampling was conducted on December 14, 2018. This sampling was performed to determine the existing state of remediation and to include U.S. EPA Method 8021 (BTEX) and Method 300 (Chlorides) as requested by NMOCD. It was clearly evident that large portions of Piles #1, #2 and #3 had been removed since the original August 2005 sample event. It was estimated that approximately 10,000 CY soil remained. For this event the stockpiles were measured into segments of approximately 500 CY each and an excavator trackhoe was used to collect 5-point composites from within each segment for laboratory analytical testing. NMOCD and BLM representatives were present to observe the sample event. The results of this sampling were documented in letter report to BPX Energy prepared by BEI dated December 21, 2018.

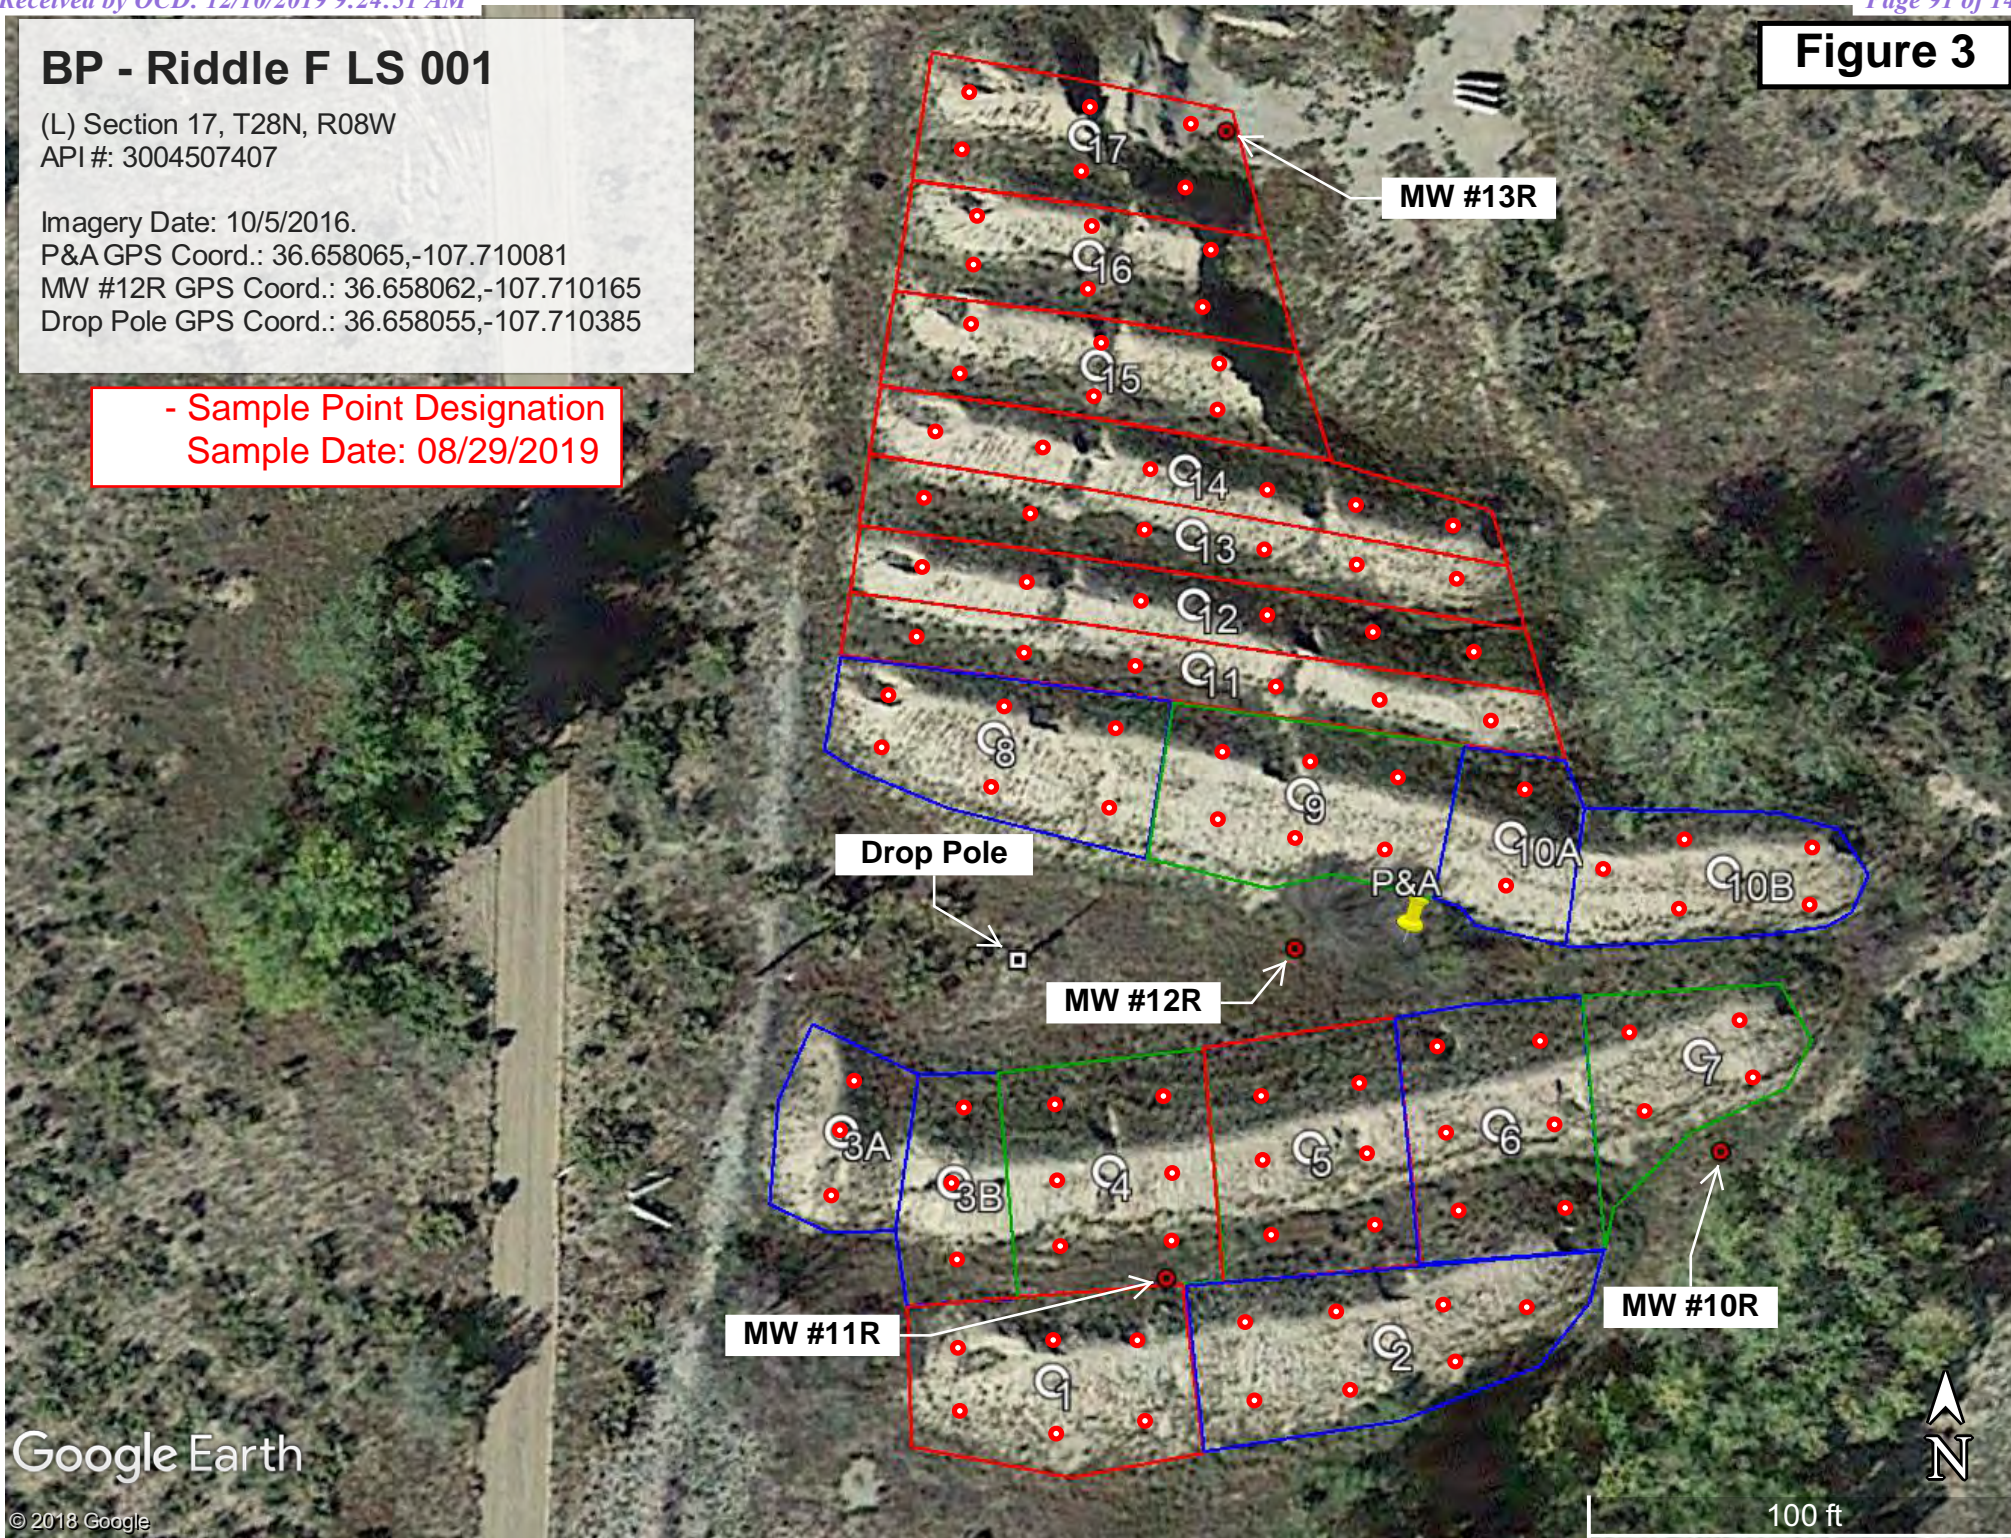
**Figure 3**

- Sample Point Designation  
Sample Date: 08/29/2019

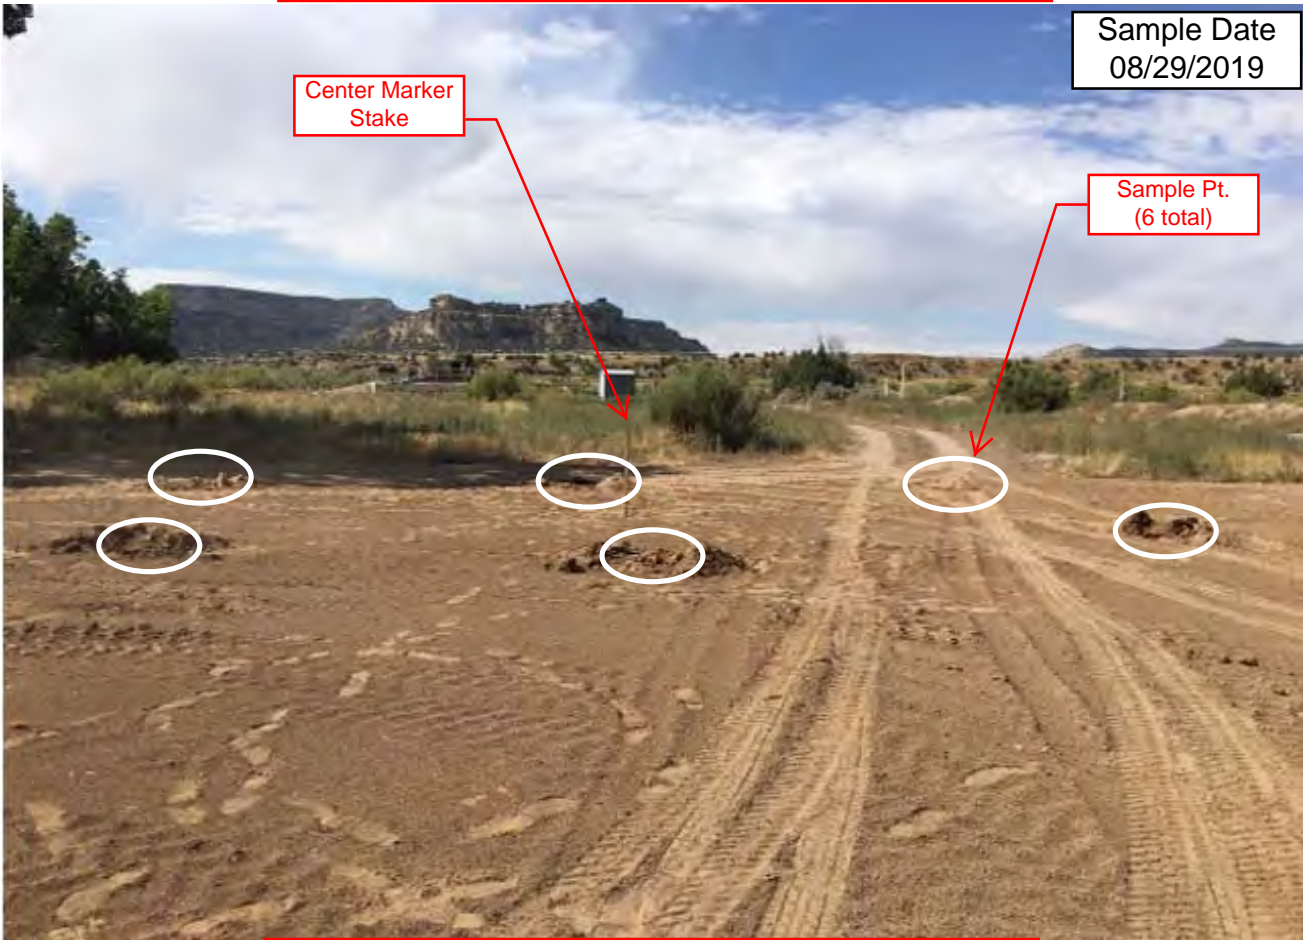
## RIDDLE F LS 1 - ZONE C1

Sample Date  
08/29/2019

Sample Pt.  
(6 total)
