**Breitburn Operating, LP
AKA Maverick Natural Resources LLC
State 647 AC 721 Tank Battery**

Closure Report

**Section 33, Township 18S, Range 28E Eddie
County, New Mexico**

2RP-4238

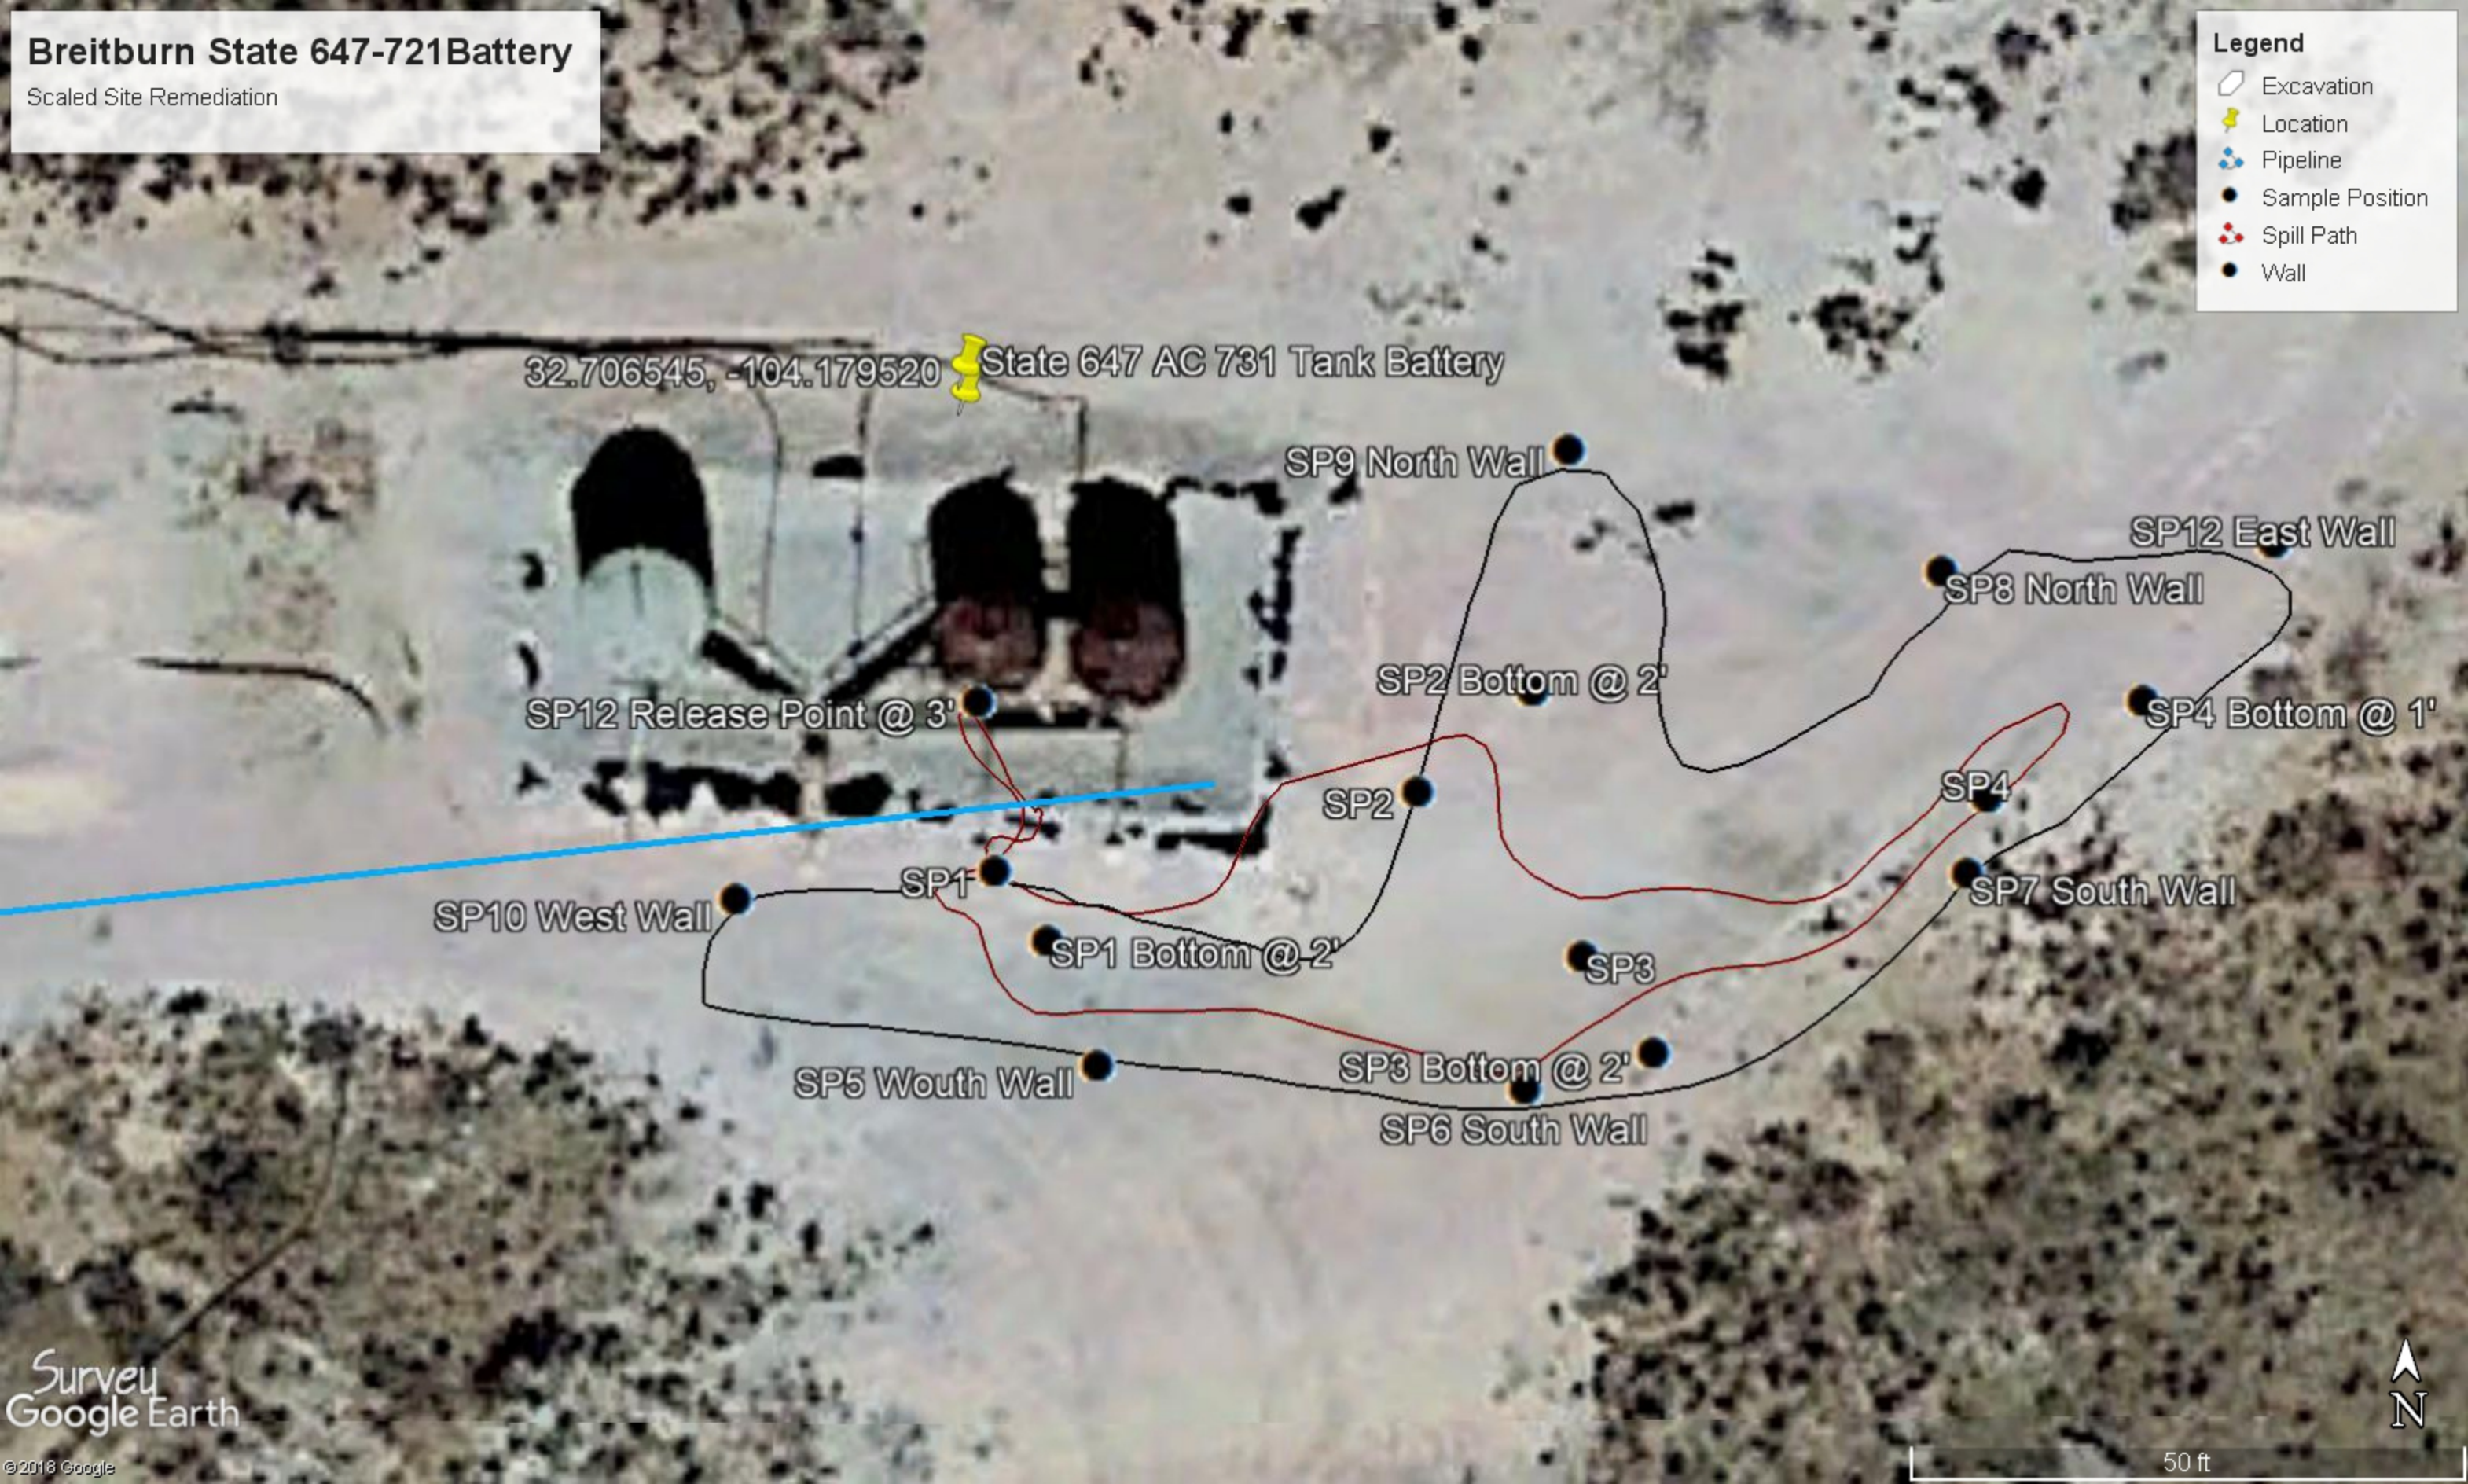
Figure 1

Site Map

Breitburn State 647-721 Battery

Scaled Site Remediation

On September 25, 2019 SESI personnel are onsite together with personnel and equipment from Custom Welding of Hobbs, NM. The SESI Field technician traversed the site assessing the release area with the equipment operator. The release area on the east side of the containment is excavated, a soil sample grabbed, and field tested for TPH. At 1ft. bgs. heavy hydrocarbon staining is encountered. The equipment operator is instructed to advance to 2 ft. bgs until the stained soil is removed. There were two (2) DCP pipelines that ran through the location along the edge of the release area. A Hydro-vac is utilized to daylight the pipeline area. The equipment continues to excavate the impacted area, while the field technician is simultaneously field testing the bottom and sidewalls of the excavation.

By permission of the current operator, the field technician sampled and delineated the release point (SP12 Release Point @3' bgs), located inside the lined containment, by hand auguring thru the liner. All confirmation samples are properly packaged, preserved, and transport via chain of custody to Hall Laboratories for analyses of Chlorides (CL EPA Method 300.0 ANIONS), Total Petroleum Hydrocarbons (DRO, GRO, MRO EPA Method 8015 M/D), as well as Benzene, Toluene, Ethylbenzene, and Xylenes (EPA Method 8021B). The results are tabulated below for ease of reference (Appendix C).

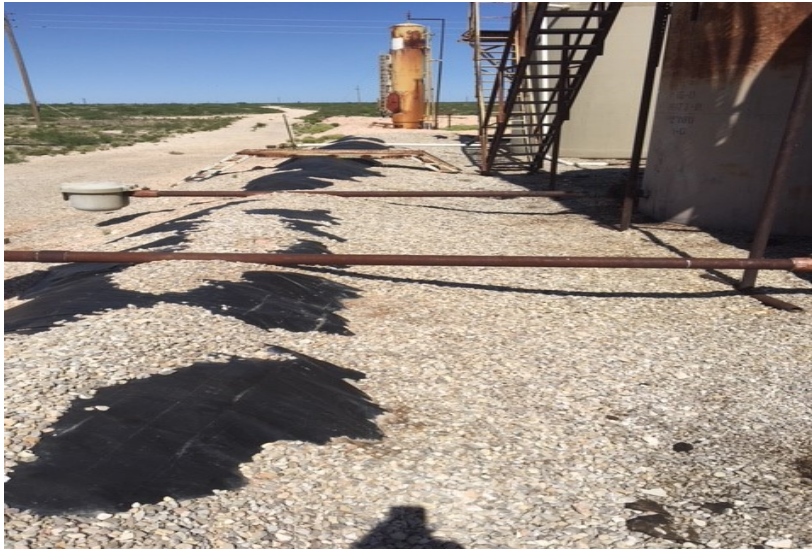
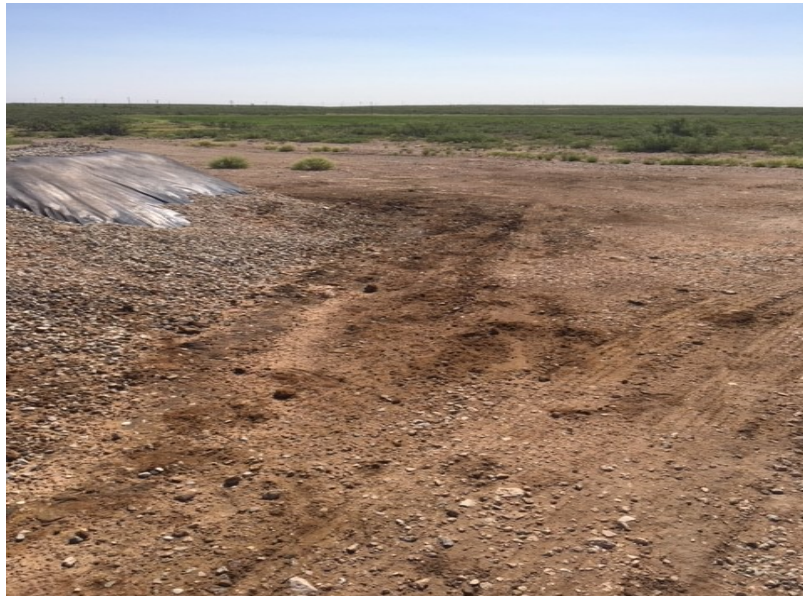
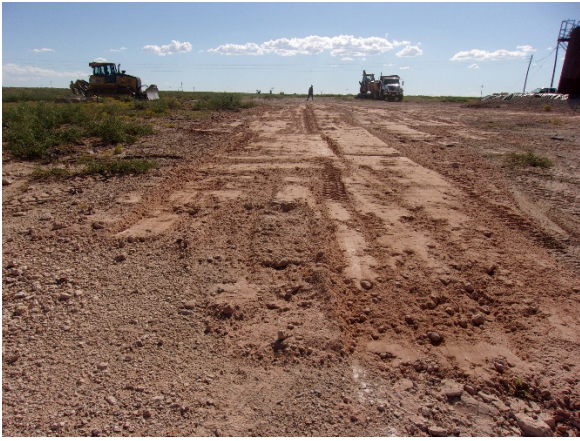
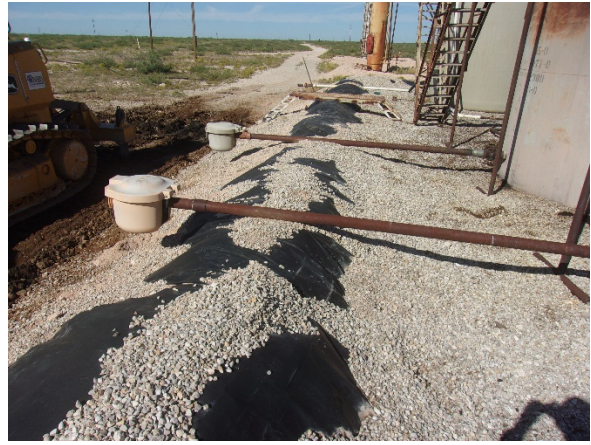
Completion
Maverick Resources
State 647-721 Battery

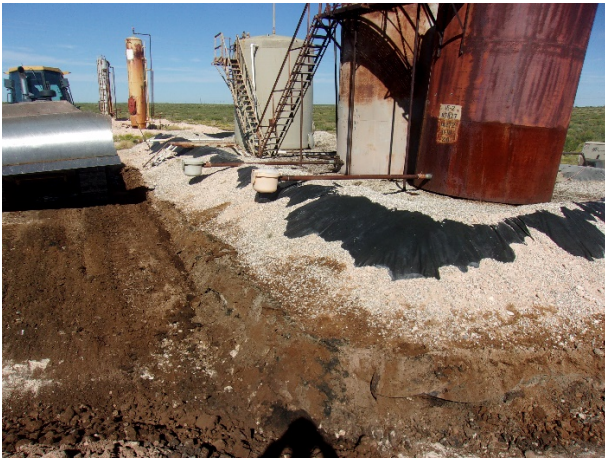
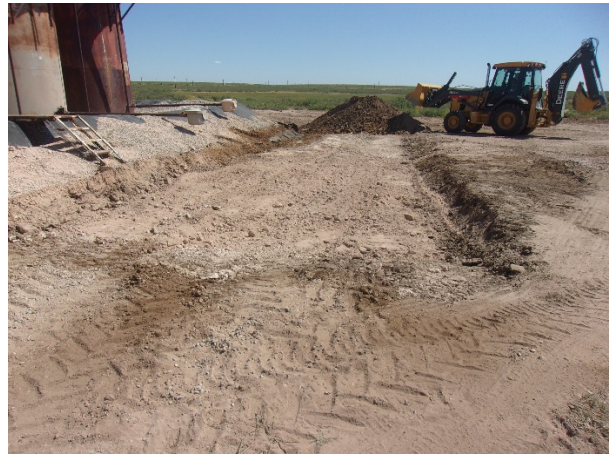
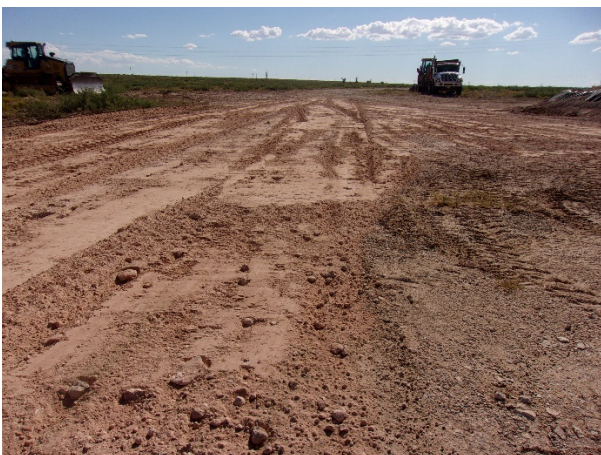
Excavation

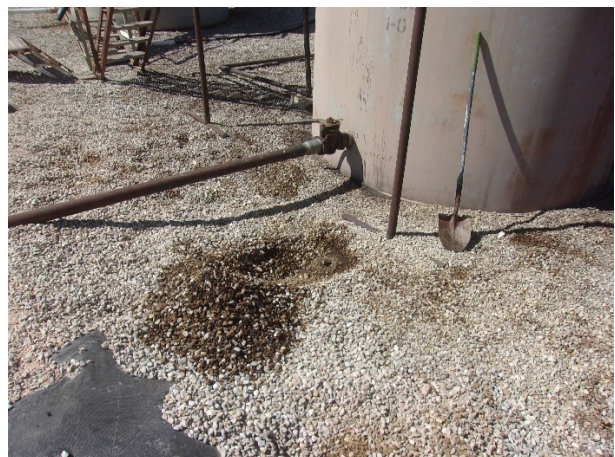
Lease Road Area

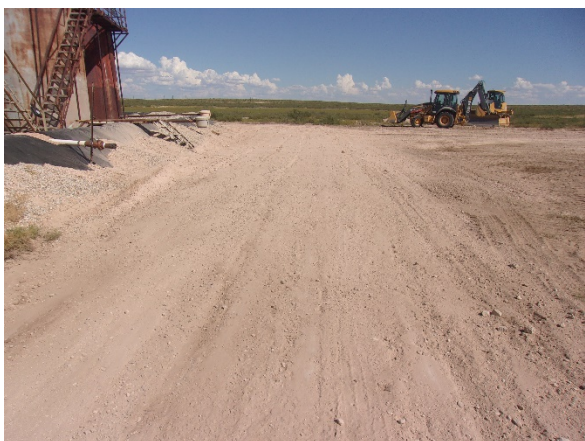
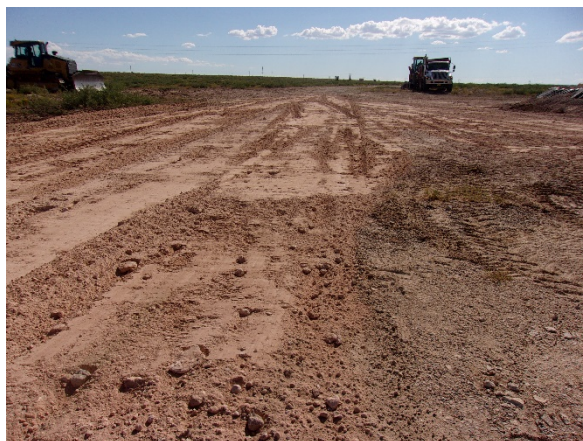
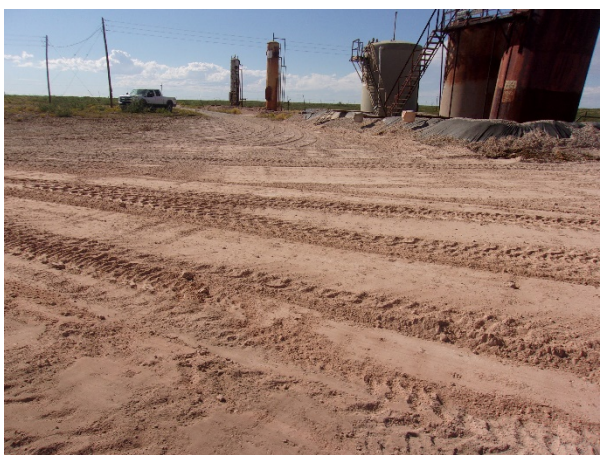
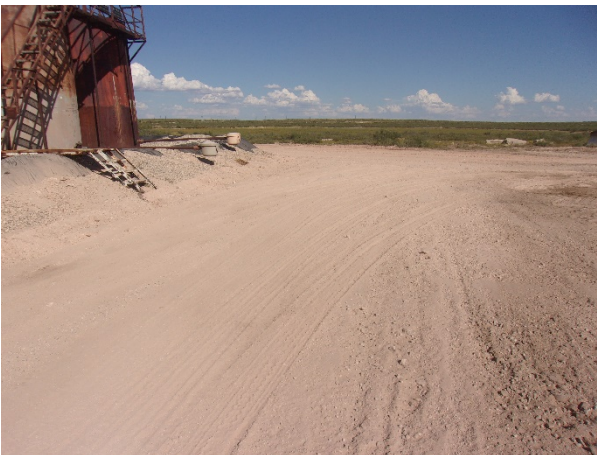
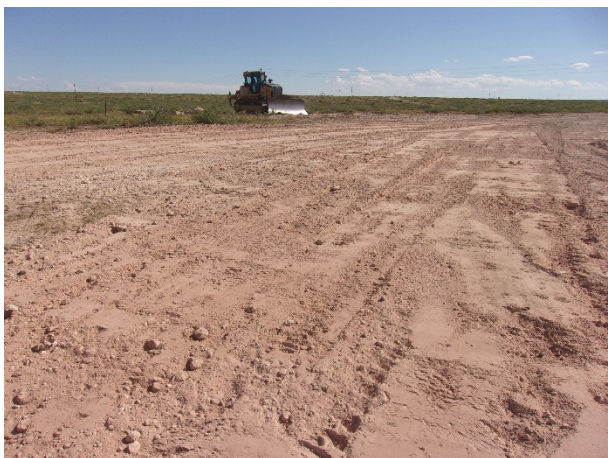
Release Point

Completion
