Responsible Party: BP America Production Co	OGRID: 778	Closure - Remediation Variance
Contact Name: Steve Moskal	Contact Telephone: (505) 330-9179	
Contact email: steven.moskal@bpx.com	Incident # (assigned by OCD) NCS1916949750	
Contact mailing address: 1199 Main St., Suite 101, Durango CO, 81301

Site Name: GALLEGOS CANYON UNIT #505	Site Type: Natural Gas Production Well Pad
Date Release Discovered: March 6, 2019	API#: 30-045-28235

SITE MAPS & PHOTOGRAPHS

GCU 505
(P) Sec 17 - T29N - R12W
API: 30-045-28235

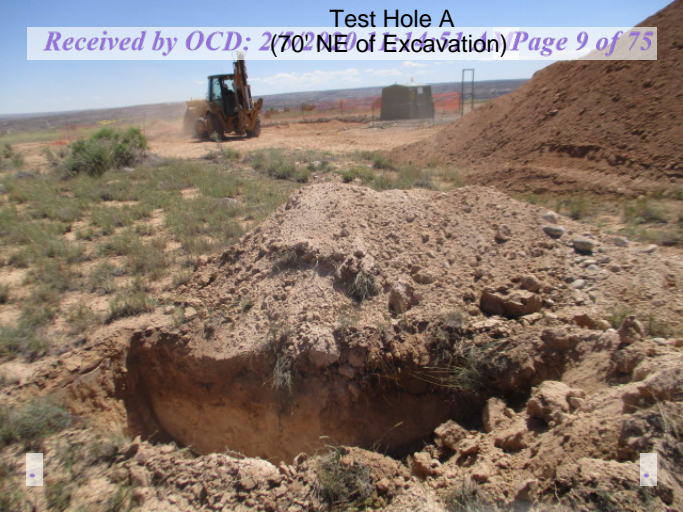
Test Hole A

(70' NE of Excavation)

Chloride	1210	20.0	mg/kg	1	1926020	06/26/19	06/26/19	EPA 300.0/9056A	
----------	------	------	-------	---	---------	----------	----------	--------------------	--

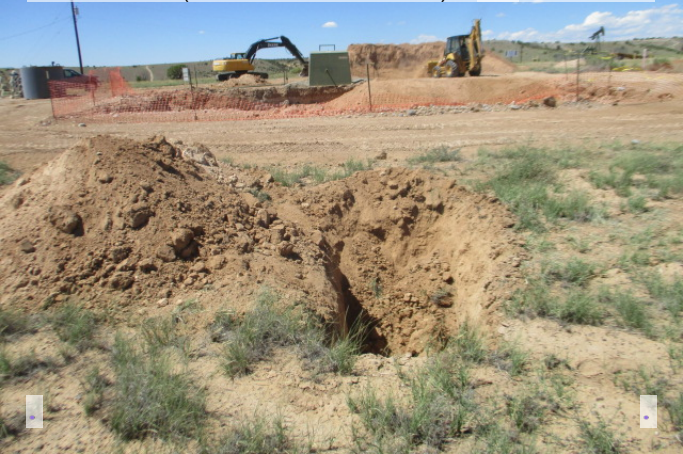
Test Hole C

(35' South of Excavation)

Chloride	827	20.0	mg/kg	1	1926020	06/26/19	06/26/19	EPA 300.0/9056A	
----------	-----	------	-------	---	---------	----------	----------	--------------------	--

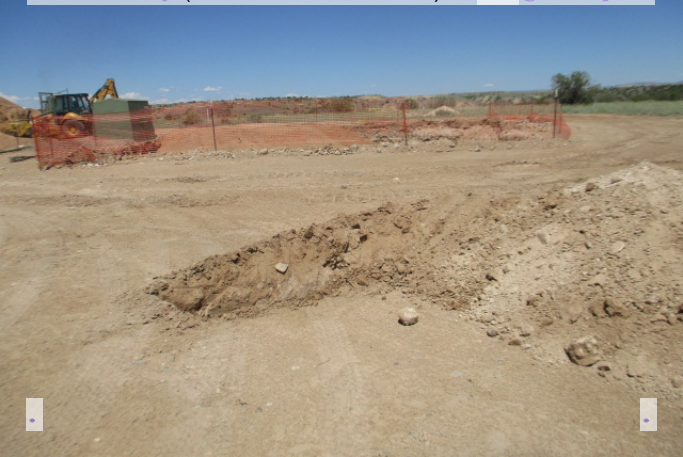
Test Hole D

Received by (35' West of Excavation) 2011/11/15 11:51 AM Page 12 of 75

Chloride	875	20.0	mg/kg	1	1926020	06/26/19	06/26/19	EPA 300.0/9056A	
----------	-----	------	-------	---	---------	----------	----------	--------------------	--

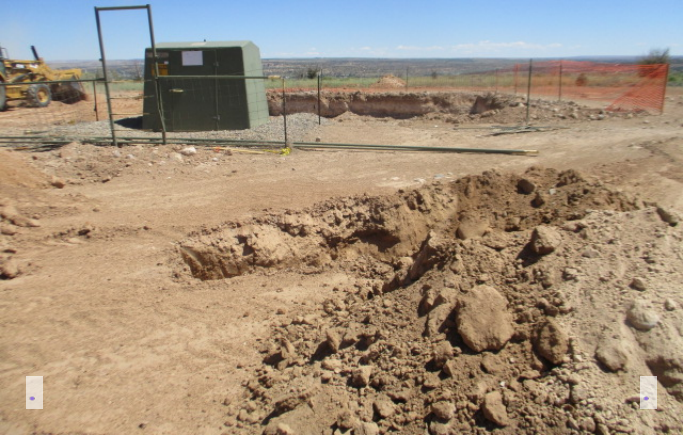
Test Hole E

(30' NW of Excavation)

Chloride	731	20.0	mg/kg	1	1926020	06/26/19	06/26/19	EPA 300.0/9056A	
----------	-----	------	-------	---	---------	----------	----------	--------------------	--

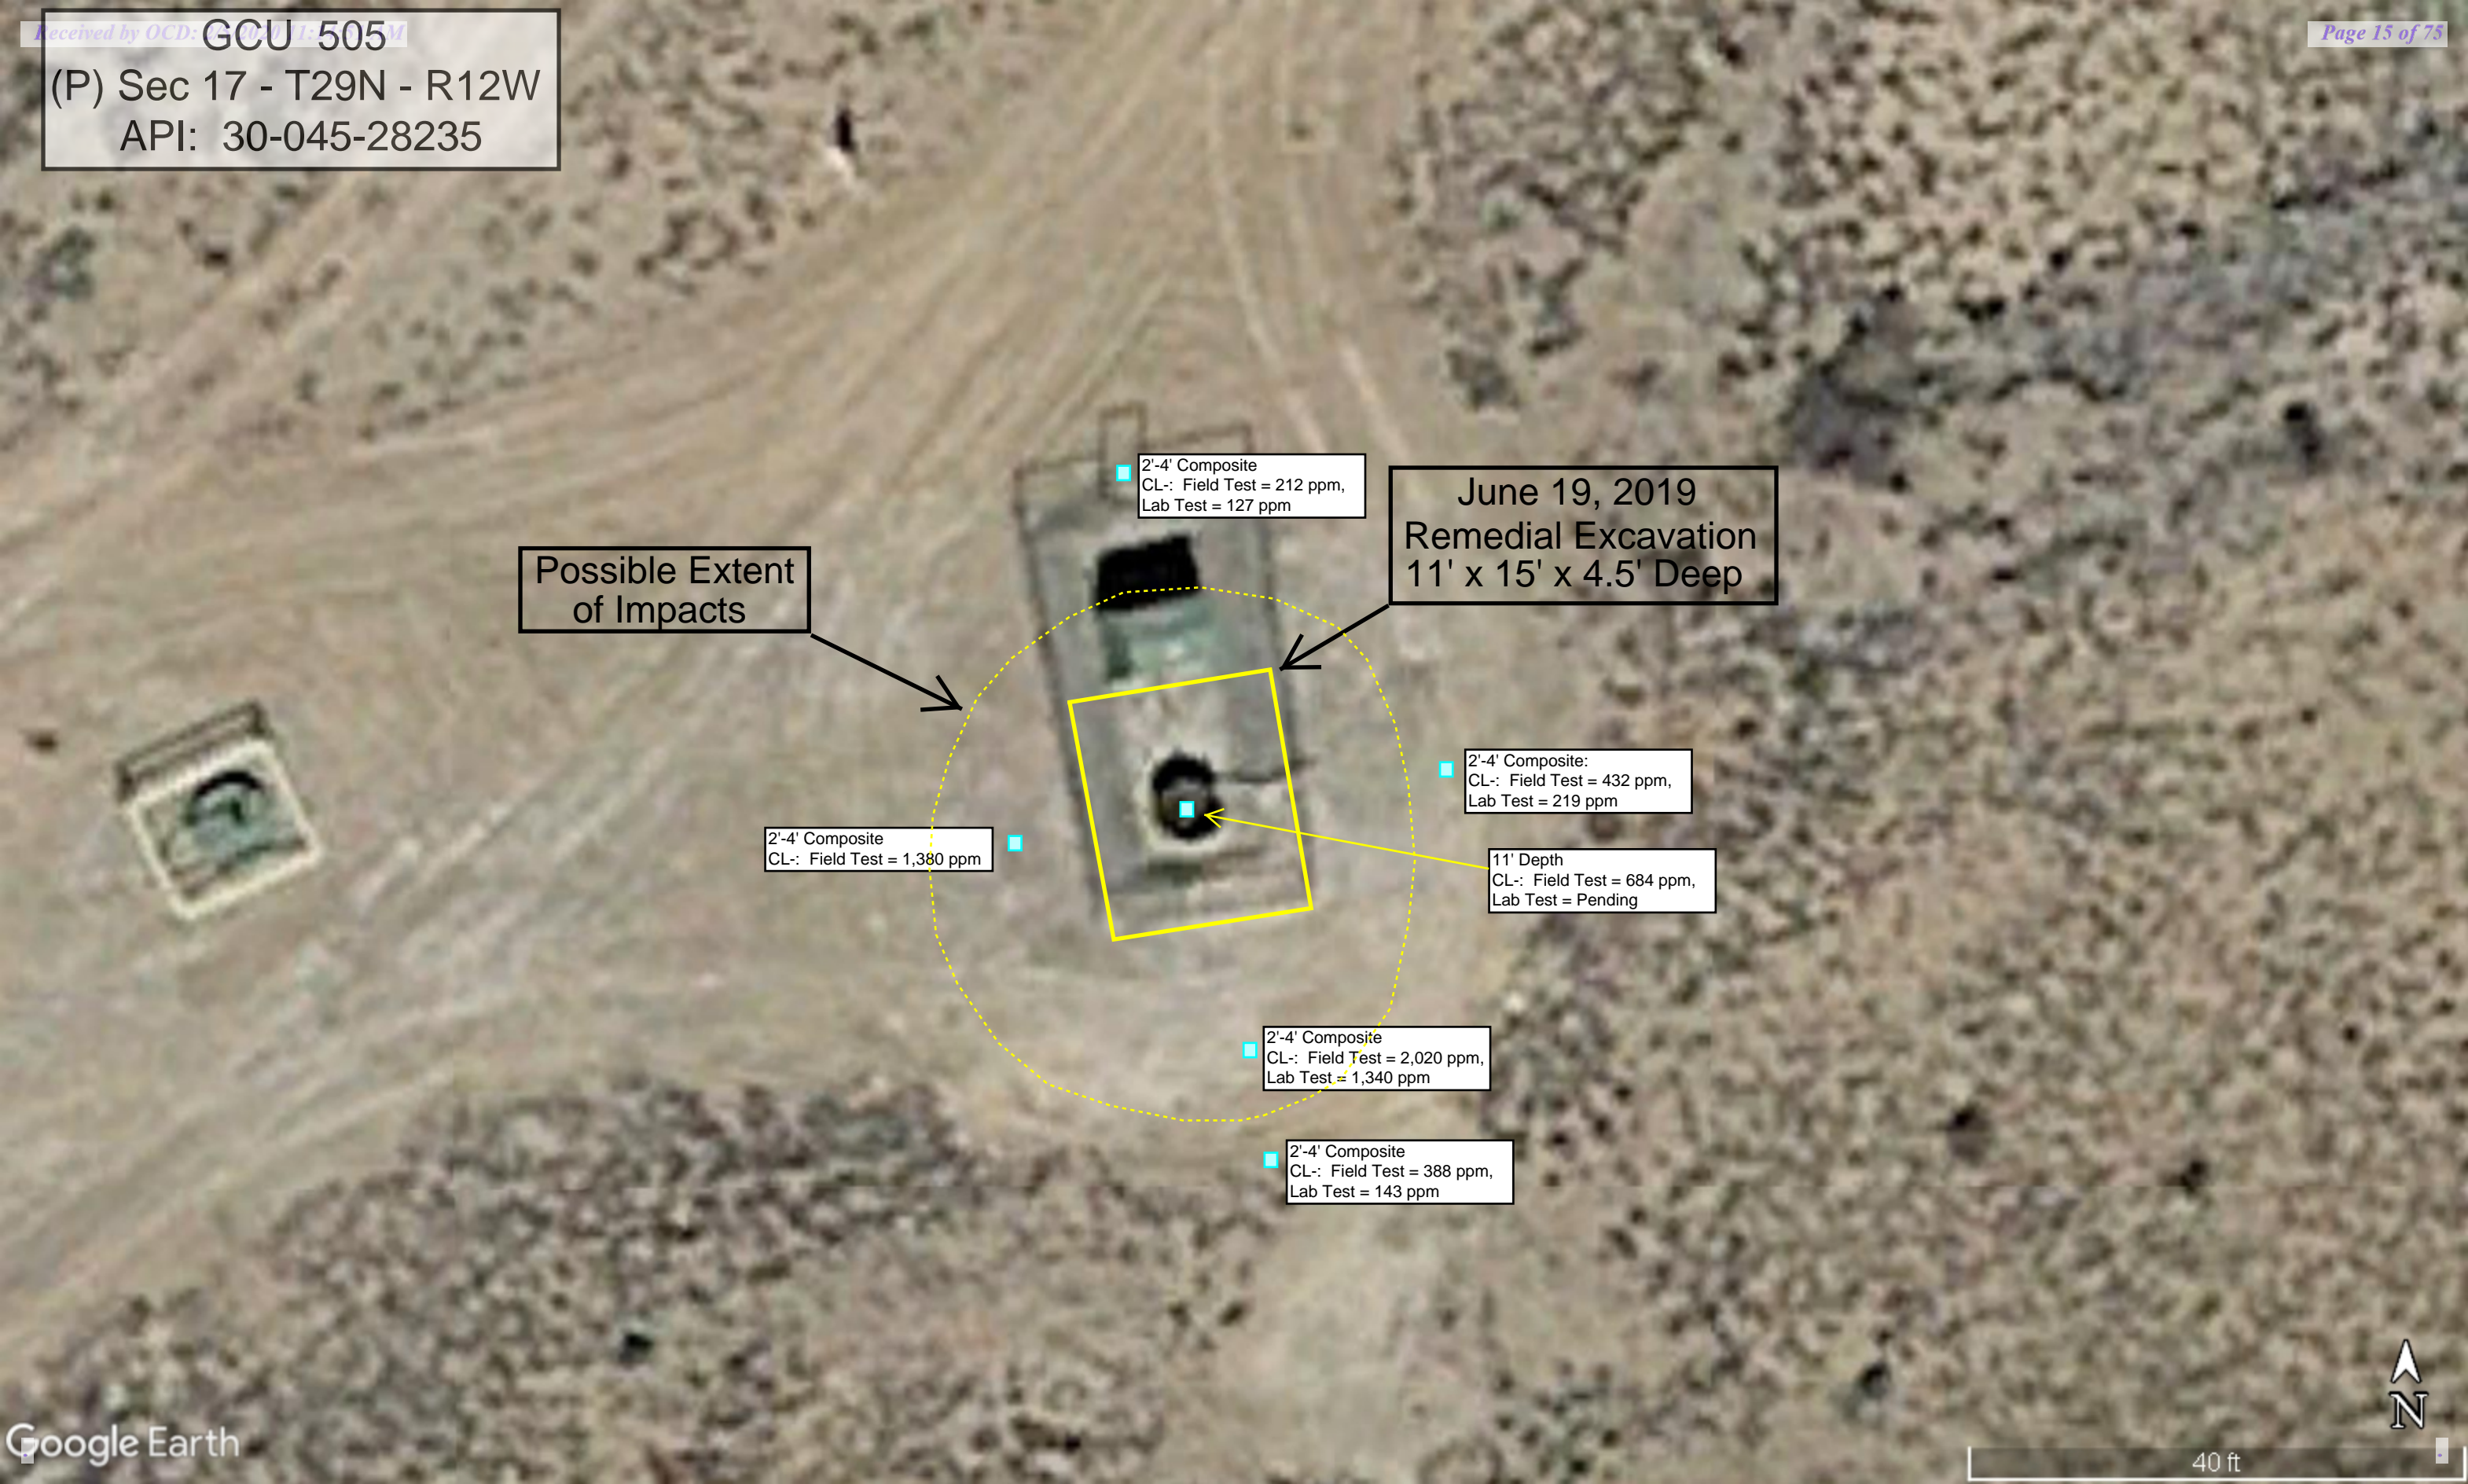
(P) Sec 17 - T29N - R12W
API: 30-045-28235

Possible Extent
of Impacts

June 19, 2019
Remedial Excavation
11' x 15' x 4.5' Deep

2'-4' Composite
CL-: Field Test = 212 ppm,
Lab Test = 127 ppm

2'-4' Composite:
CL-: Field Test = 432 ppm,
Lab Test = 219 ppm

11' Depth
CL-: Field Test = 684 ppm,
Lab Test = Pending

2'-4' Composite
CL-: Field Test = 1,380 ppm

2'-4' Composite
CL-: Field Test = 2,020 ppm,
Lab Test = 1,340 ppm

2'-4' Composite
CL-: Field Test = 388 ppm,
Lab Test = 143 ppm

BP has found that the extent of the elevated chlorides appears to not be related to the below grade tank, but may in fact be naturally occurring. The attached document and lab results indicate that the chloride impact footprint far exceeds what is expected and is consistent across approximately 4' from ground surface. The estimated minimum disturbance is approximately 200'x150', or 3,000 square feet, based on current delineation points. Two thirds of this area is covered with native vegetation.

Further, based on the vegetation growth and density, it is apparent that the chloride serves no impact to plan vigor. The excavation and continued delineation would in fact be more detrimental to the area than to leave in place. Currently, the area is covered with native grasses and other plant species that are not exhibiting any type of stress. **BP requests a variance for closure of this release.**
