Release Notification

Site Name: Rosa Unit 354A	Site Type: Wellsite
Date Release Discovered: 9/6/19	API# (if applicable) 30-039-27832

Re: nCS1929540748

Rosa Unit 354A Remediation Activity
30-039-27832
SEC. 19, T31N AND R04W
Rio Arriba County, NM

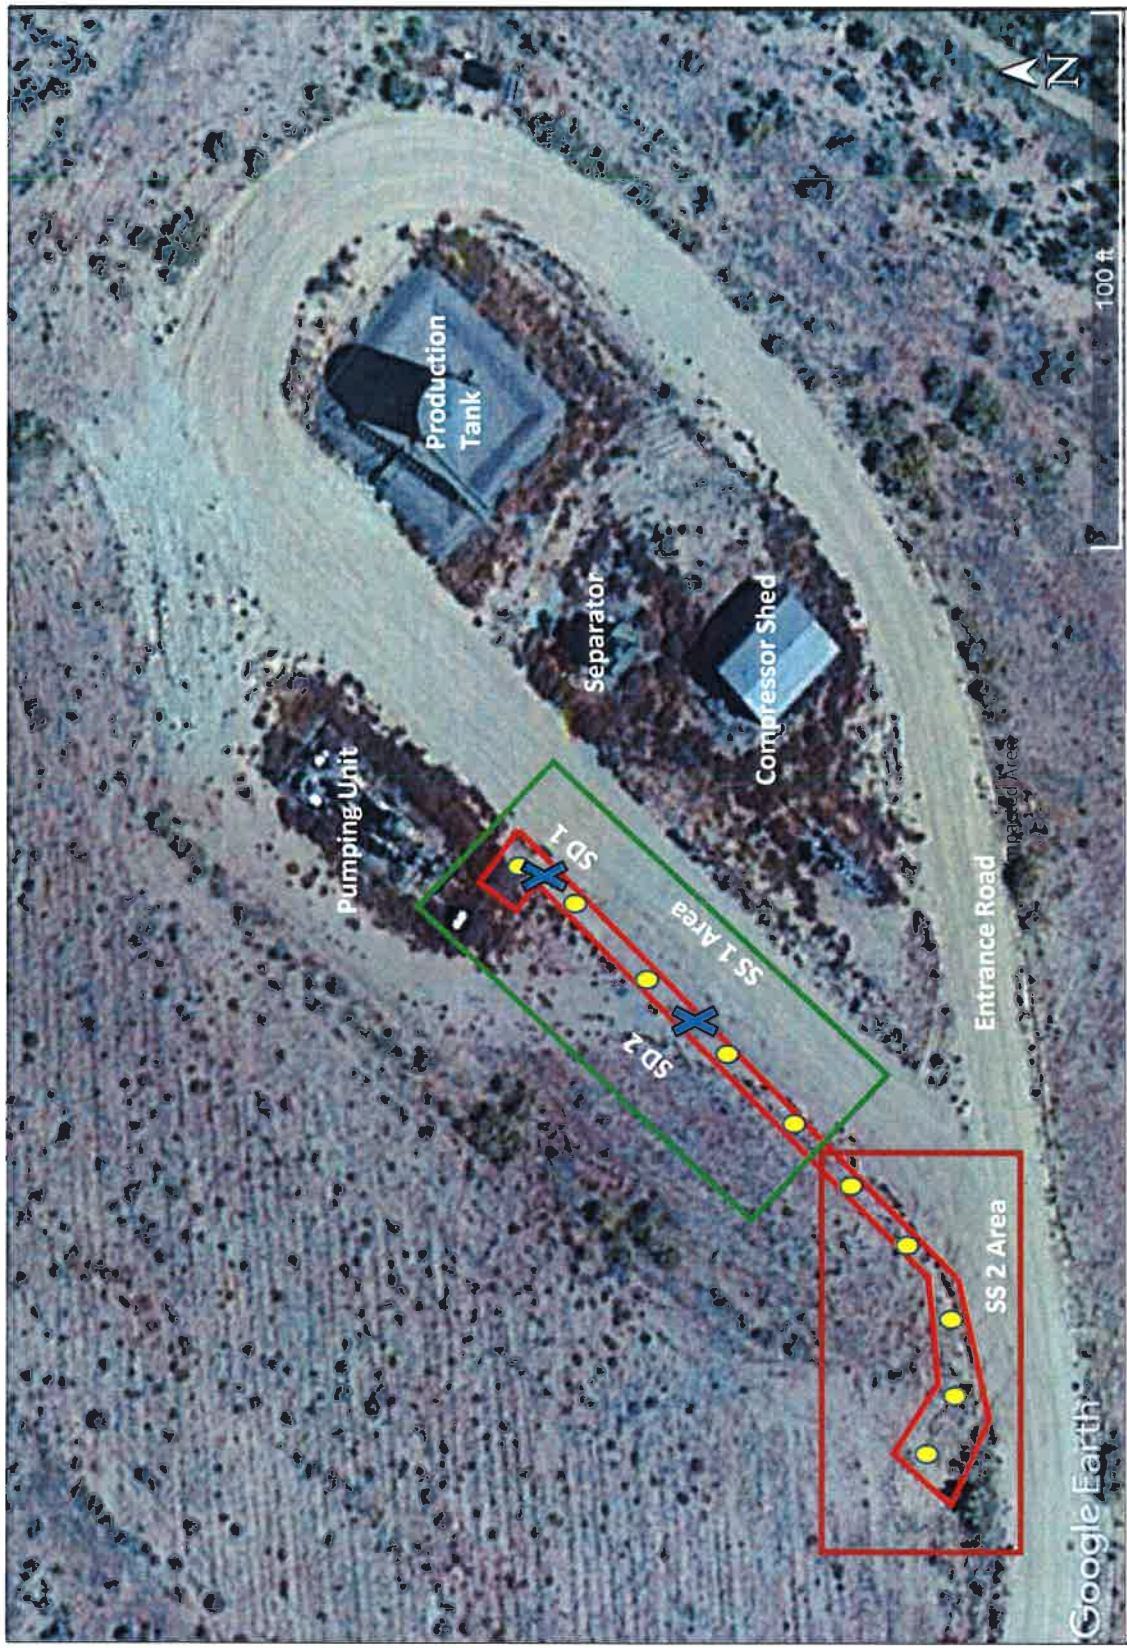
Rosa Unit 354A – 30-039-27832
Sampling Map
Unit I, Section 19, T31N, R4W
Rio Arriba County, NM

- Legend
- Impacted Area
 - Composite Sample Point
 - Delineation
