Release Notification

Site Name South Blanco State 36 #006	Site Type Oil Well Site
Date Release Discovered 11/22/2019	API# (if applicable) 30-045-27639

Below Grade Tank was closed on November 19, 2019. Analytical results were demonstrated a release occurred but were below the regulatory standards pursuant to 19.15.29.

South Blanco State 36 #006
30-045-27639
Summary of Events

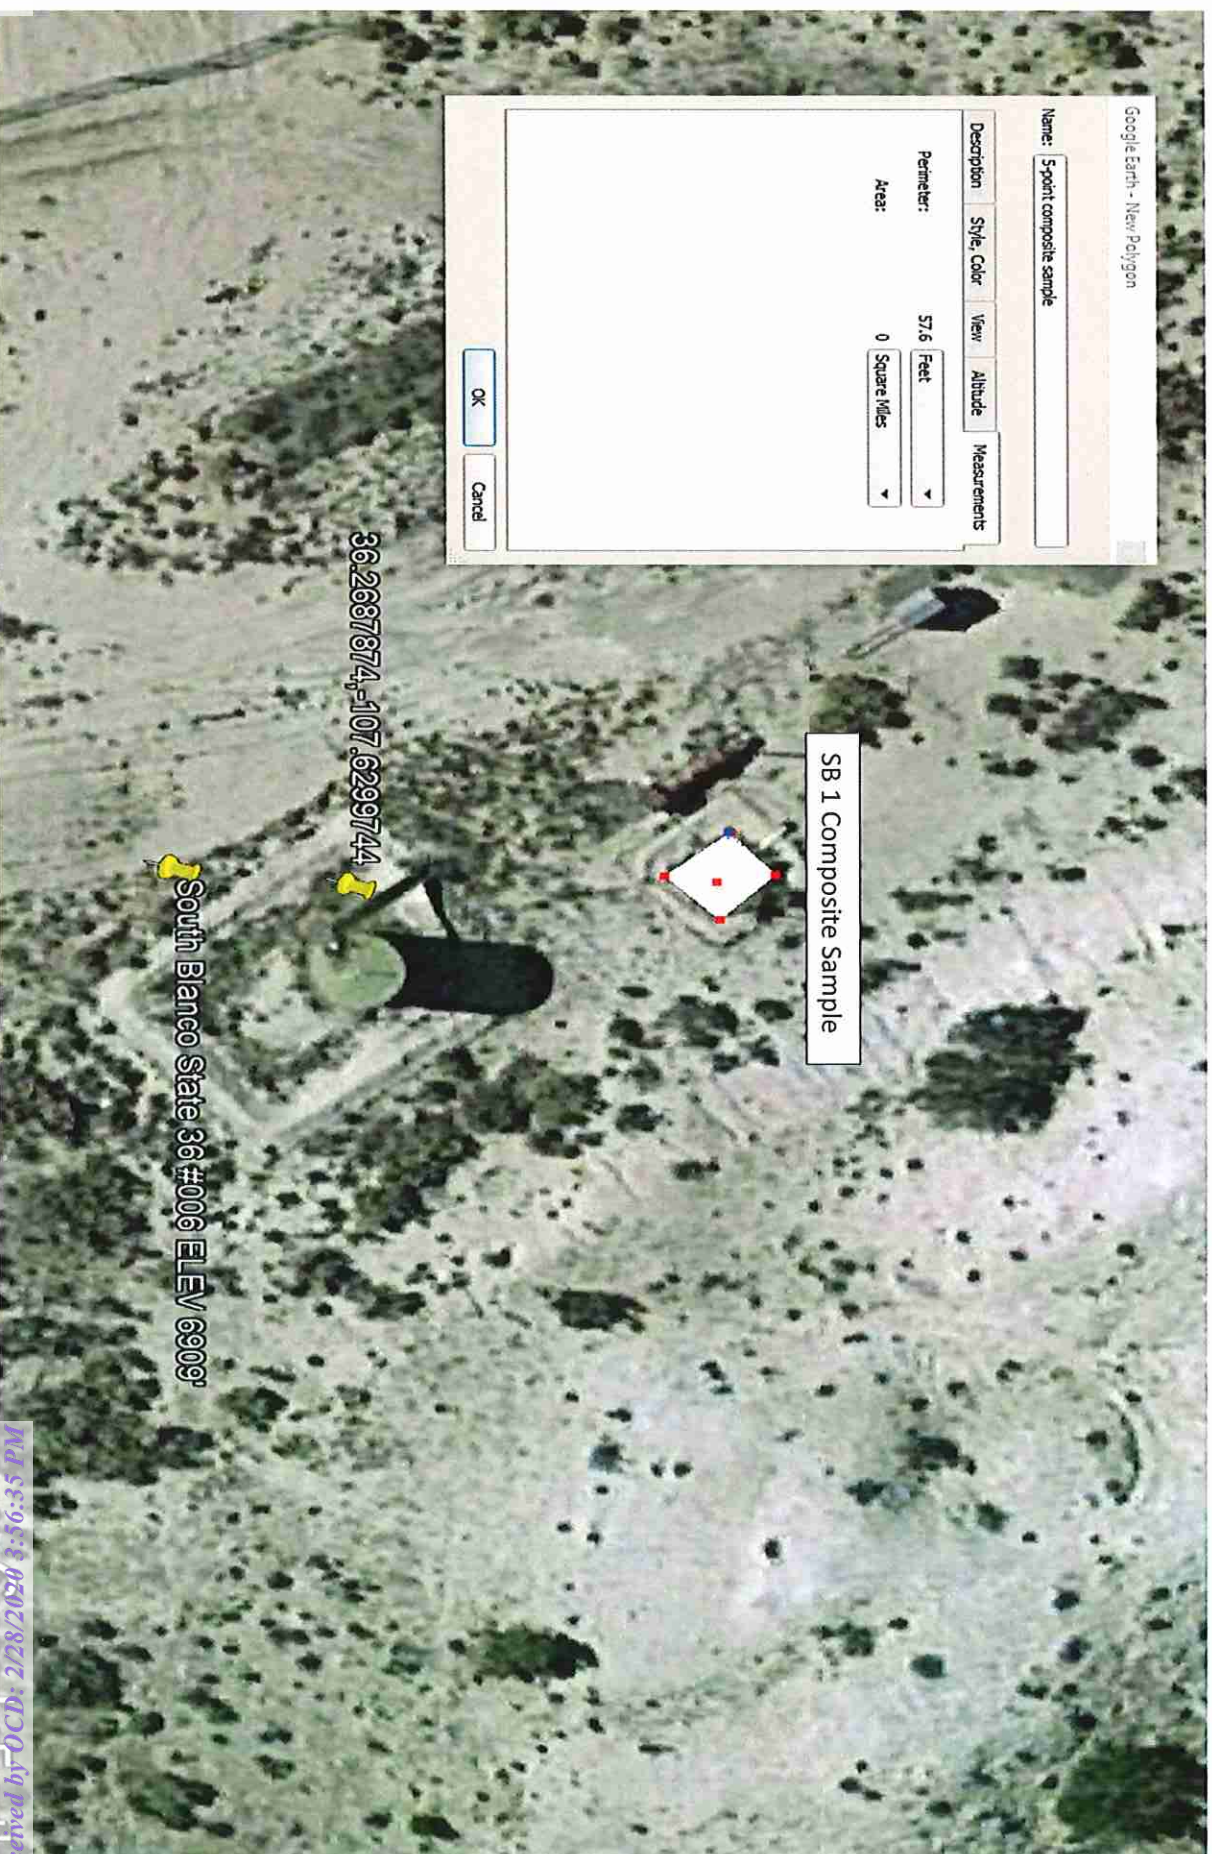
Sitting Criteria South Blanco State 36 #006

See attached Water Report

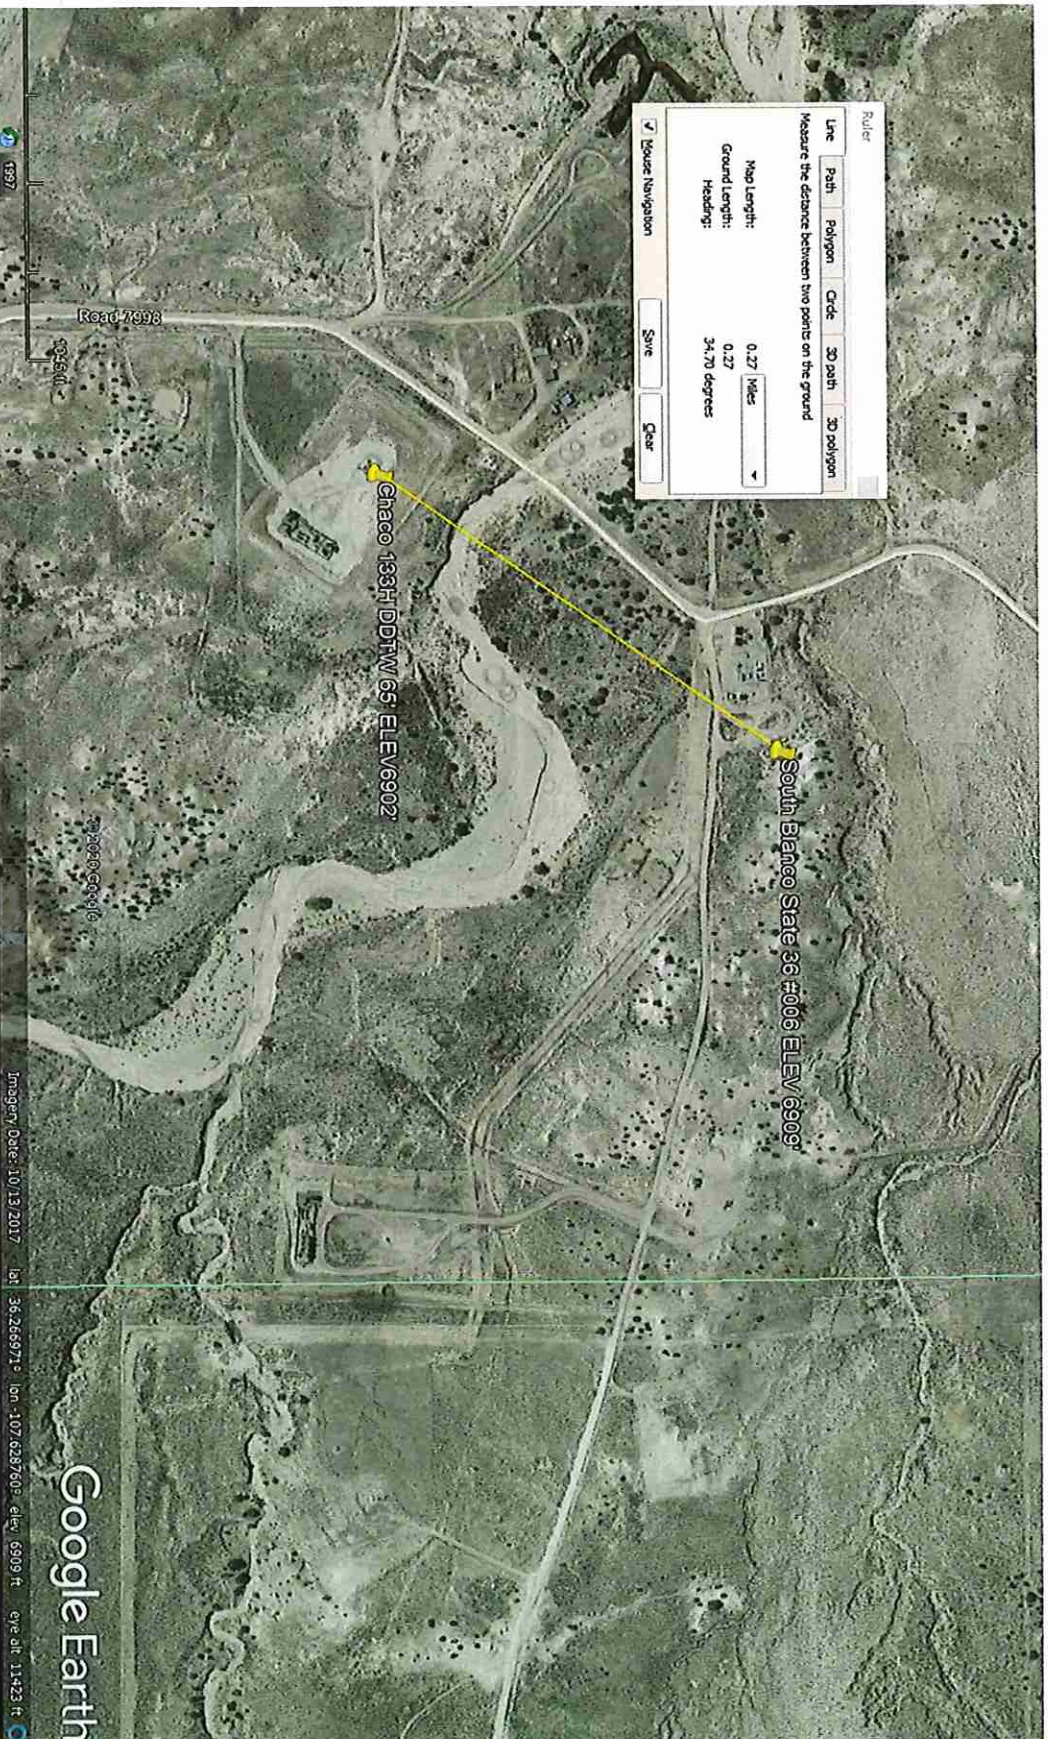
GROUNDWATER DEPTH LOG			
Company: WPX Energy		Location: #120 #133H 134H	
Probe type: Powers H.P. II Sonde			
Date	Time	Depth	Comments
3-26-15	12:20	75	water at 75 ft.
3-26-15	1:30	65	water leveled out at
