Release Notification

Re: Closure Report
San Juan 28-4 No. 18 Release (SW $\frac{1}{4}$, SW $\frac{1}{4}$, Sec. 31, T28N, R4W)
Rio Arriba County, New Mexico
OCD Incident No.: NCS1901155075

Closure Report

San Juan 28-4 No. 18 Release - OCD Incident No. NCS1901155075
Hilcorp Energy Company
Rio Arriba County, New Mexico

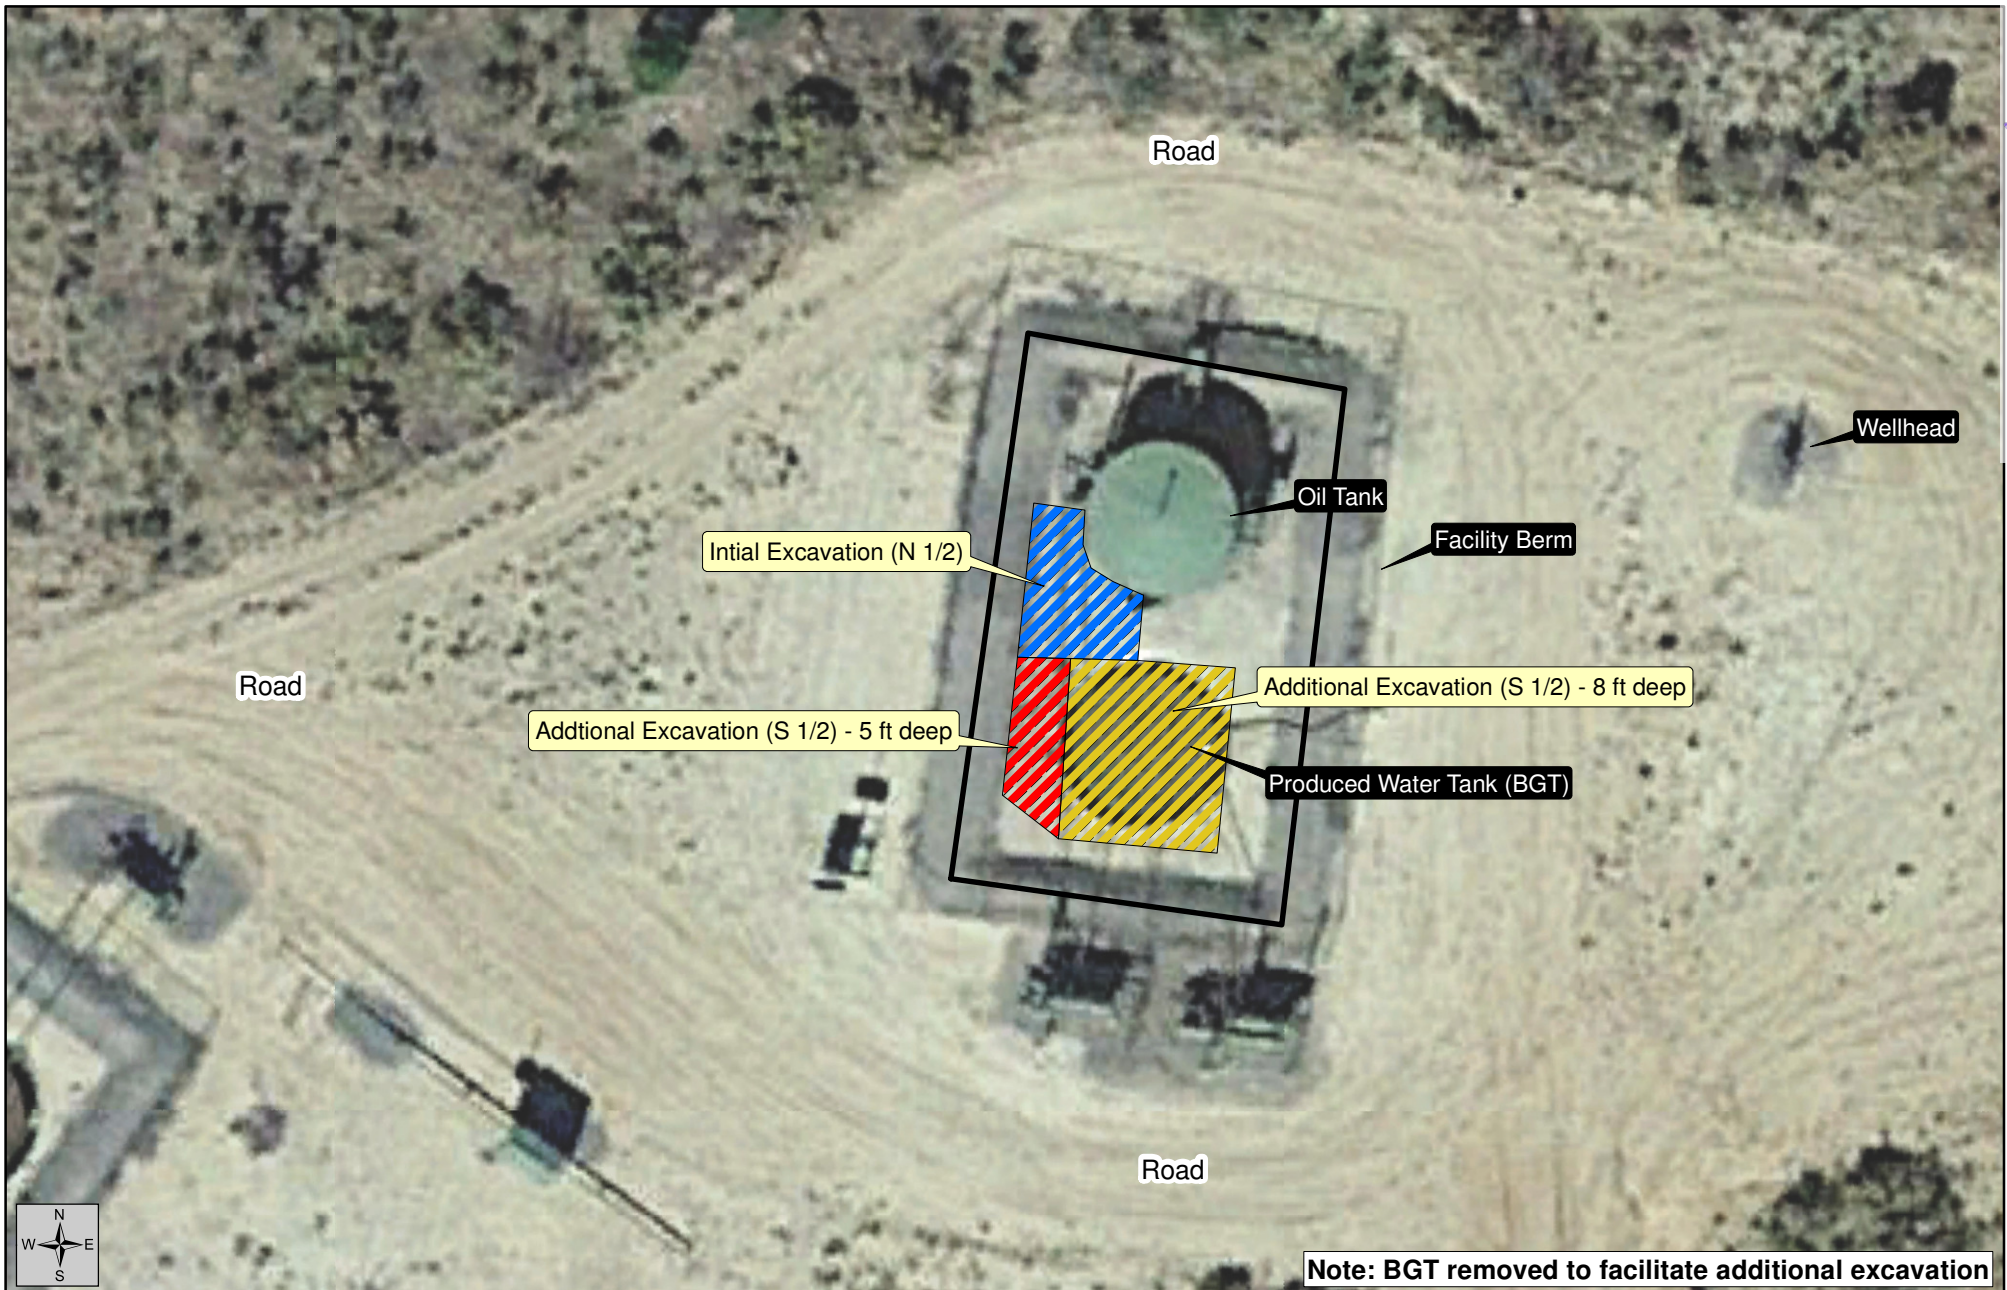
Figure 4
Excavation Map

- Facility Berm
- Previous Excavation
- Excavated Area - 5 ft deep
- Excavated Area - 8 ft deep

On 5/13/19, Hilcorp conducted additional excavation efforts on the south half ("S ½") of the excavation. Construction crews removed the below grade tank (BGT) to facilitate additional excavation. Following tank removal, the southern portion of the excavation was deepened to approximately 5 ft below ground surface (bgs) along the west side of the battery and 8 ft bgs beneath the BGT area. A total of approximately 61 cubic yards of soil was excavated; excavated soil was trucked to Industrial Ecosystems, Inc. (IEI) in Aztec, New Mexico. Excavation extents and volume of soil removed for disposal are shown in the table below.

Excavation Area	Average Length (ft)	Average Width (ft)	Average Depth (ft)	Volume (yds ³)
S ½ – 5' Deep	14	11	3.5	20
S ½ – 8' Deep (BGT Area)	20	8.3	6.5	40

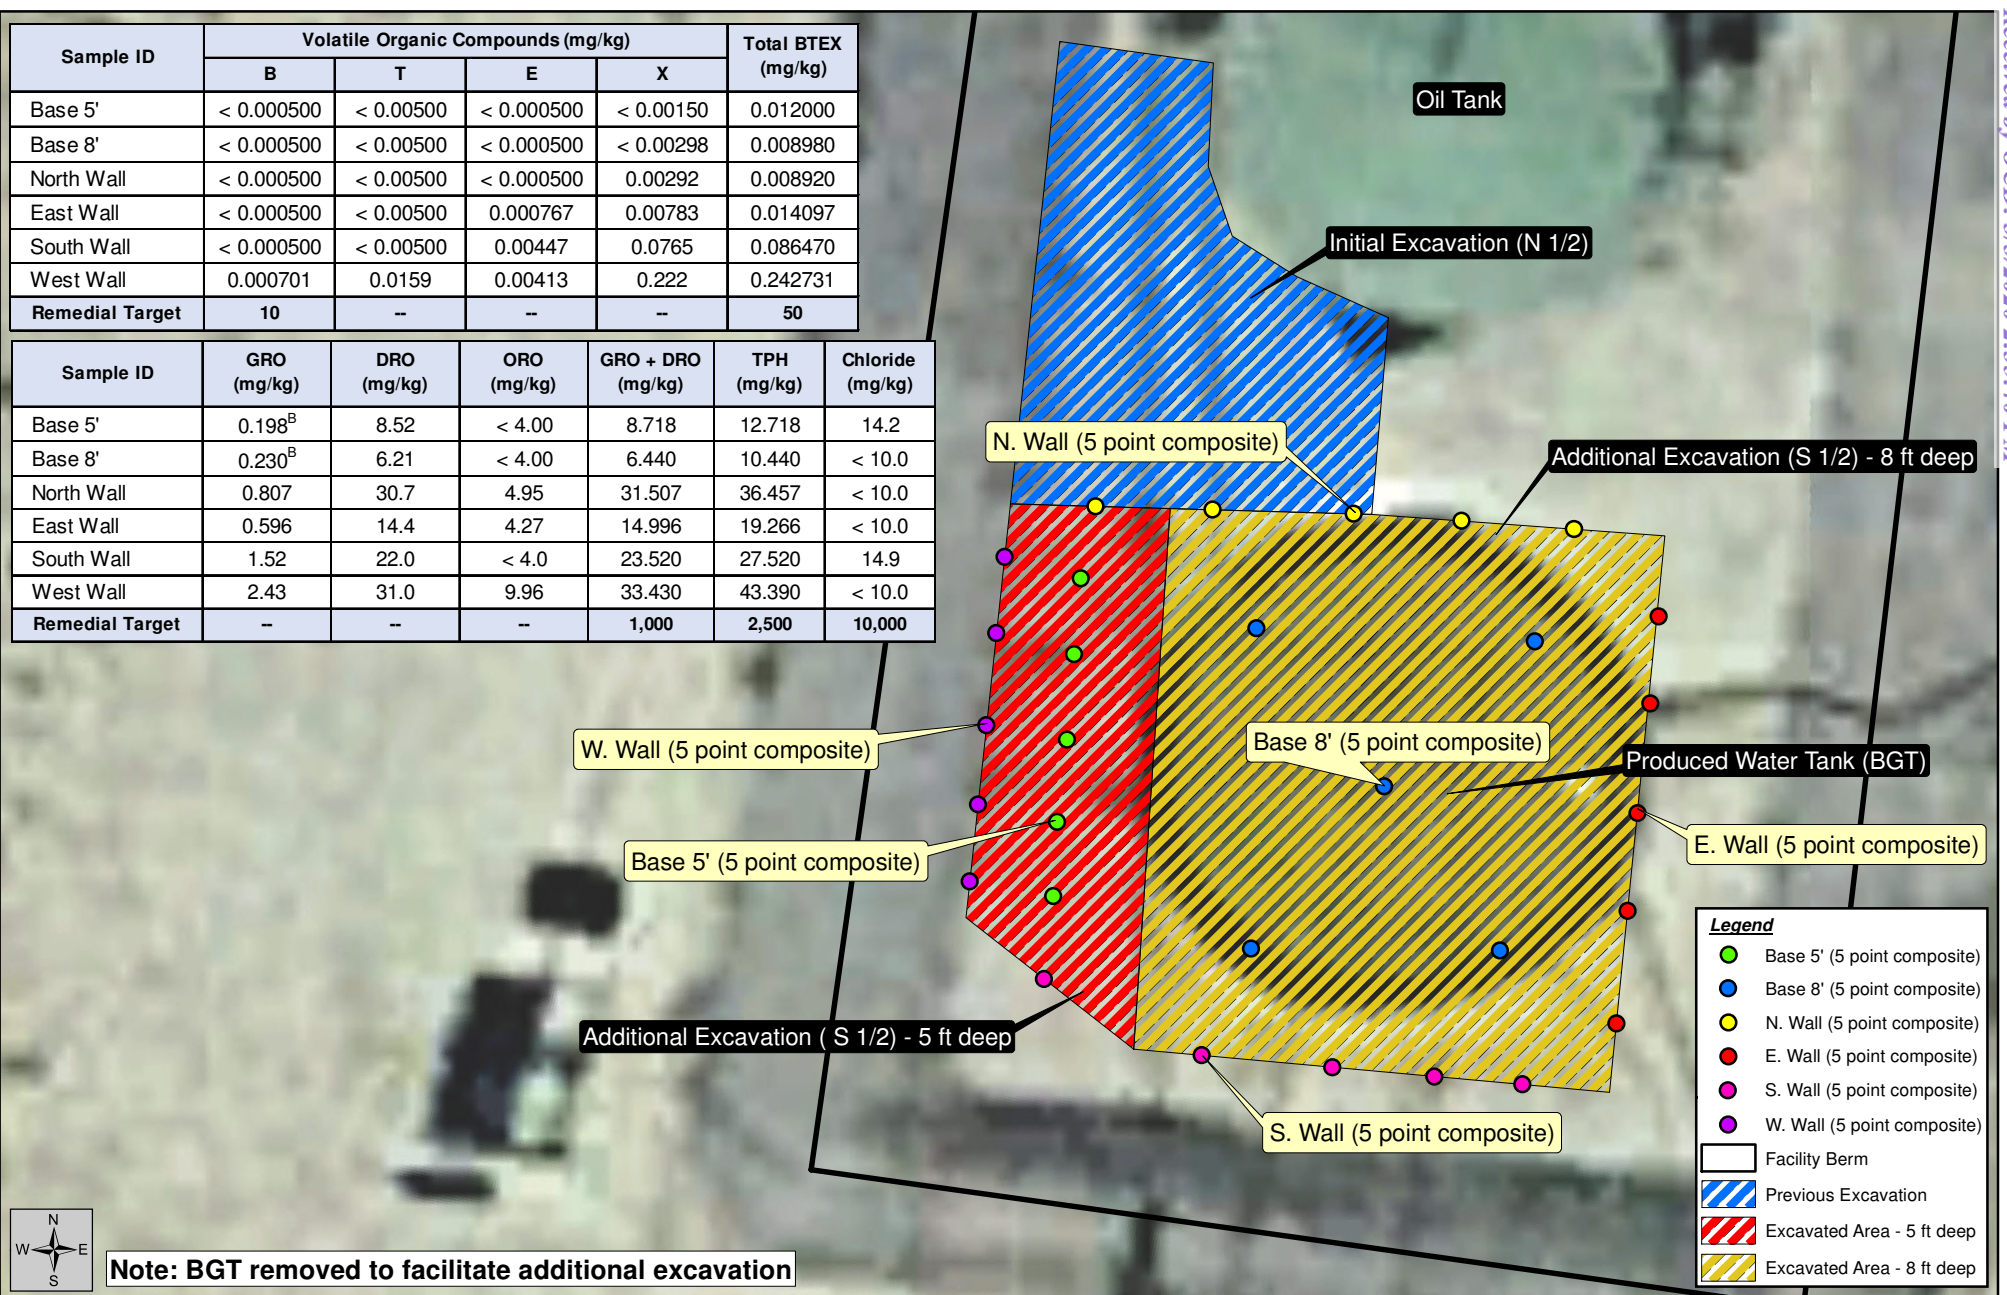
Figure 5
Confirmation Sample
Location Map

Sample ID	Volatile Organic Compounds (mg/kg)				Total BTEX (mg/kg)
	B	T	E	X	
Base 5'	< 0.000500	< 0.00500	< 0.000500	< 0.00150	0.012000
Base 8'	< 0.000500	< 0.00500	< 0.000500	< 0.00298	0.008980
North Wall	< 0.000500	< 0.00500	< 0.000500	0.00292	0.008920
East Wall	< 0.000500	< 0.00500	0.000767	0.00783	0.014097
South Wall	< 0.000500	< 0.00500	0.00447	0.0765	0.086470
West Wall	0.000701	0.0159	0.00413	0.222	0.242731
Remedial Target	10	--	--	--	50

Sample ID	GRO (mg/kg)	DRO (mg/kg)	ORO (mg/kg)	GRO + DRO (mg/kg)	TPH (mg/kg)	Chloride (mg/kg)
Base 5'	0.198 ^B	8.52	< 4.00	8.718	12.718	14.2
Base 8'	0.230 ^B	6.21	< 4.00	6.440	10.440	< 10.0
North Wall	0.807	30.7	4.95	31.507	36.457	< 10.0
East Wall	0.596	14.4	4.27	14.996	19.266	< 10.0
South Wall	1.52	22.0	< 4.0	23.520	27.520	14.9
West Wall	2.43	31.0	9.96	33.430	43.390	< 10.0
Remedial Target	--	--	--	1,000	2,500	10,000

On 06/11/19, Hilcorp personnel Kurt Hoekstra collected six composite confirmation samples from the excavation base and side walls. In accordance with 19.15.29 NMAC, NMOCD staff was provided two-day advance notice prior to confirmation sampling and each composite sample consisted of a 5-point sample representing an area less than 200 square ft. The excavation and confirmation sample locations are depicted on Figure 4. Remedial actions and locations of composite confirmation samples are documented in the attached Photographic Log.

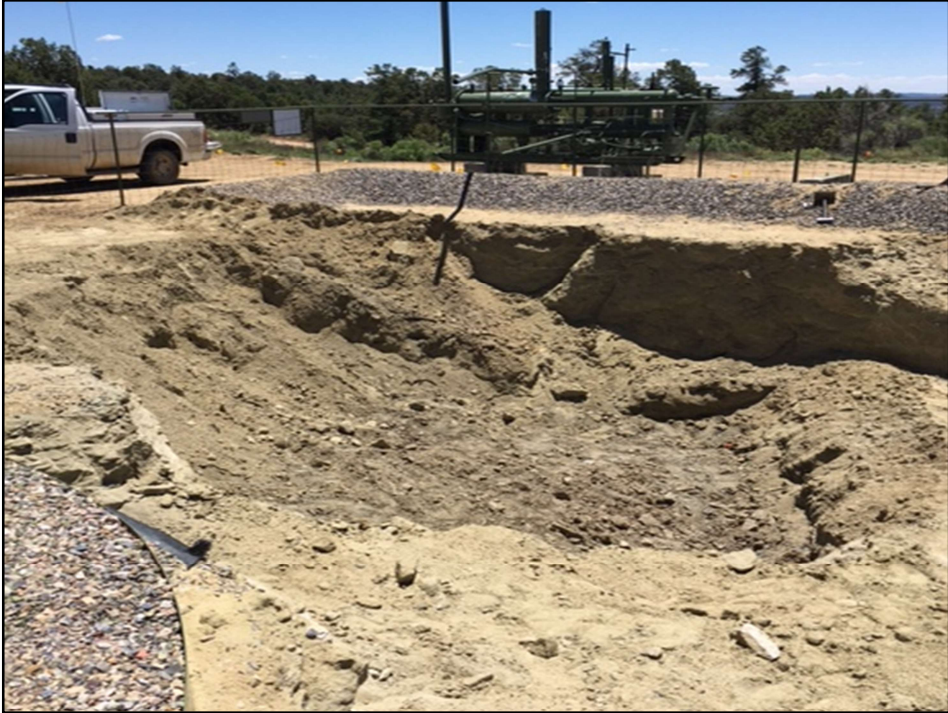
Project No.:	HEC-190004	Client:	Hilcorp Energy Company
Project Name:	San Juan 18-4 #18	Site Location:	Rio Arriba County, New Mexico
Task Description:	Confirmation Samples	Date:	June 11, 2018
Photo No.: 1

Direction: South			
Comments: View of 8 ft excavation at the former BGT location. Note: production equipment in background and oil storage tank ring in left foreground.			
Photo No.: 2

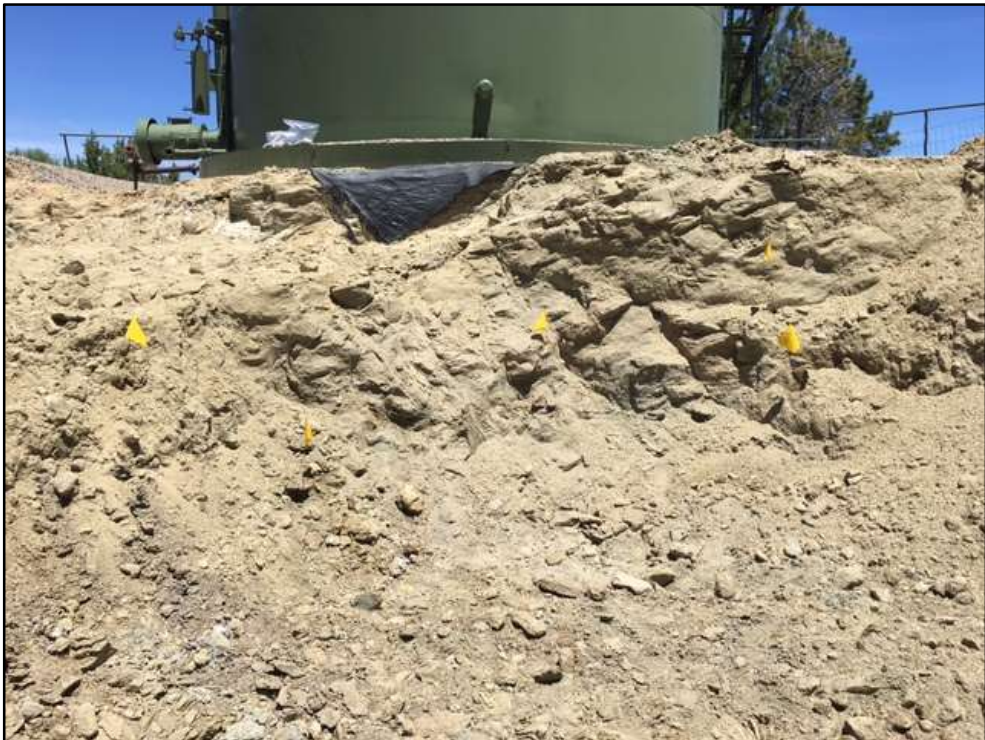
Direction: North			
Comments: View of north wall of S 1/2 Excavation and composite points.

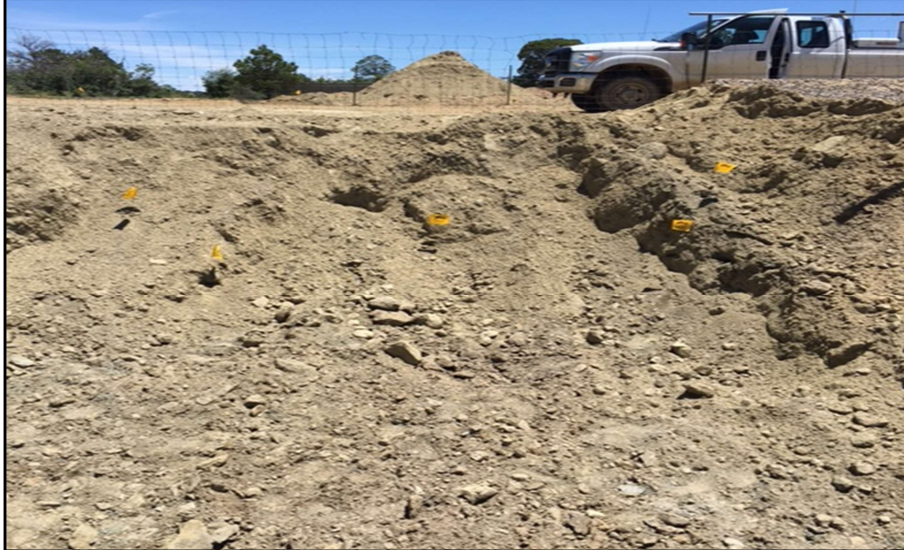
Project No.:	HEC-190016	Client:	Hilcorp Energy Company
Project Name:	San Juan 18-4 #18	Site Location:	Rio Arriba County, New Mexico
Task Description:	Confirmation Sampling	Date:	June 11, 2018
Photo No.: 3

Direction: East			
Comments: View of east wall of S 1/2 Excavation and composite points. .			
Photo No.: 4

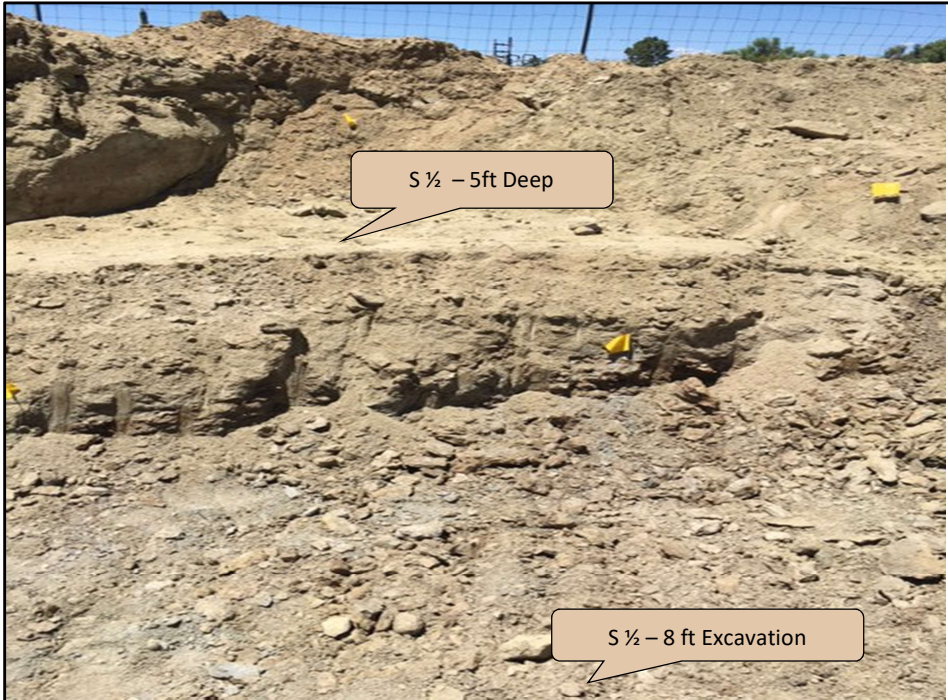
Direction: West			
Comments: View of 5 ft and 8 ft excavations and composite sample points

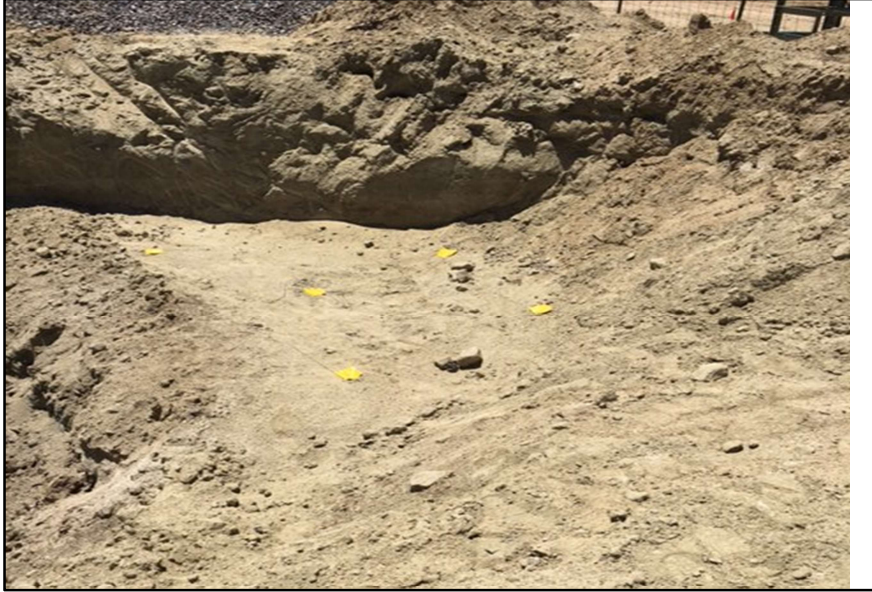
Project No.:	HEC-190004	Client:	Hilcorp Energy Company
Project Name:	San Juan 18-4 #18	Site Location:	Rio Arriba County, New Mexico
Task Description:	Site Characterization	Date:	June 11, 2018
Photo No.: 5

Direction: N/A			
Comments: View composite sample point from base of S ½ Excavation – 8 ft			
Photo No.: 6

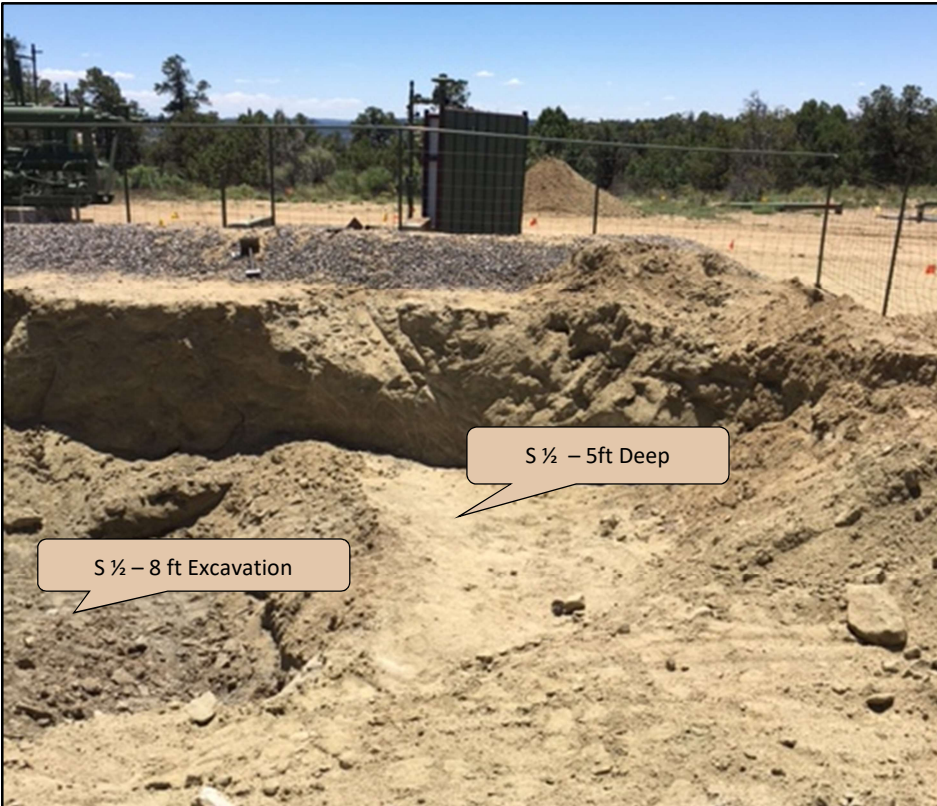
Direction: South			
Comments: View of 5 ft and 8 ft excavations
