Release Notification

Site Name: JACQUEZ #002	Site Type: Natural Gas Production Well Pad
Date Release Discovered: March 4, 2020	API#: 30-045-27522

Release of produced water caused from cracked gas eliminator on water transfer line.

SITING AND HYDRO-GEOLOGICAL REPORT FOR JACQUEZ 002

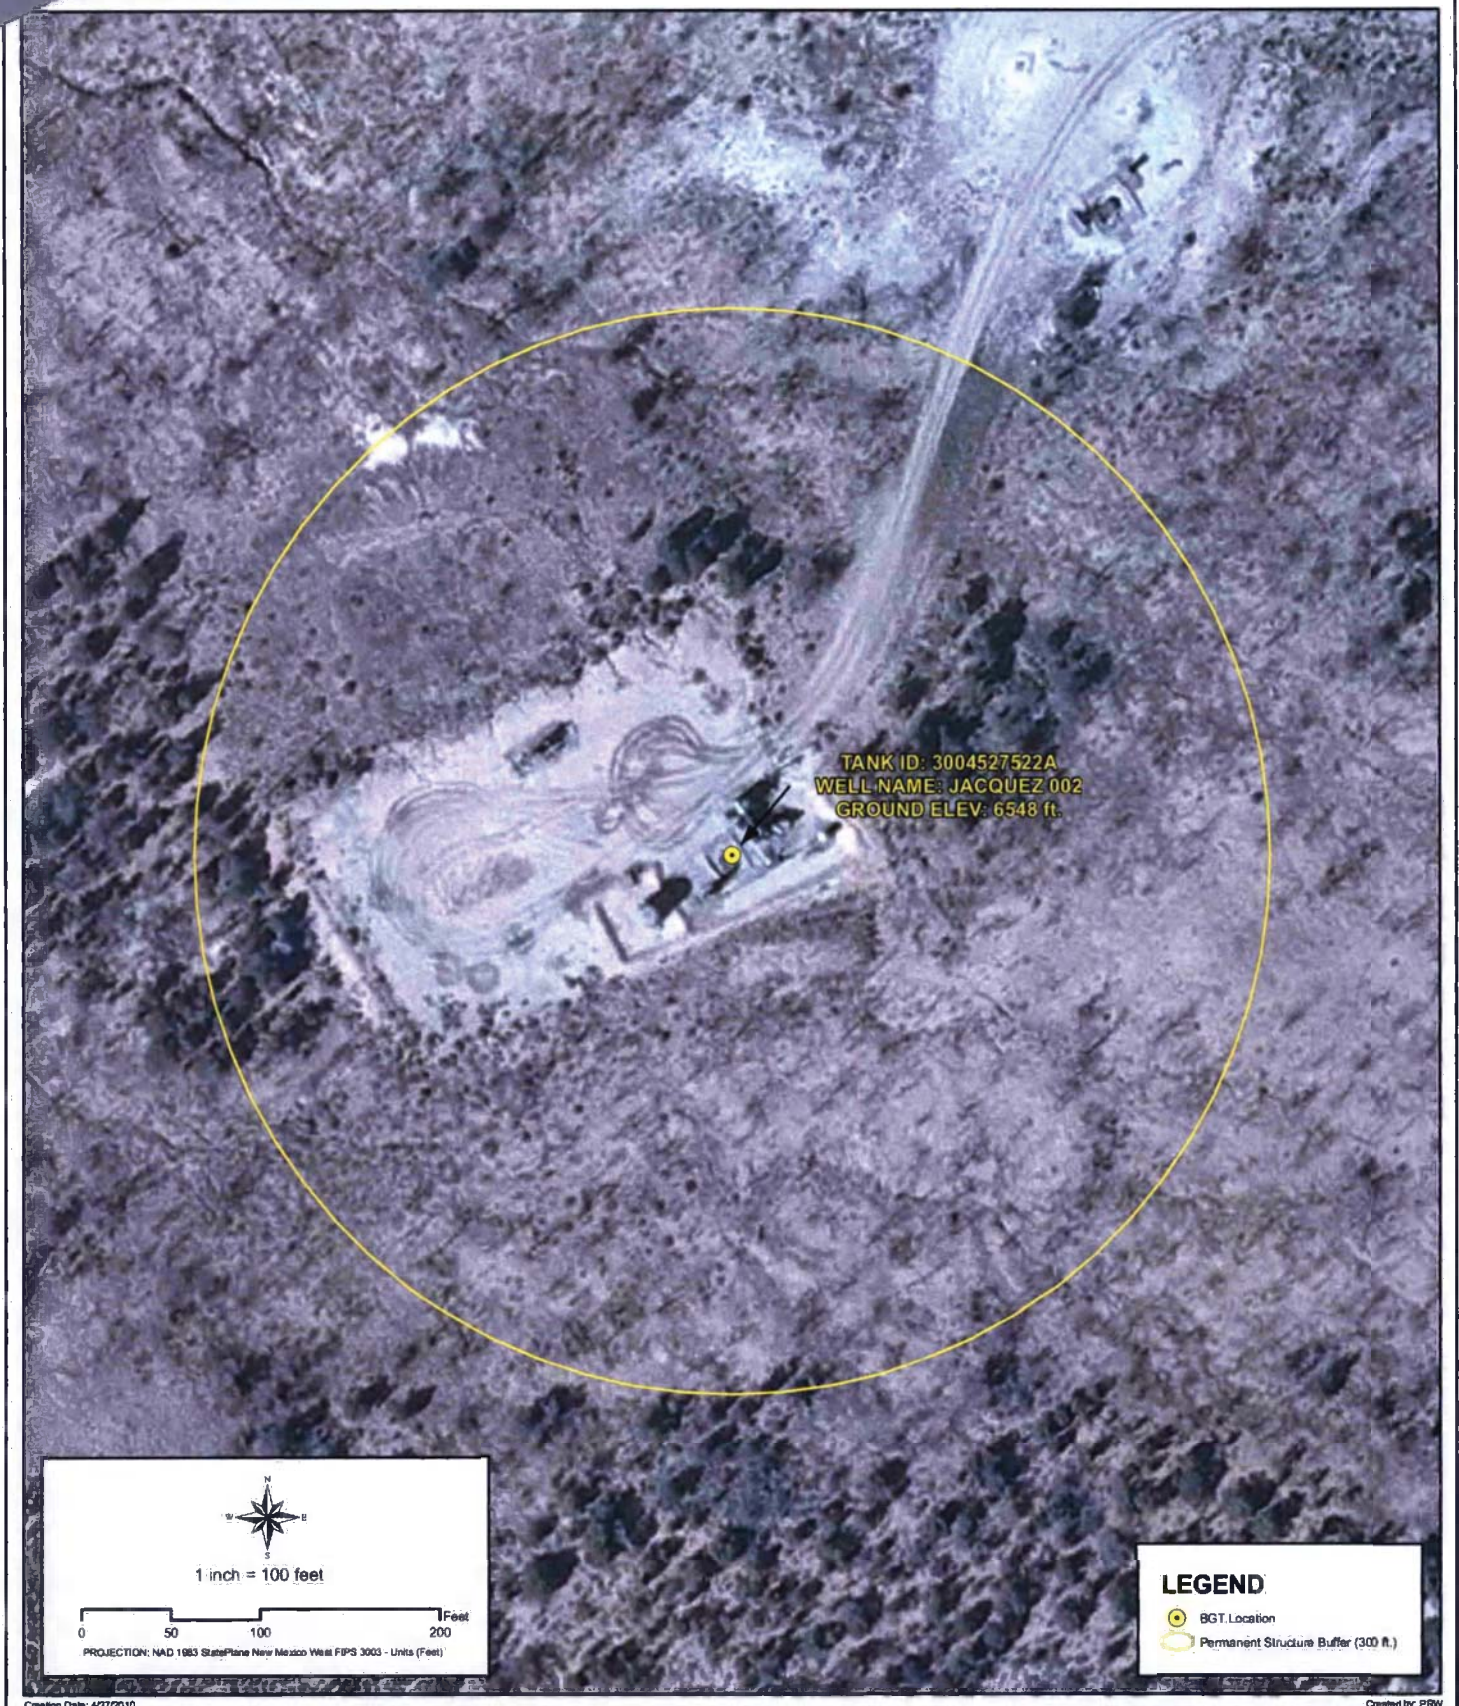
FIGURE
3

PROXIMITY TO PERMANENT STRUCTURE

Figure 3: Proximity to Permanent Structure**Layers:****Aerial Imagery:****Conoco (Summer 2009)**

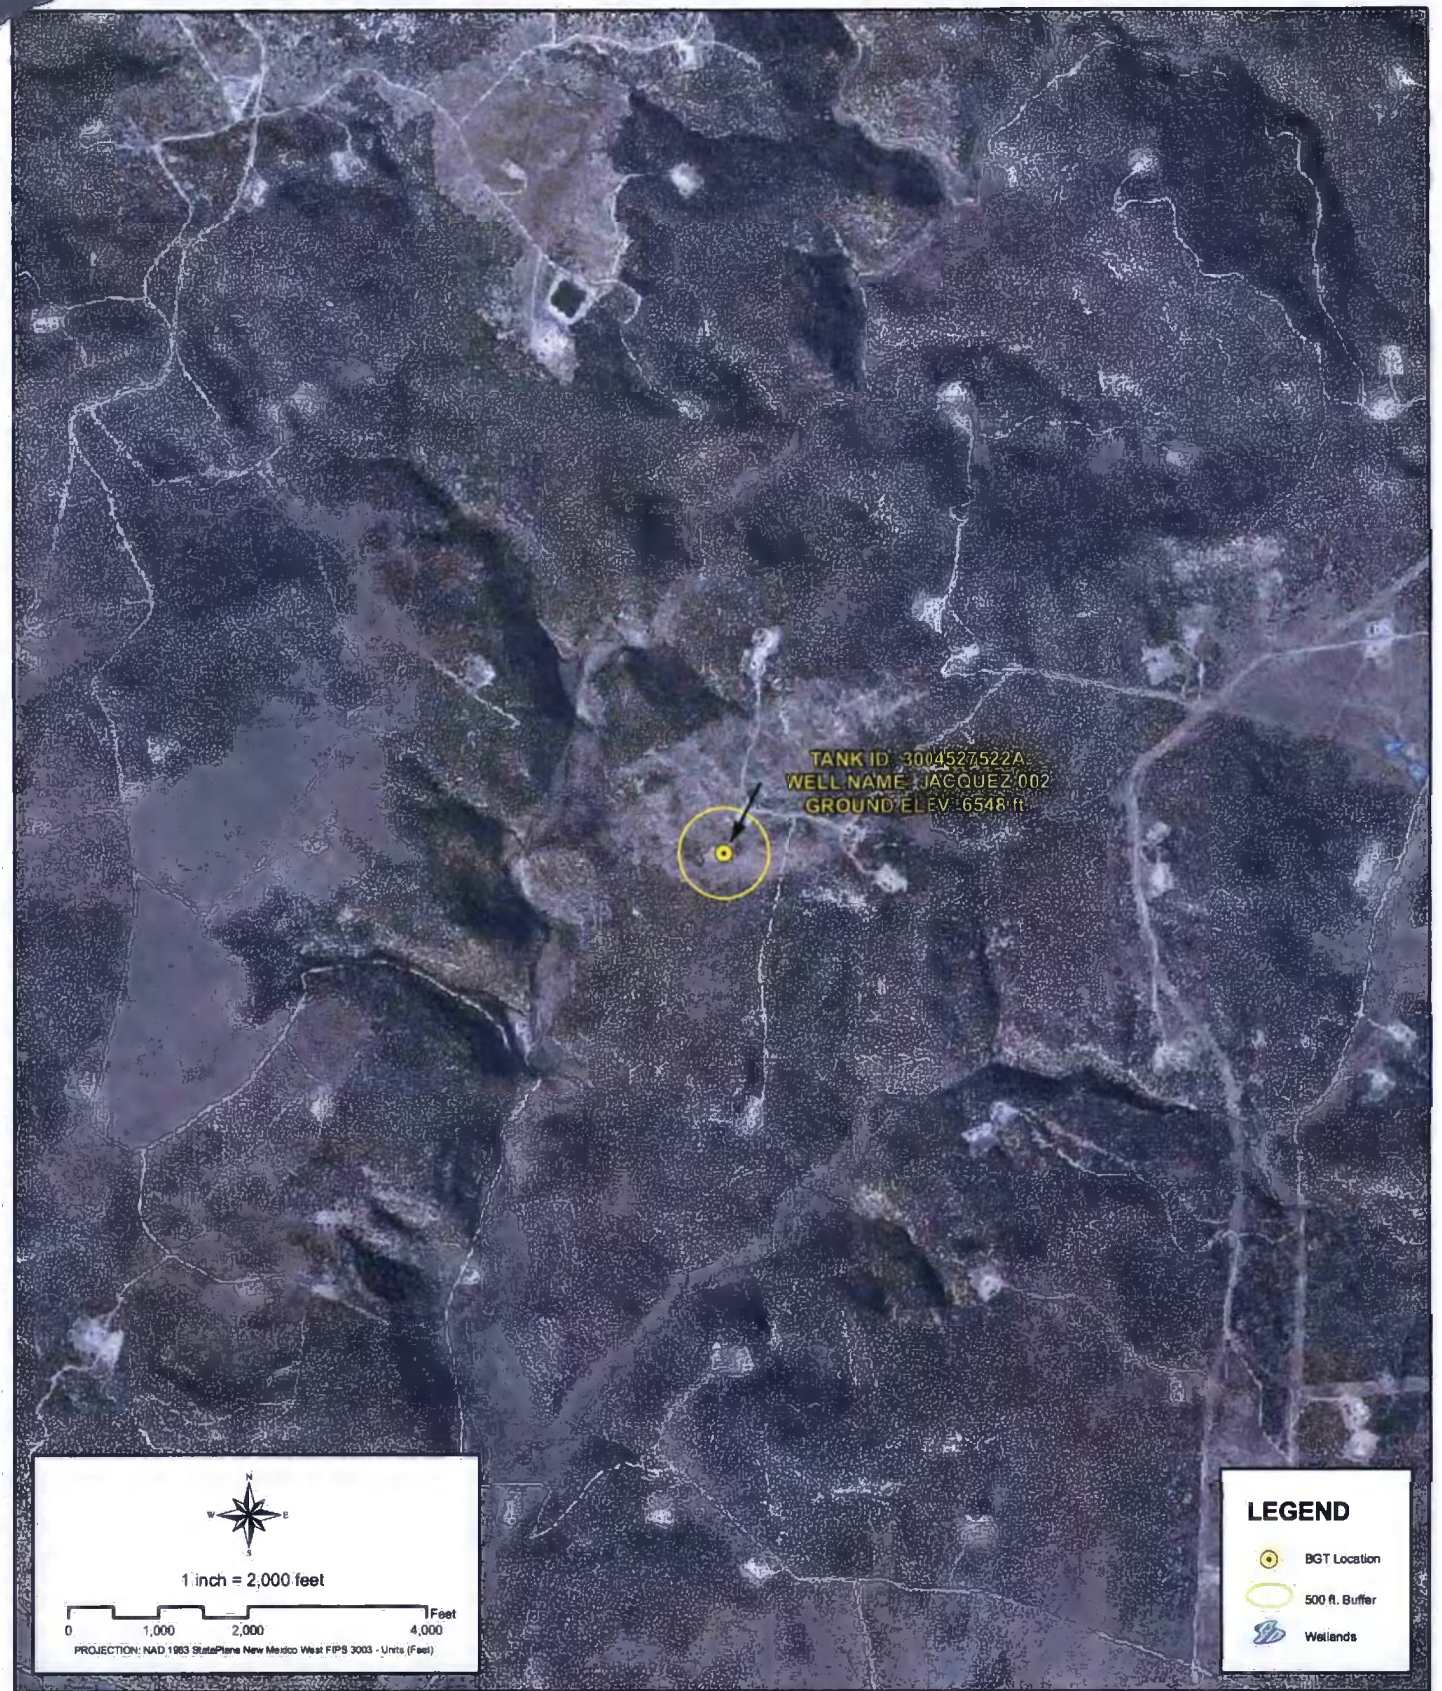
FIGURE
6

PROXIMITY TO WETLANDS

Figure 6: Proximity to Wetlands**Layers:****Wetlands:****NWI (2010)**

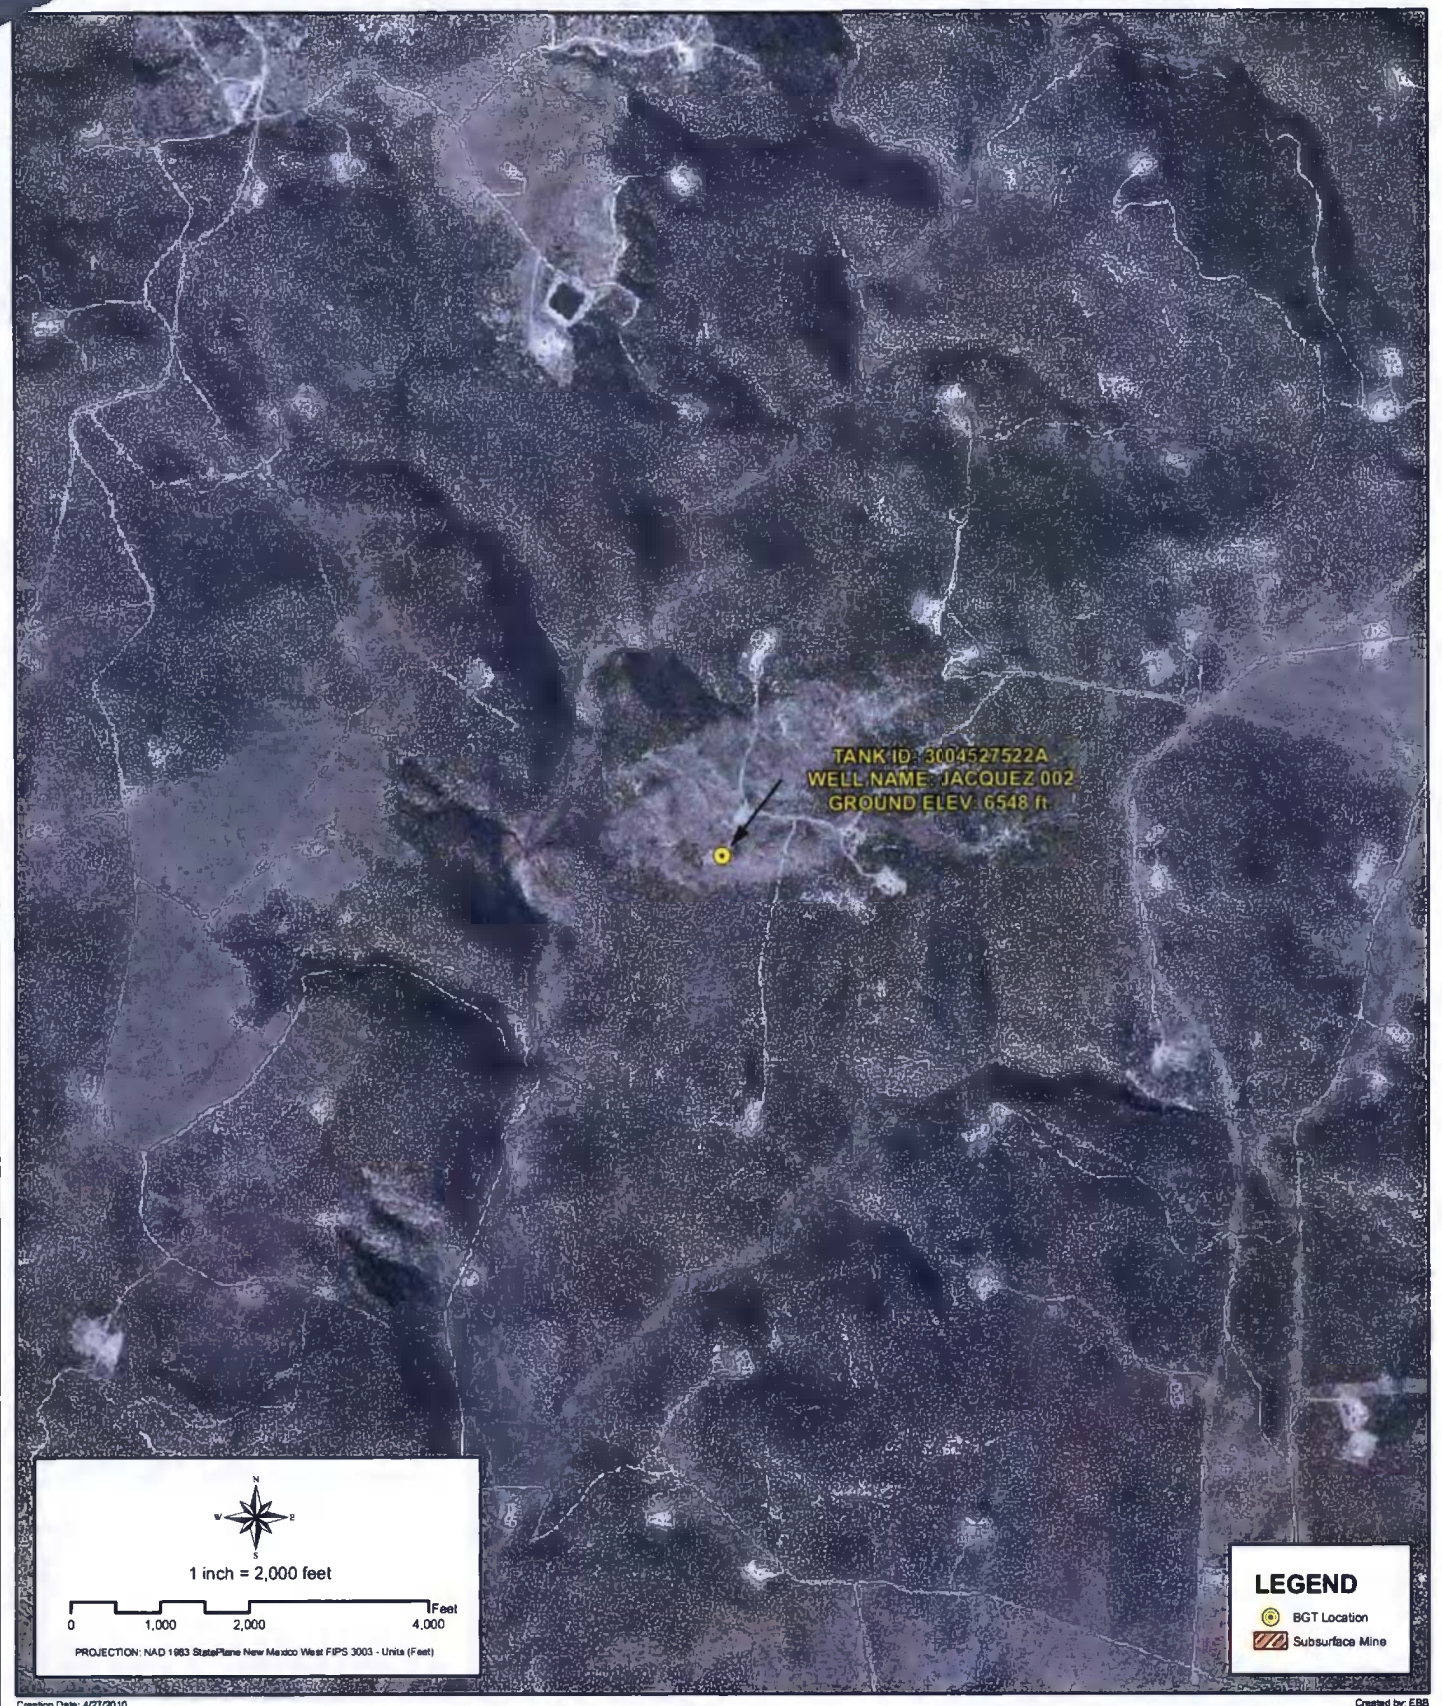
FIGURE
7

PROXIMITY TO SUBSURFACE MINES

Figure 7: Proximity to Subsurface Mine**Layers:****Subsurface Mine:****NM Mining and Minerals Division (2010)**
