Site Name: Jicarilla Apache F 10	Site Type: Well Site
Date Release Discovered: 2/28/2020	API# (if applicable) 30-039-82339

Project #17035-0181  
NMOCD Incident #nRM2006557992

**RE: BGT and Release Closure Report for the Jicarilla Apache F-10 Compressor Station Located in Section 16, Township 25N, Range 5W, Rio Arriba County, New Mexico**

**SITE PHOTOGRAPHY  
BGT AND RELEASE CLOSURE REPORT  
DJR OPERATING, LLC.  
JICARILLA APACHE F #010 COMPRESSOR STATION  
PROJECT #17035-0181  
FEBRUARY 2020**

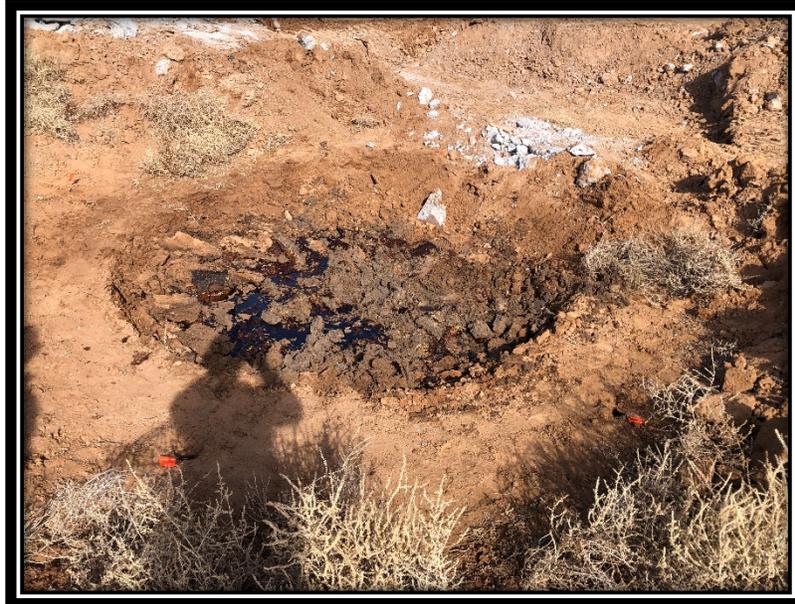
Picture 1: View of BGT Removal

On February 21, 2020, DJR contracted roustabout personnel removed the BGT and Envirotech personnel collected a five-point composite soil sample from the exposed surface of the former location of the BGT. The sample was identified as *BGT Composite* and prepared for field screening activities.

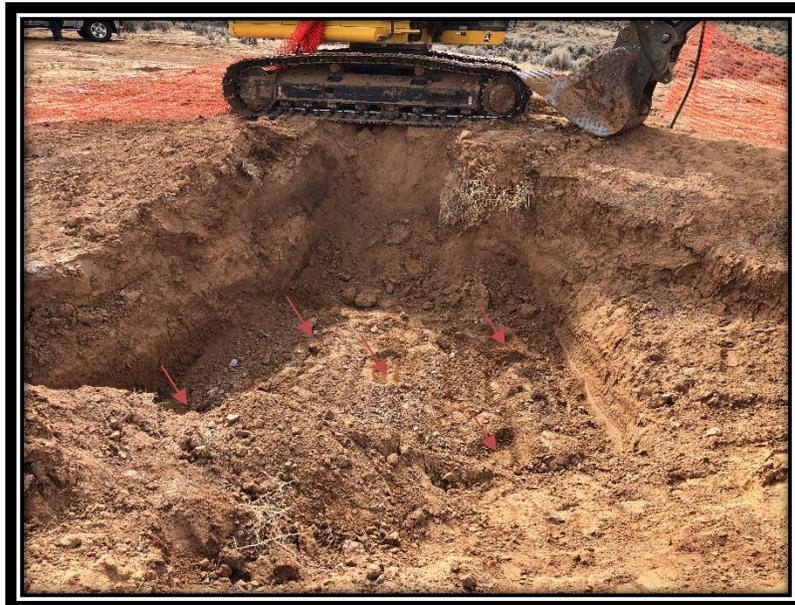
Picture 2: View of Excavation of Former BGT

DJR contracted roustabout personnel completed the remediation excavation on February 28, 2020; the final excavation measured 15 feet by 15 feet by 6 feet in depth. On the same day, Envirotech personnel returned to the site to perform confirmation sampling activities under the witness of DJR representative Richard Graves and JOGA representative Alfred Vigil, Jr. Per the direction of Mr. Vigil, one five-point composite sample was collected from the base of the excavation. The soil sample was placed into individual laboratory provided 4-ounce jars, capped head space free, and transported on ice to Envirotech Analytical Laboratory. The soil sample location is illustrated in **Figure 2, Site Map** and excavation activities are documented in the attached **Site Photography**.

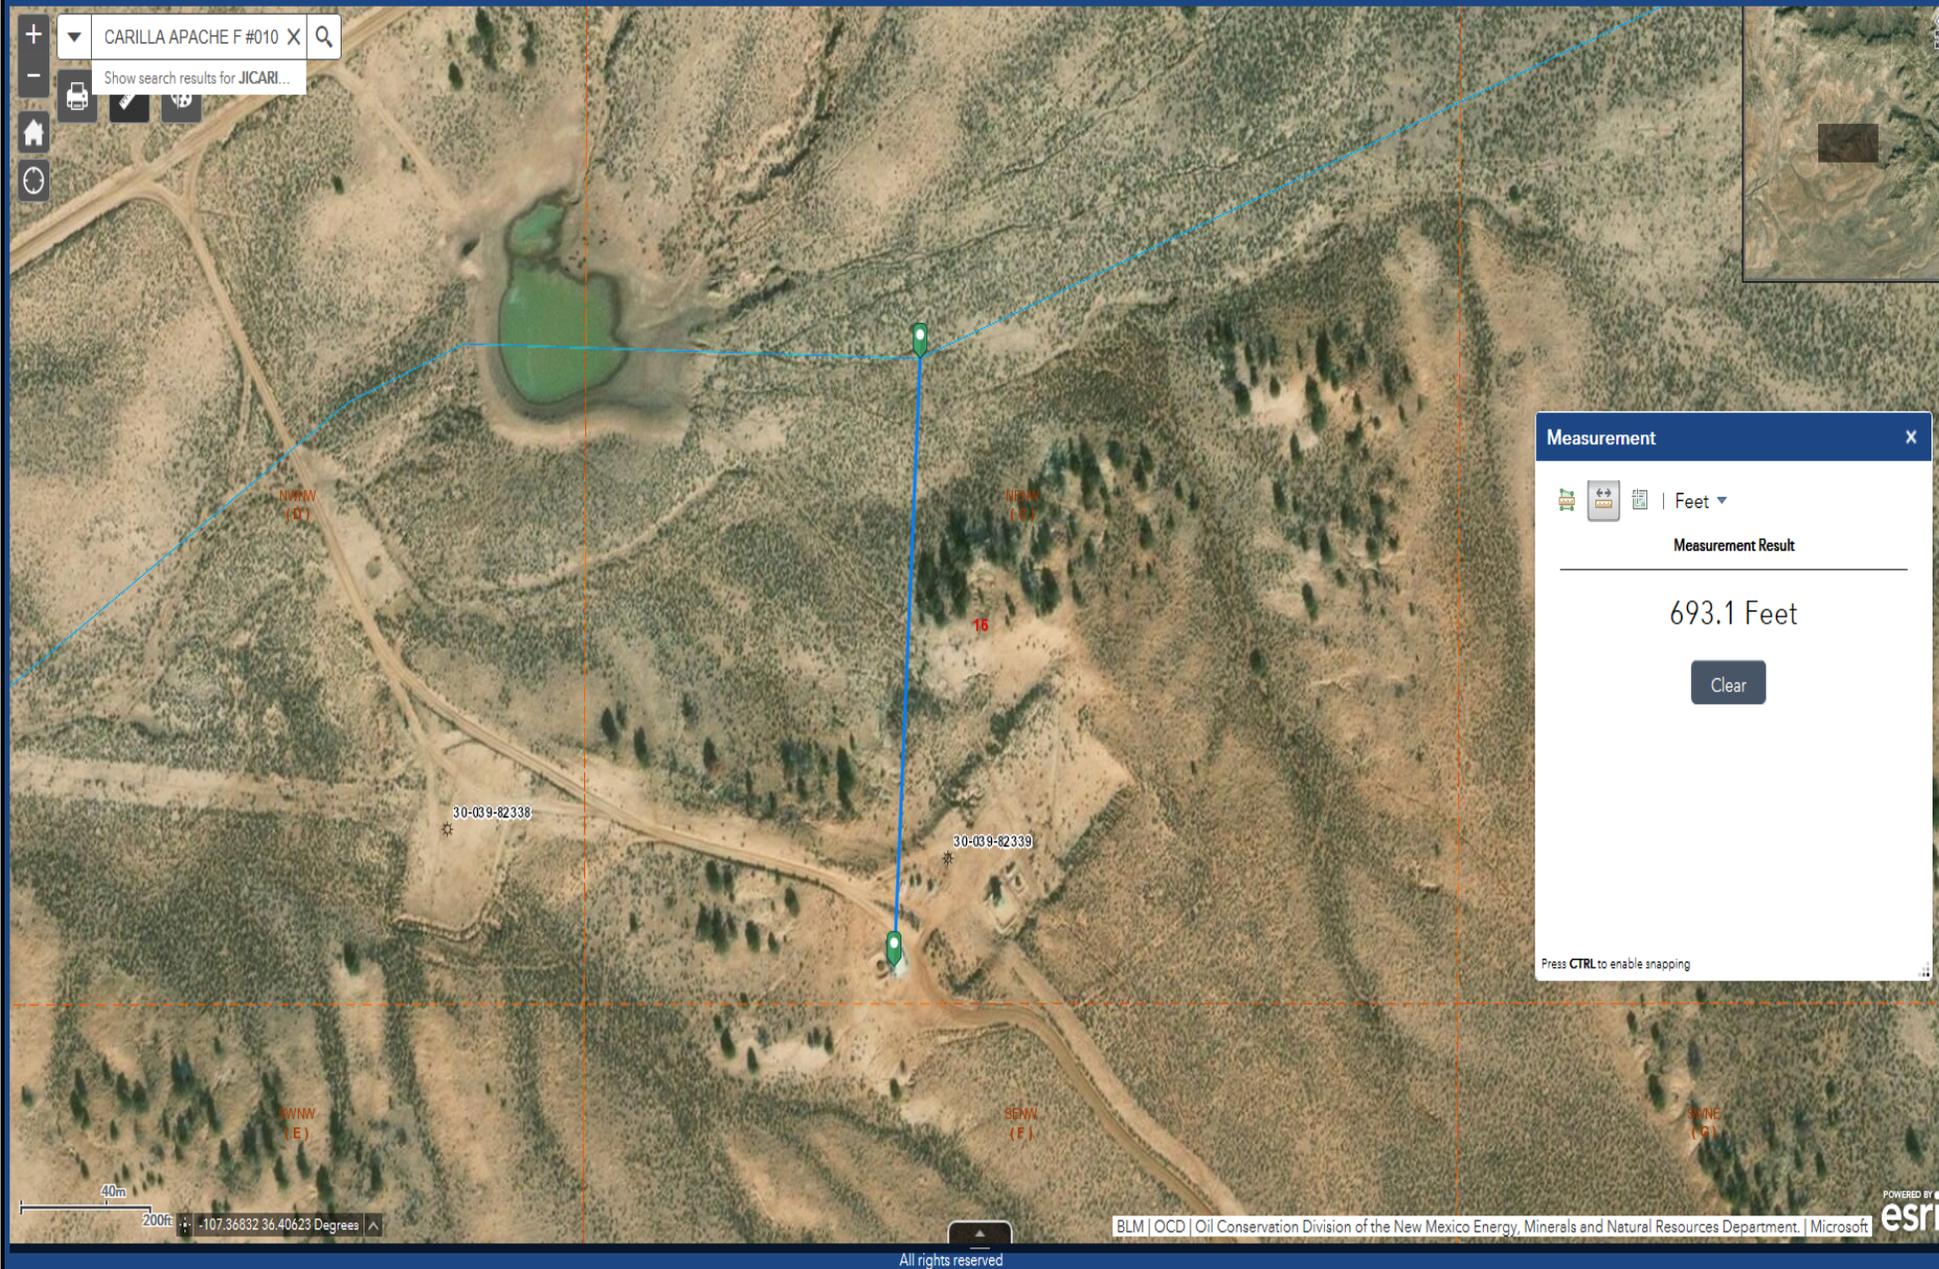
Jicarilla Apache F 10  
 30-039-82339  
 UL-C, Section 16, T25N, R05W  
 Distance to Surface Water 693'
