## Release Notification

**RE: BGT and Release Closure Report for the Jicarilla Apache F-6 Compressor Station  
Located in Section 22, Township 25N, Range 5W, Rio Arriba County, New Mexico**

DJR Operating, LLC  
 Jicarilla Apache F-6  
 BGT and Release Closure  
 Project #17035-0181  
 February-March, 2020  
 Page 2

**SITE PHOTOGRAPHY  
BGT AND RELEASE CLOSURE REPORT  
DJR OPERATING, LLC.  
JICARILLA APACHE F #6 COMPRESSOR STATION  
PROJECT #17035-0181  
INCIDENT #NRM2006541507**

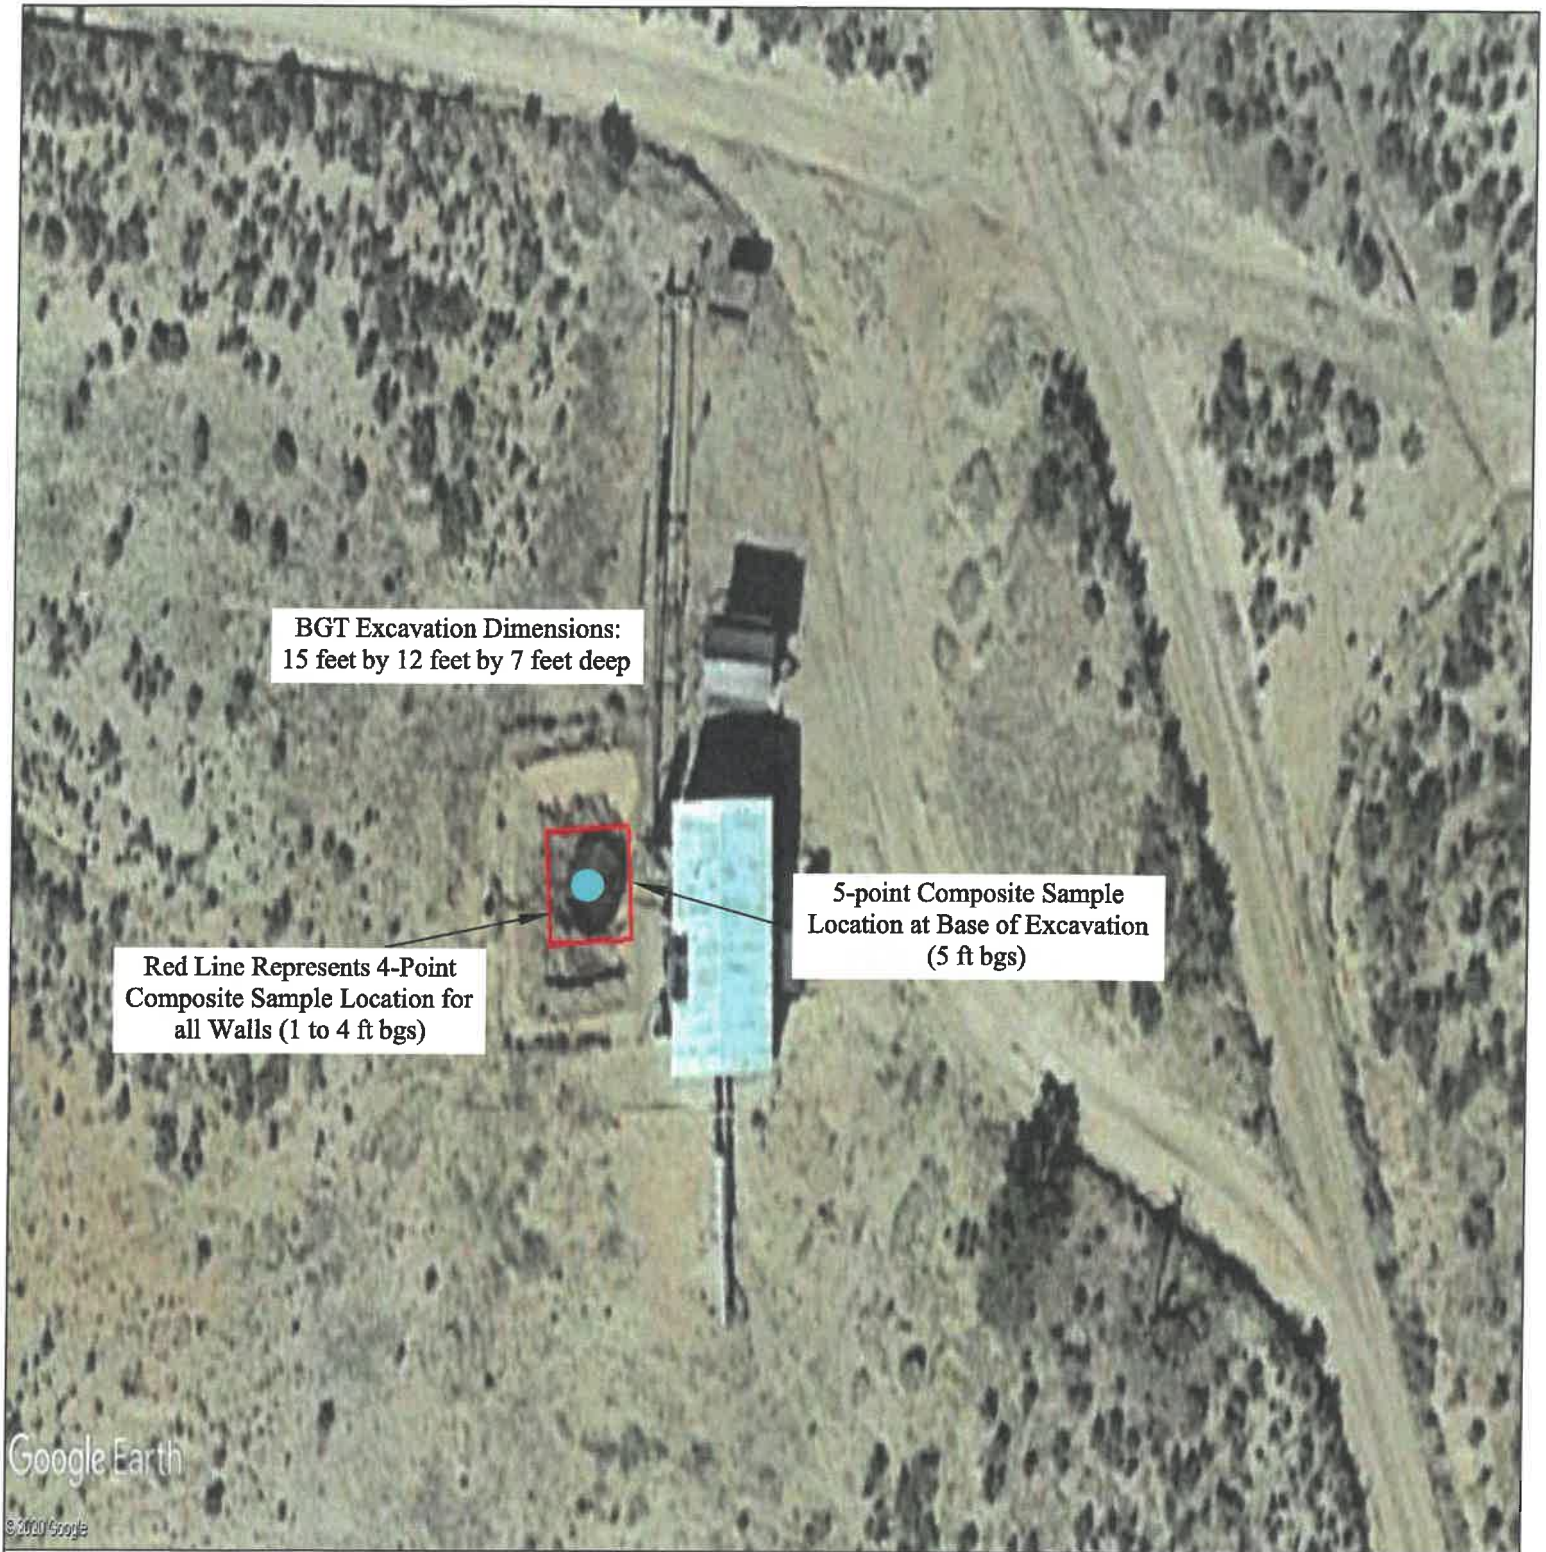
## Figure 2, Site Map

— F-6 BGT Wall Composite

● F-6 BGT Base

\* Sample locations represent 5-point composite samples

DJR contracted roustabout personnel completed the remediation excavation on March 17, 2020; the final excavation measured 15 feet by 12 feet by 7 feet in depth. On the same day, Envirotech personnel returned to the site to perform confirmation sampling activities under the witness of DJR representatives Richard Graves and Larissa Farrell.

Per verbal direction from a JOGA representative, one (1) five-point composite sample was collected from the base of the excavation and one five-point composite sample was collected from the excavation walls. Soil samples were placed into individual laboratory provided 4-ounce jars, capped head space free, and transported on ice to Envirotech Analytical Laboratory. Soil sample locations are illustrated in **Figure 2, Site Map** and excavation activities are documented in the attached **Appendix C, Site Photography**.

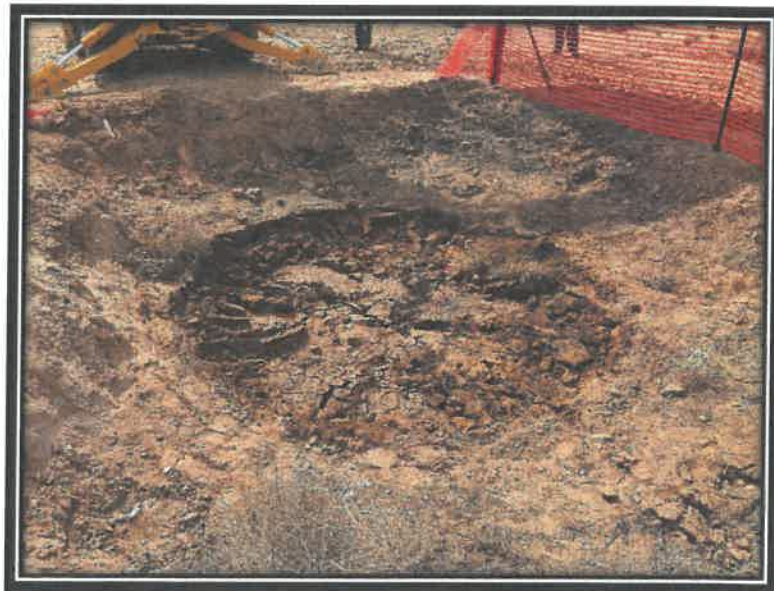
Picture 2: View of BGT Removal

On February 28, 2020, DJR contracted roustabout personnel removed the BGT and Envirotech personnel collected a five-point composite soil sample from the exposed surface of the former location of the BGT. The sample was identified as *Composite* and prepared for field screening activities.

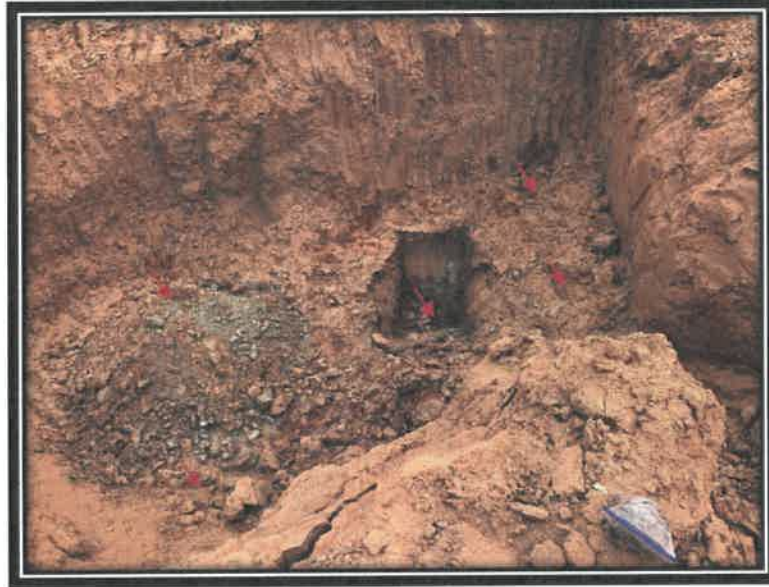
Picture 3: View of BGT Excavation

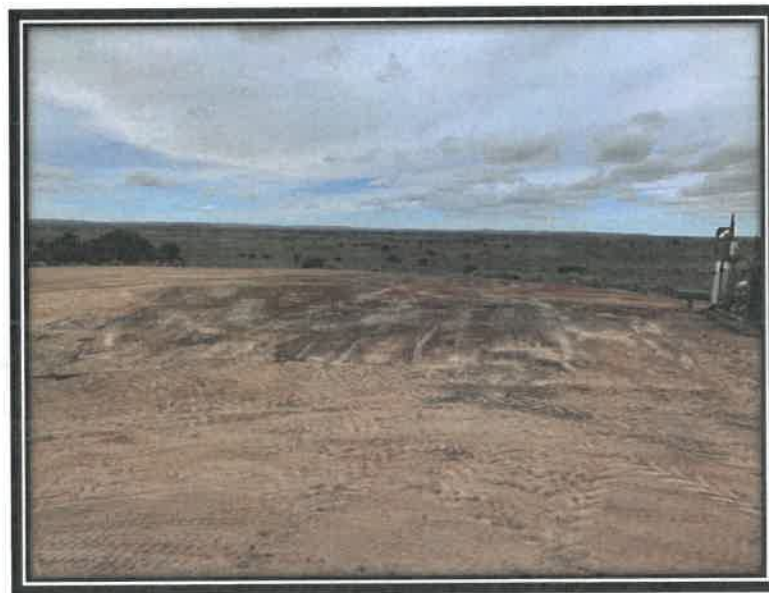
Picture 4: View of Backfilled and Recontoured Area

laboratory analytical results and verbal approval from JOGA, on March 26, 2020, DJR personnel backfilled and re-contoured the location of the former BGT. The site was reseeded with the approved Jicarilla Mesa seed mixture.
