SVE REPORT

Re: Status Report – 1<sup>st</sup> Quarter 2020  
San Juan 28-7 Unit 183M  
Rio Arriba County, New Mexico  
OCD Incident No. NCS1901627746

On behalf of Hilcorp Energy Company (Hilcorp), Timberwolf Environmental, LLC (Timberwolf) presents this report to document remedial activities conducted during the first quarter of 2020 (1Q20) at the San Juan 28-7 Unit 183M (Site). Activities conducted during the 1Q20 consisted of the following:

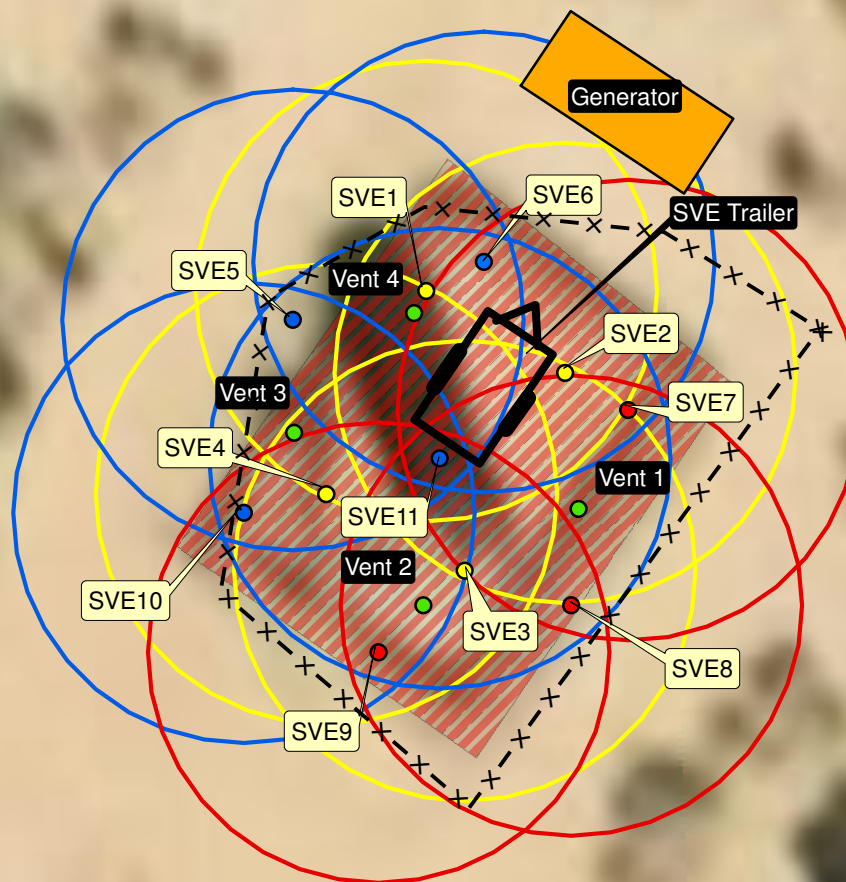
**Figure 4**  
**SVE System Overview**

The SVE trailer is equipped with a programmable automation panel to control valves for each manifold leg. The SVE system creates a treatment field of approximately 0.15 acres and treats soil to a depth of approximately 30 ft bgs for a total volume of approximately 7,021 cubic yards of soil. The SVE wells, measured radius of influence of 25 ft, and leg configurations are shown in Figure 4.

Treatment Area= 6,320 ft<sup>2</sup>  
Assuming a 25 ft radius of influence

- Leg 1 SVE Wells (7, 8, & 9)
- Leg 2 SVE Wells (1, 2, 3, & 4)
- Leg 3 SVE Wells (5, 6, 10, & 11)
- Vent
- Leg 1
- Leg 2
- Leg 3
- ▨ Impacted Area
- SVE Trailer
- Generator
- x- Fence

The SVE system was designed with three independent legs (i.e., Leg 1, Leg 2, and Leg 3). Legs 1 and 3 provide vacuum extraction to the deep SVE wells; Leg 2 is piped to the shallow wells. System startup was initiated on 12/18/19.

<b>Leg</b>	<b>SVE Wells and Location</b>	<b>Scheduled Runtime</b>
Leg 1	Deep Wells SVE7, SVE8, and SVE9 Eastern side of treatment zone	4 hours
Leg 2	Shallow Wells SVE1, SVE2, SVE3, and SVE4	4 hours
Leg 3	Deep Wells SVE5, SVE6, SVE10, and SVE11 Central and Western side of treatment zone	4 hours
Leg 1	Deep Wells SVE7, SVE8, and SVE9 Eastern side of treatment zone	4 hours
Leg 2	Shallow Wells SVE1, SVE2, SVE3, and SVE4	4 hours
Leg 3	Deep Wells SVE5, SVE6, SVE10, and SVE11 Central and Western side of treatment zone	4 hours

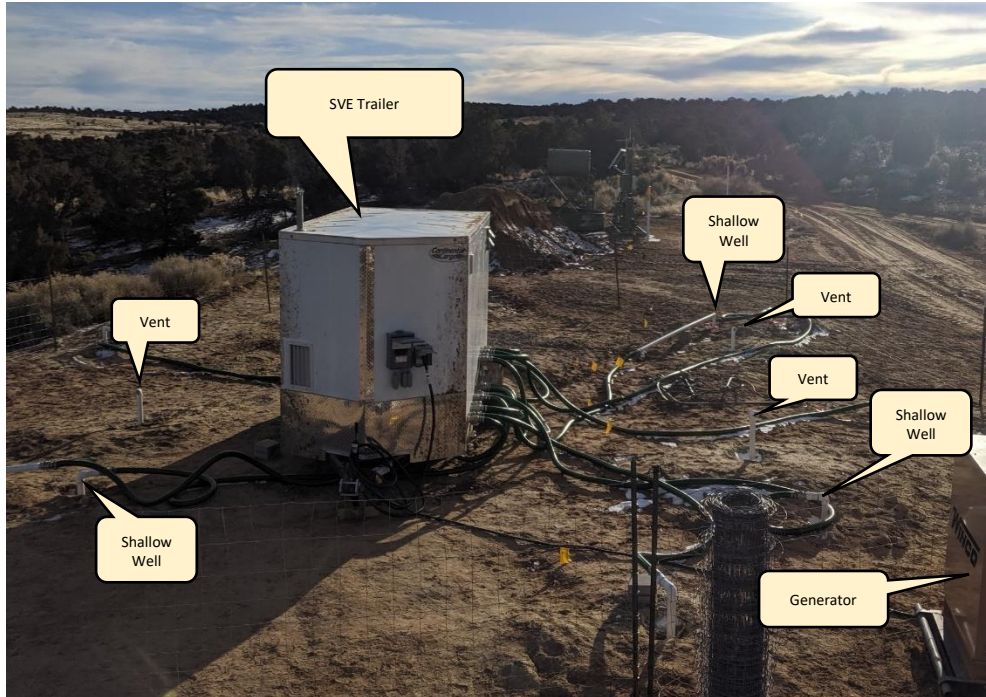
<b>Project No.:</b>	HEC-190007	<b>Client:</b>	Hilcorp Energy Company
<b>Project Name:</b>	San Juan 28-7 No. 183M	<b>Site Location:</b>	Rio Arriba County, New Mexico
<b>Task Description:</b>	1 <sup>st</sup> Quarter 2020 Report	<b>Date:</b>	January-March, 2020
<b>Photo No.:</b> 1

To remediate impacted soil at the Site, Hilcorp installed and operates a soil vapor extraction (SVE) system. The SVE system is comprised 11 SVE wells, four vent wells, and a SVE trailer (Photo No. 1).

<p>This photograph shows an outdoor site with a white SVE Trailer in the center. Several yellow callout boxes identify key features: 'SVE Trailer' points to the main unit; 'Vent' points to a vent pipe on the left; 'Shallow Well' points to a wellhead in the lower left; another 'Shallow Well' points to a wellhead on the right; two more 'Vent' labels point to vent pipes on the right; and 'Generator' points to a generator unit on the far right. The background shows a dry, hilly landscape under a cloudy sky.</p>		
<b>Direction:</b> South			
<b>Comments:</b> SVE Trailer and Wells.  Note: Locations of vents and shallow wells.

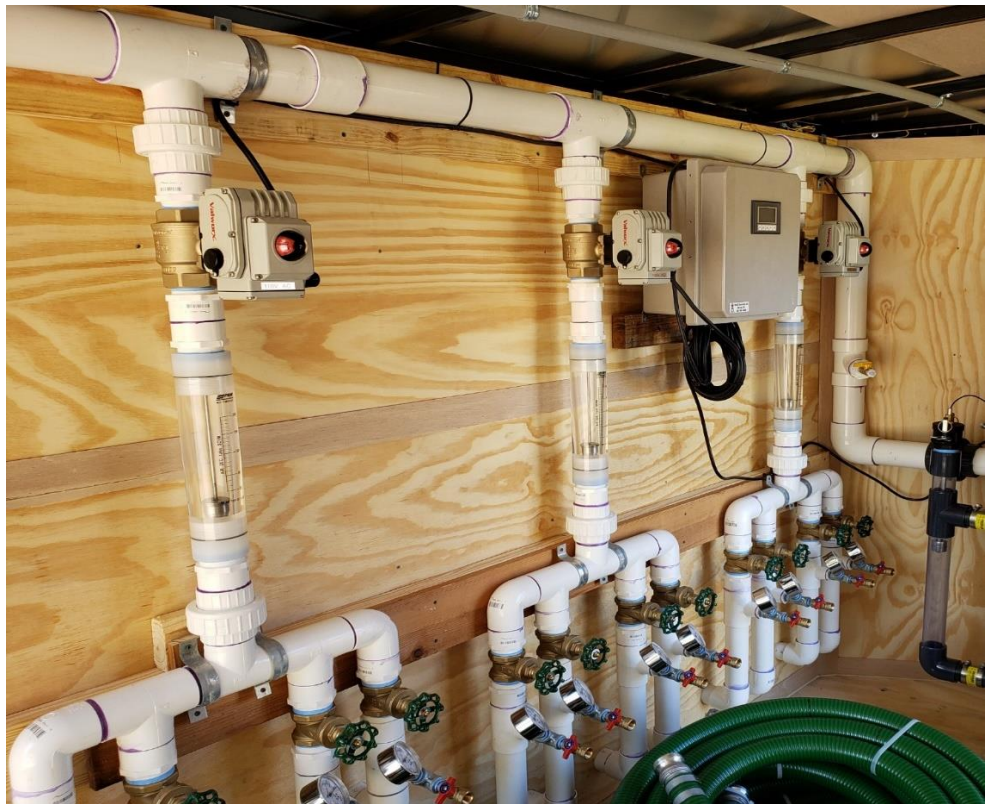
<b>Photo No.:</b> 2

<p>This photograph shows the interior of a facility with a wooden wall. It features a complex network of white PVC pipes and valves. Three vertical pipes with flow meters are prominent. Electrical control boxes are mounted on the wall. A green hose is visible in the foreground.</p>		
<b>Direction:</b> N/A			
<b>Comments:</b> View of manifold and 3 independent legs

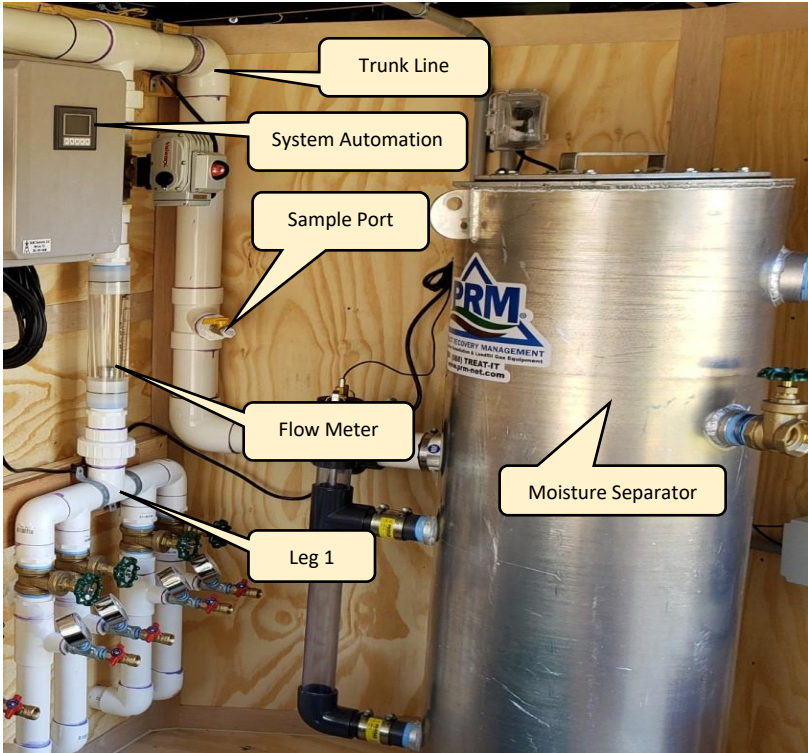
<b>Project No.:</b>	HEC-190007	<b>Client:</b>	Hilcorp Energy Company
<b>Project Name:</b>	San Juan 28-7 No. 183M	<b>Site Location:</b>	Rio Arriba County, New Mexico
<b>Task Description:</b>	1 <sup>st</sup> Quarter 2020 Report	<b>Date:</b>	January-March, 2020
<b>Photo No.:</b> 3

<b>Direction:</b> N/A			
<b>Comments:</b> View inside SVE trailer: system automation, flow meter, leg 1, 3-inch trunk line, sample port, and moisture separator.			
<b>Photo No.:</b> 4

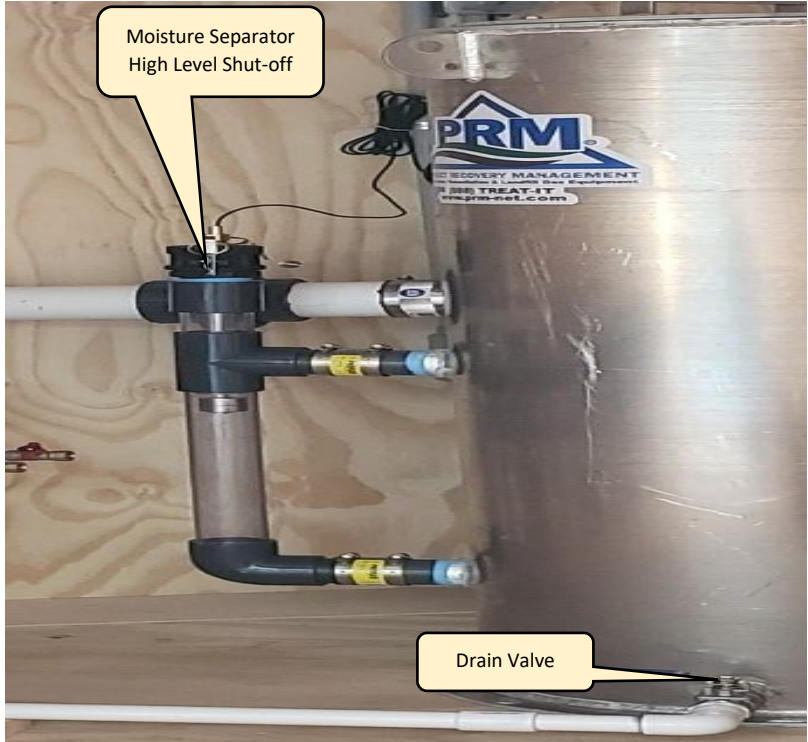
<b>Direction:</b> N/A			
<b>Comments:</b> Moisture Separator high level shut-off and drain.

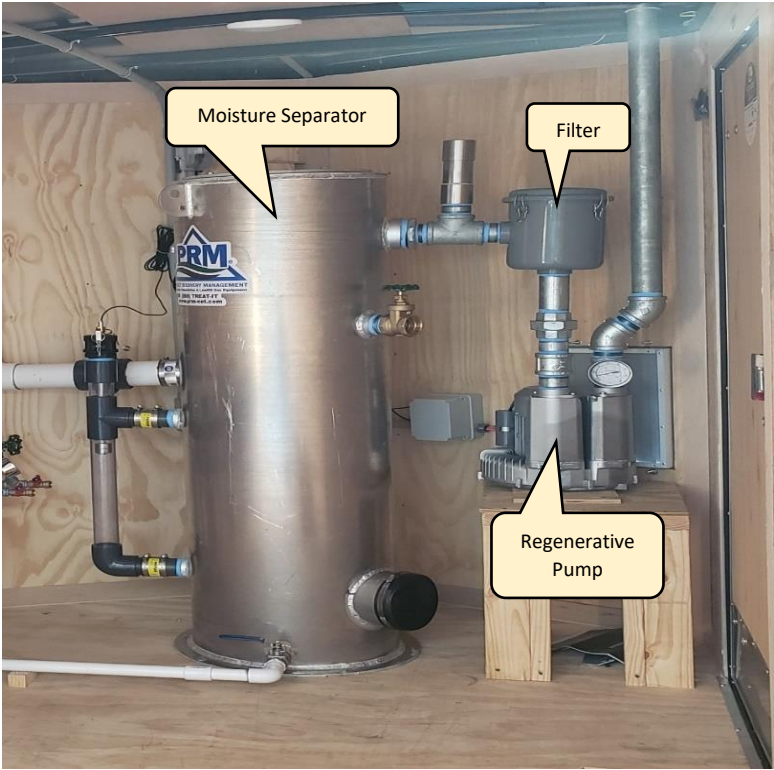
<b>Project No.:</b>	HEC-190007	<b>Client:</b>	Hilcorp Energy Company
<b>Project Name:</b>	San Juan 28-7 No. 183M	<b>Site Location:</b>	Rio Arriba County, New Mexico
<b>Task Description:</b>	1 <sup>st</sup> Quarter 2020 Report	<b>Date:</b>	January-March, 2020
<b>Photo No.:</b> 5

<p>Moisture Separator</p> <p>Filter</p> <p>Regenerative Pump</p>		
<b>Direction:</b> N/A			
<b>Comments:</b> Moisture Separator, filter, and regenerative pump.			
<b>Photo No.:</b> 6

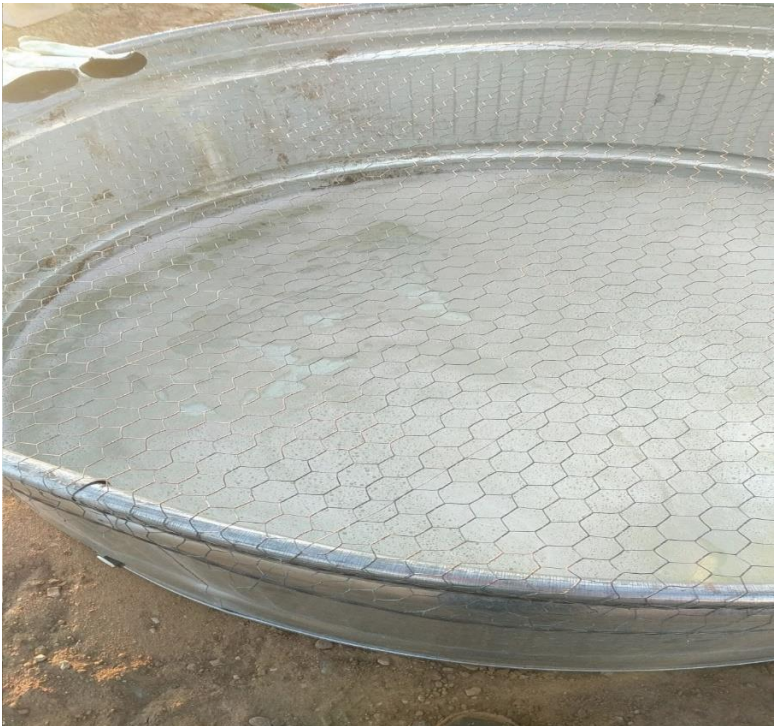
Water and condensate collected in the moisture separator was drained through a 1-inch PVC pipe and transferred to an open-top tank fitted with bird netting as shown in Photo No. 6. Approximately 41 gallons of water/condensate was recovered during the first quarter of 2020.

<b>Direction:</b> N/A			
<b>Comments:</b> Open top water/condensate storage tank fitted with bird netting.
