Release Notification and Corrective Action

Name of Company Burlington Resources Oil & Gas Company	Contact Crystal Tafoya
Address 3401 East 30th St, Farmington, NM	Telephone No. (505) 326-9837
Facility Name: San Juan 30-6 Unit 475S	Facility Type: Gas Well

**RE: Below Grade Tank Closure Report
San Juan 30-6 #475S
Rio Arriba County, New Mexico**

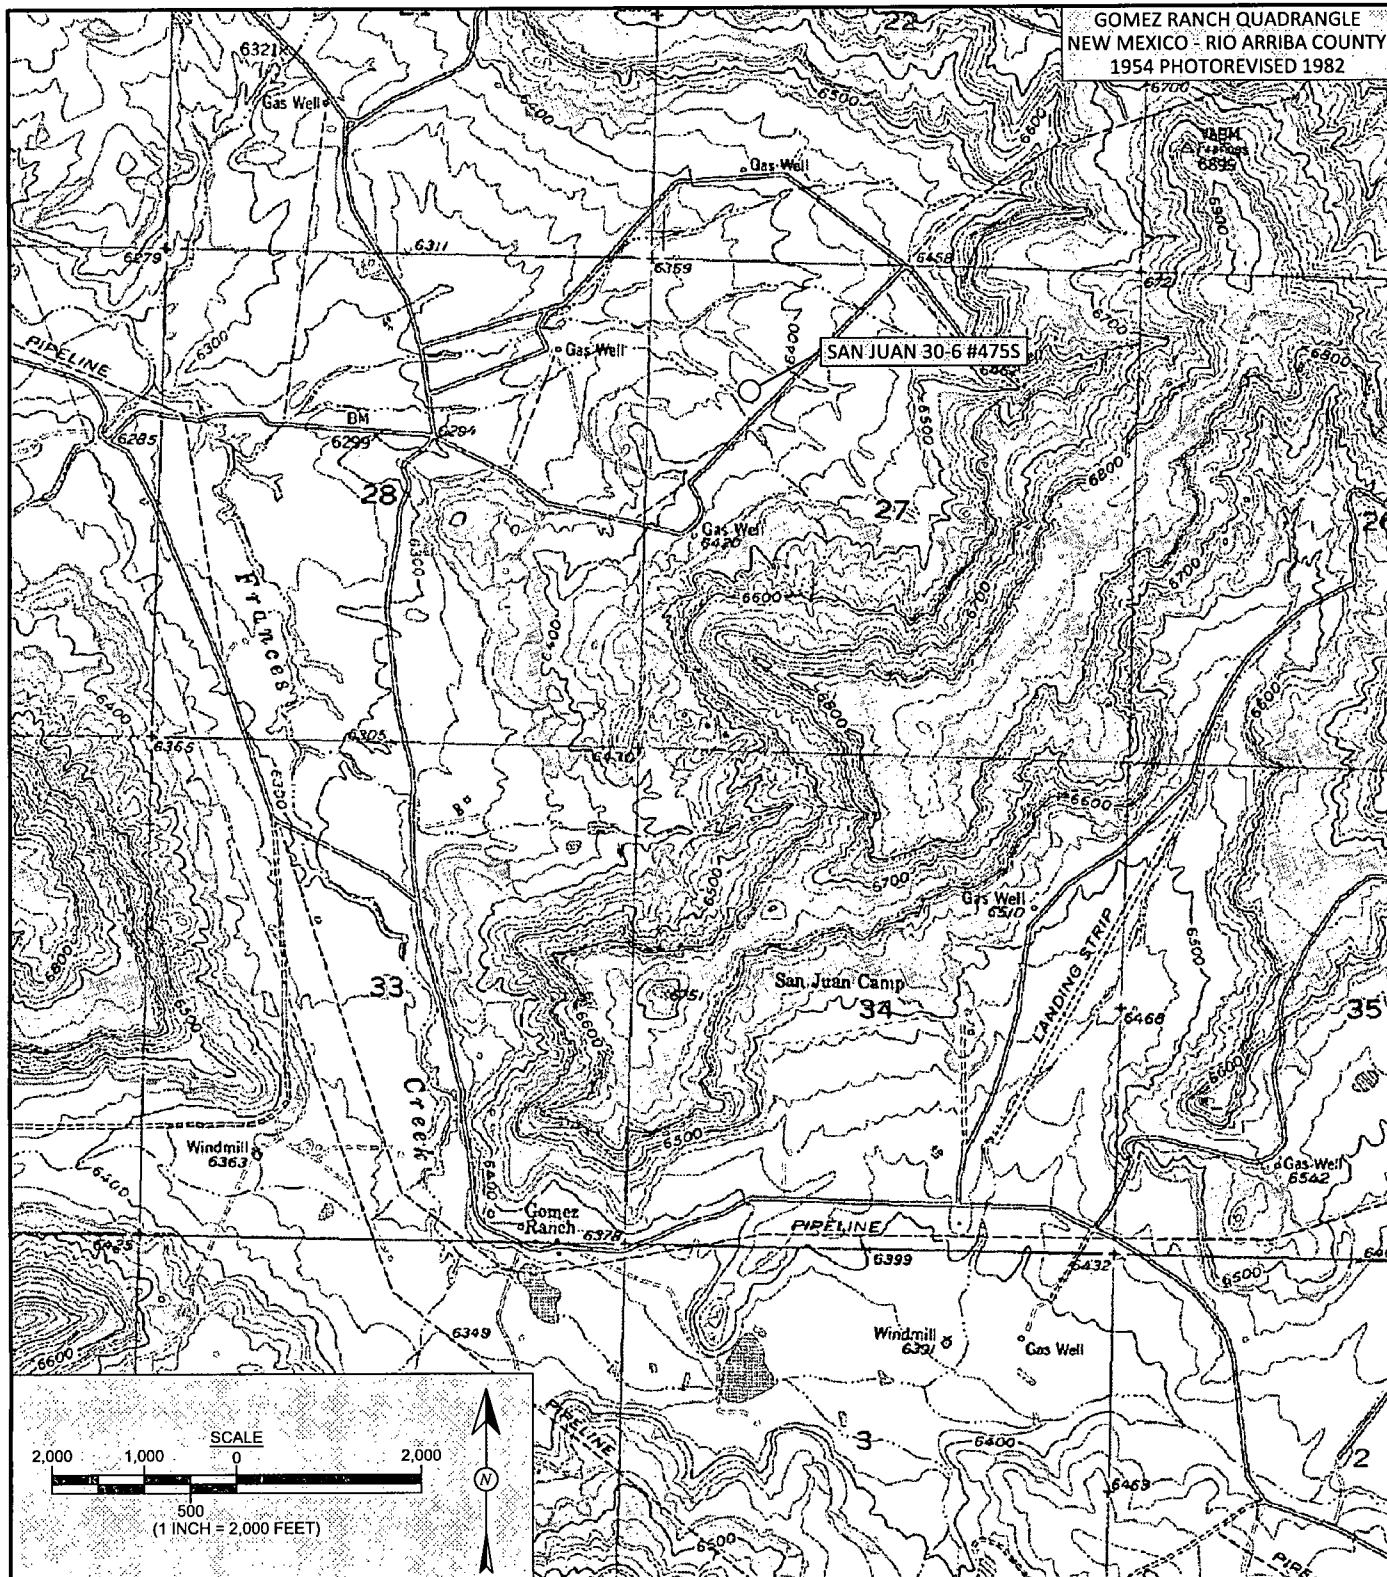
FIGURE 2

Field screening readings for VOCs via OVM ranged from 1.4 ppm in S-4 and S-5 up to 4.5 ppm in SC-1. Field TPH concentrations ranged from less than 20.0 mg/kg in S-1 and S-2 up to 62.0 mg/kg in S-3. The field chloride concentration in SC-1 was 60 mg/kg. Field screening results are summarized in Table 1 and presented on Figure 2. The AES Field Screening Report is attached.

concentration was 78 mg/kg. Laboratory analytical results are summarized in Table 2 and included on Figure 2. Laboratory analytical reports are attached.

SAN JUAN 30-6 #475S MONUMENT

BGT - N36.78701
W107.45522

**AERIAL SITE MAP
BELOW GRADE TANK CLOSURE
NOVEMBER 2012**
ConocoPhillips
SAN JUAN 30-6 #475S
RIO ARriba COUNTY, NEW MEXICO
SW¼ NW¼, SECTION 27, T30N, R6W
N36.78722, W107.45531

NMOCD action levels for BGT closures are specified in New Mexico Administrative Code (NMAC) 19.15.17.13E. Benzene and total BTEX concentrations in SC-1 were below the NMOCD action levels of 0.2 mg/kg and 50 mg/kg, respectively. Field TPH concentrations were below the NMOCD action level of 100 mg/kg, with the highest concentration reported in S-3 with 62.0 mg/kg. Chloride concentrations in SC-1 were below the NMOCD action level of 250 mg/kg. Based on field screening and laboratory analytical results for benzene, total BTEX, TPH, and chlorides, no further work is recommended.
