Form C-144 Revised June 6, 2013

Burlington Resources Oil Gas Company, LP San Juan Basin Below Grade Tank Closure Report

Lease Name: SJ 28-6 Unit 210M

RE: Below Grade Tank Closure Report San Juan 28-6 #210 M

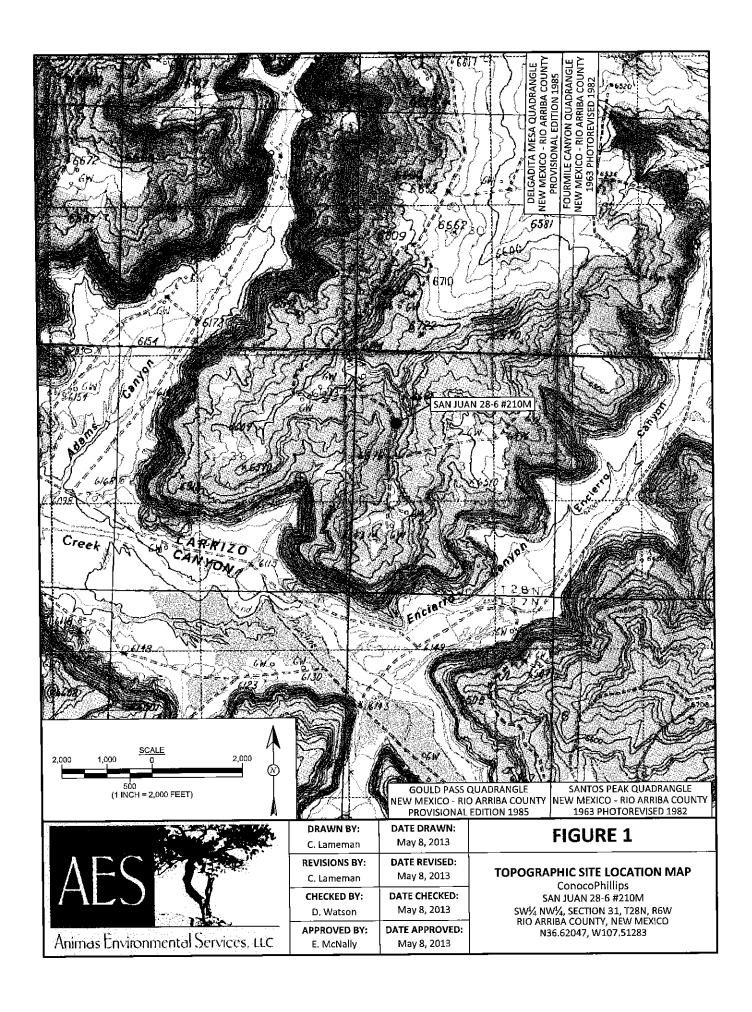
Figure 1. Topographic Site Location Map Figure 2. Aerial Site Map, April 2013 AES Field Screening Report 042913 Hall Analytical Report 1304B59

Site Name – San Juan 28-6 #210M
Legal Description – SW¼ NW¼, Section 31, T28N, R6W, Rio Arriba County, New Mexico
Well Latitude/Longitude – N36.62047 and W107.51283, respectively
BGT Latitude/Longitude – N36.62057 and W107.51261, respectively
Land Jurisdiction – Bureau of Land Management (BLM)
Figure 1. Topographic Site Location Map
Figure 2. Aerial Site Map, April 2013
