Pit, Below-Grade Tank, or  
Proposed Alternative Method Permit or Closure Plan Application

**ConocoPhillips Company  
San Juan Basin  
Below Grade Tank Closure Report**

**Lease Name: SJ 28-7 Unit 11**

**API No.: 3003907263**

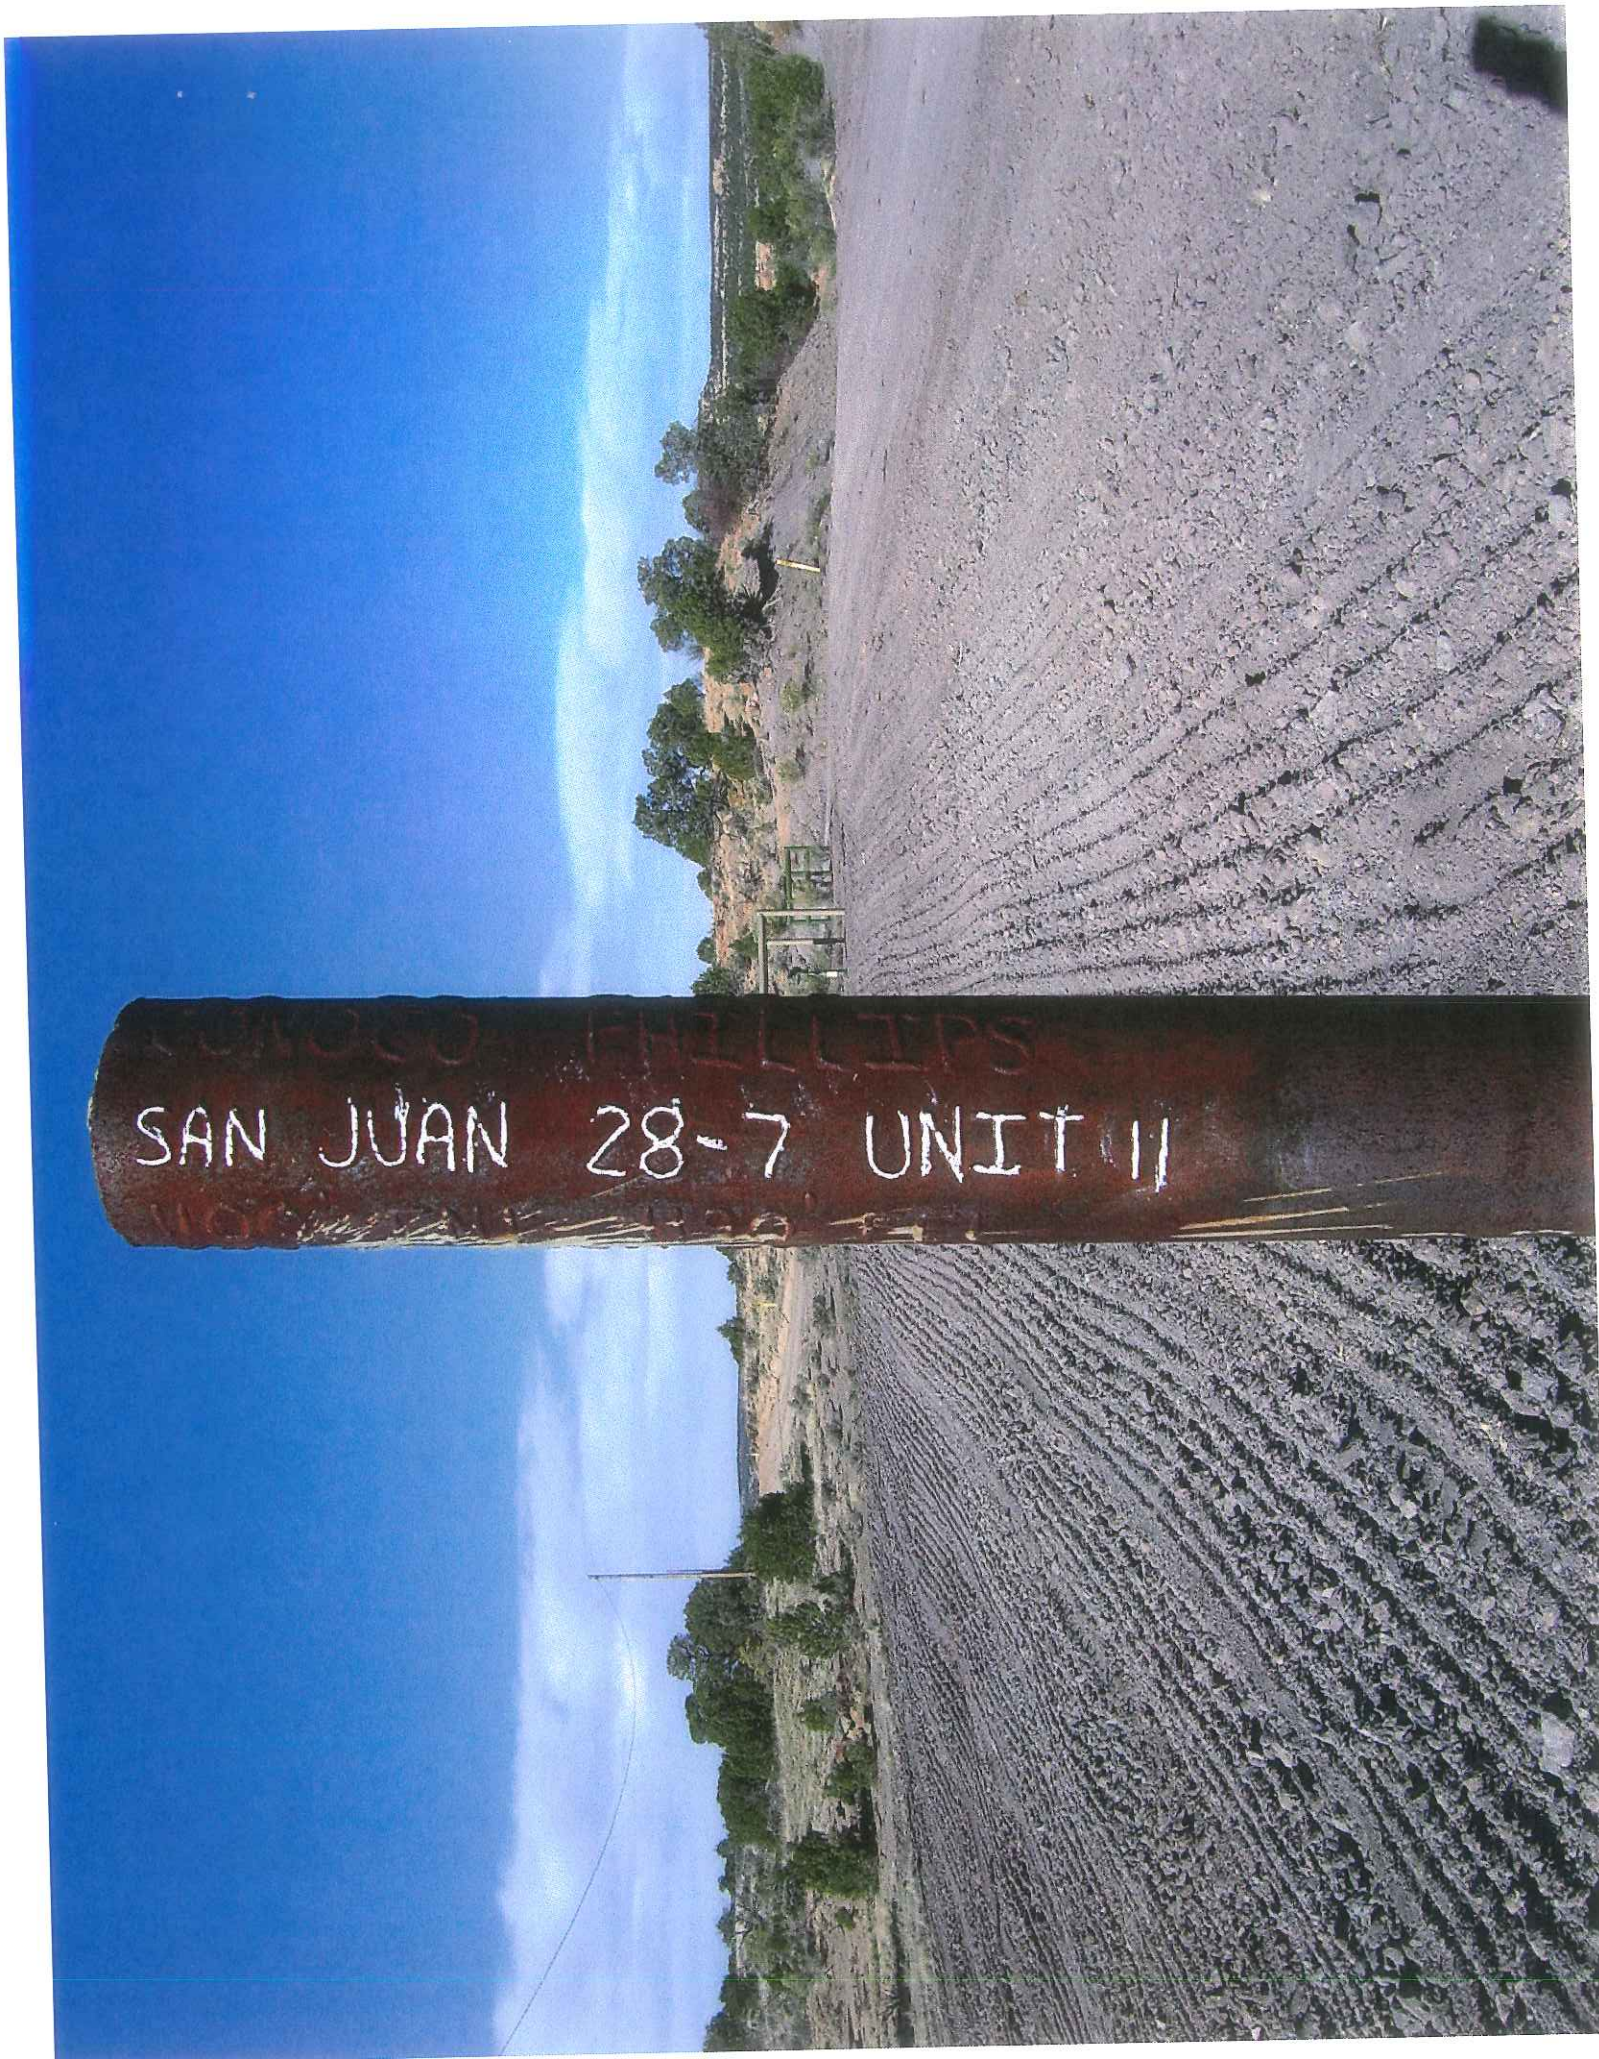
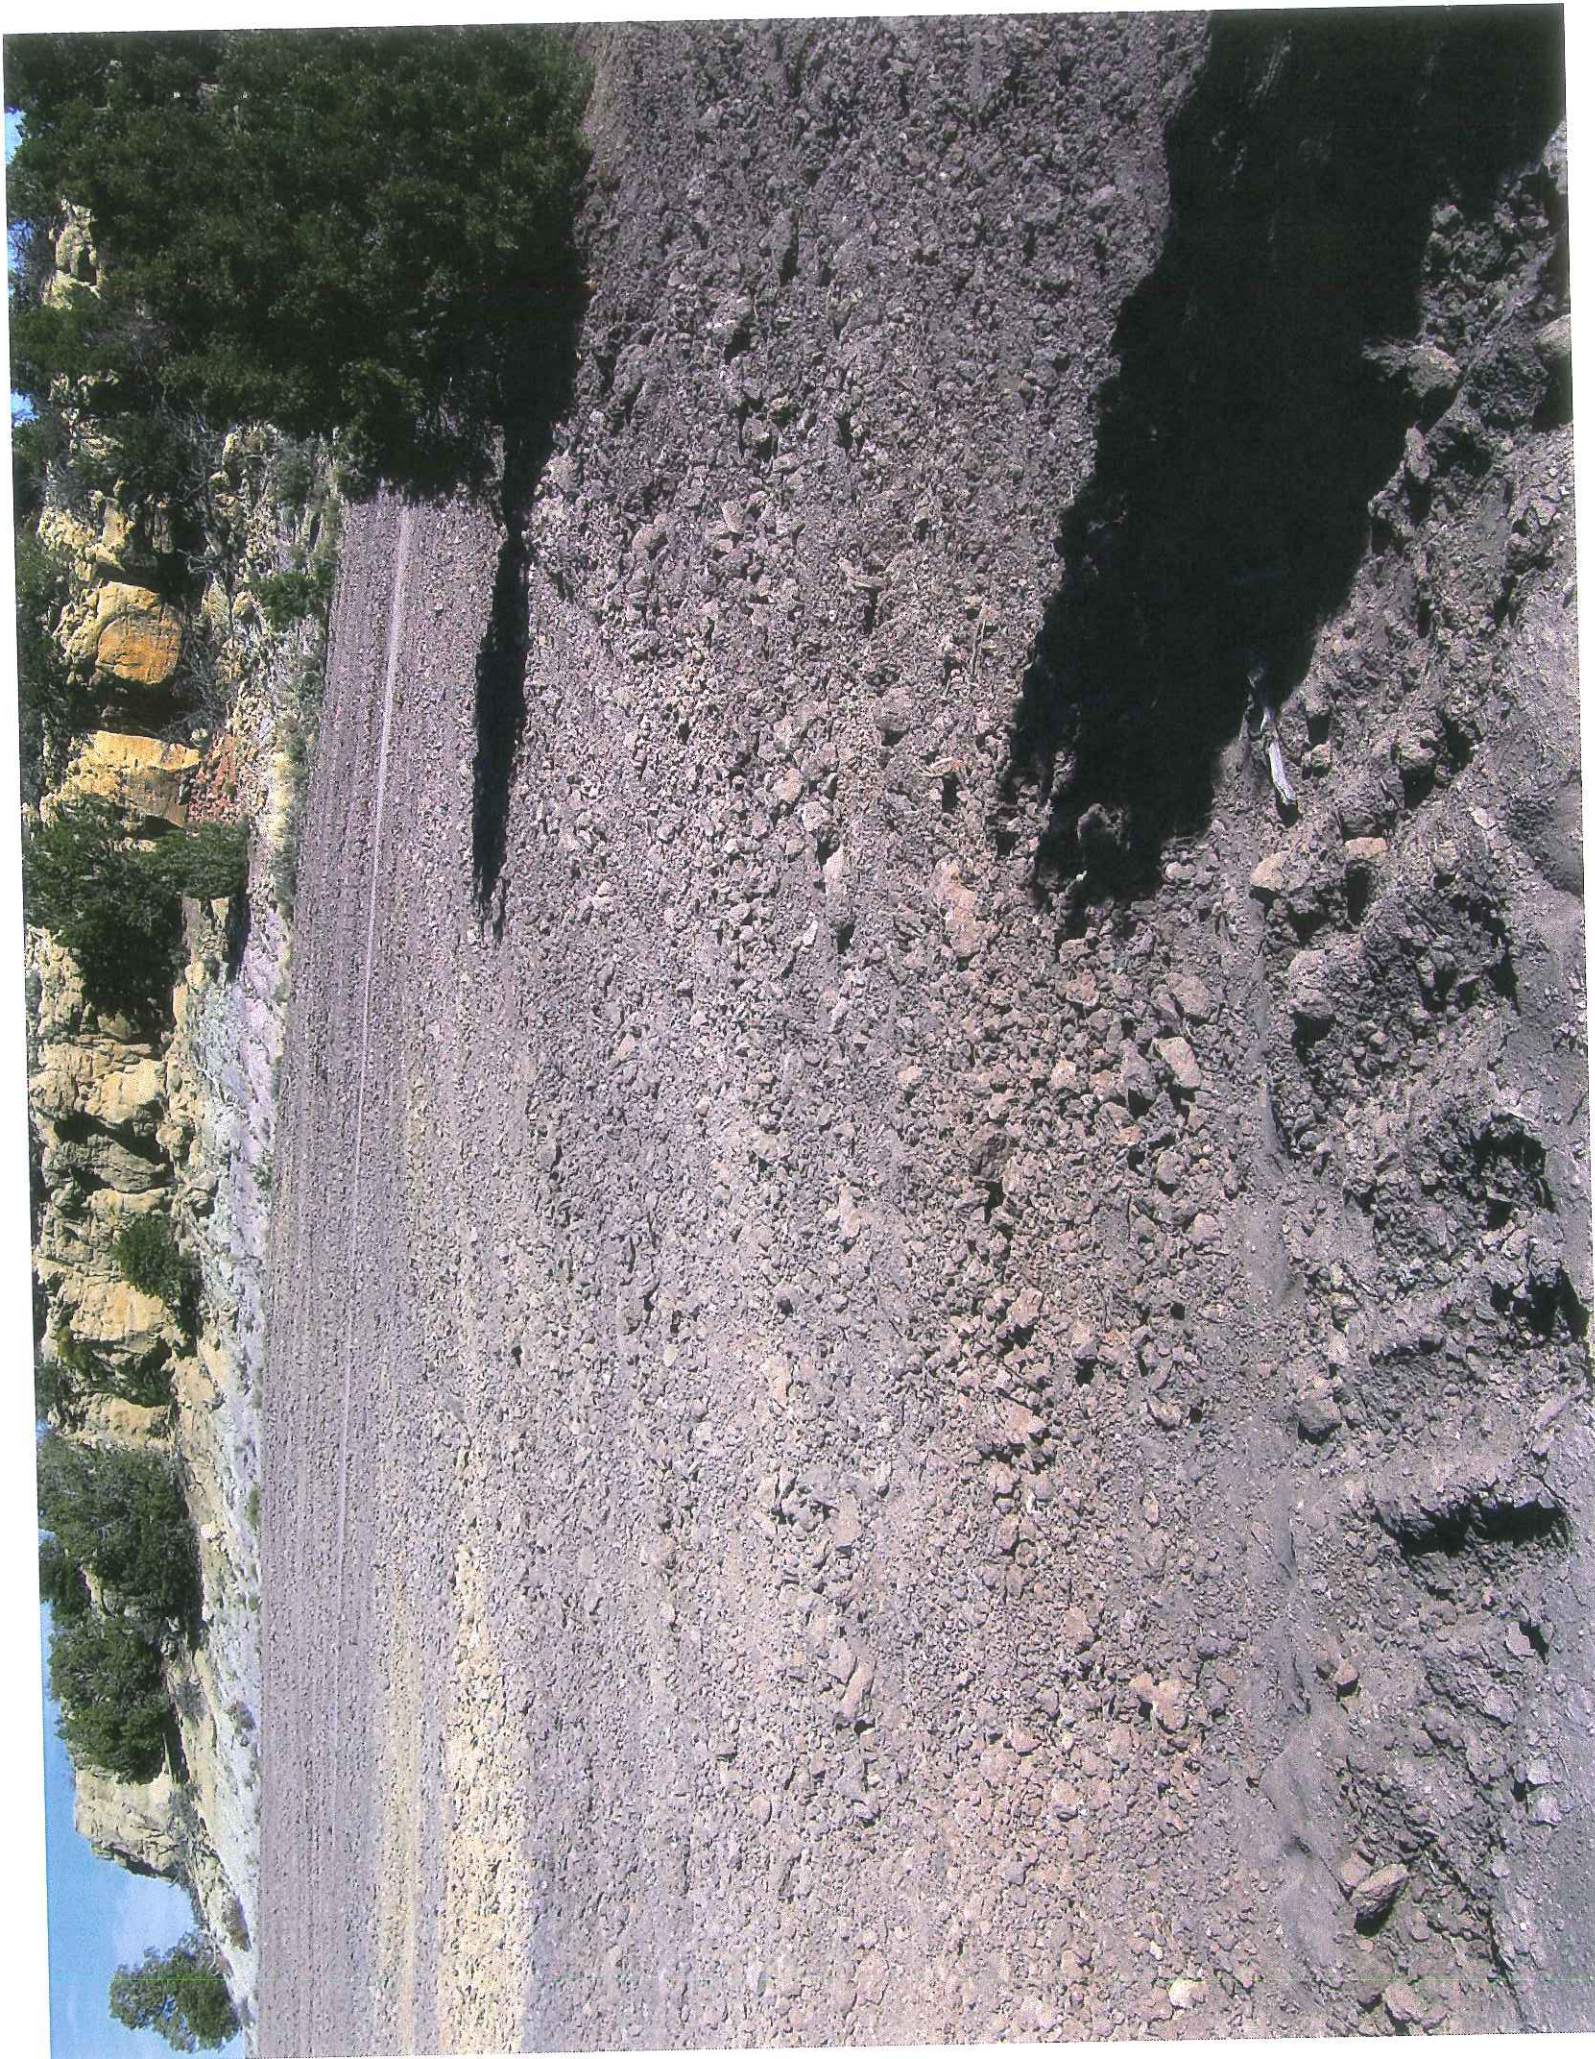
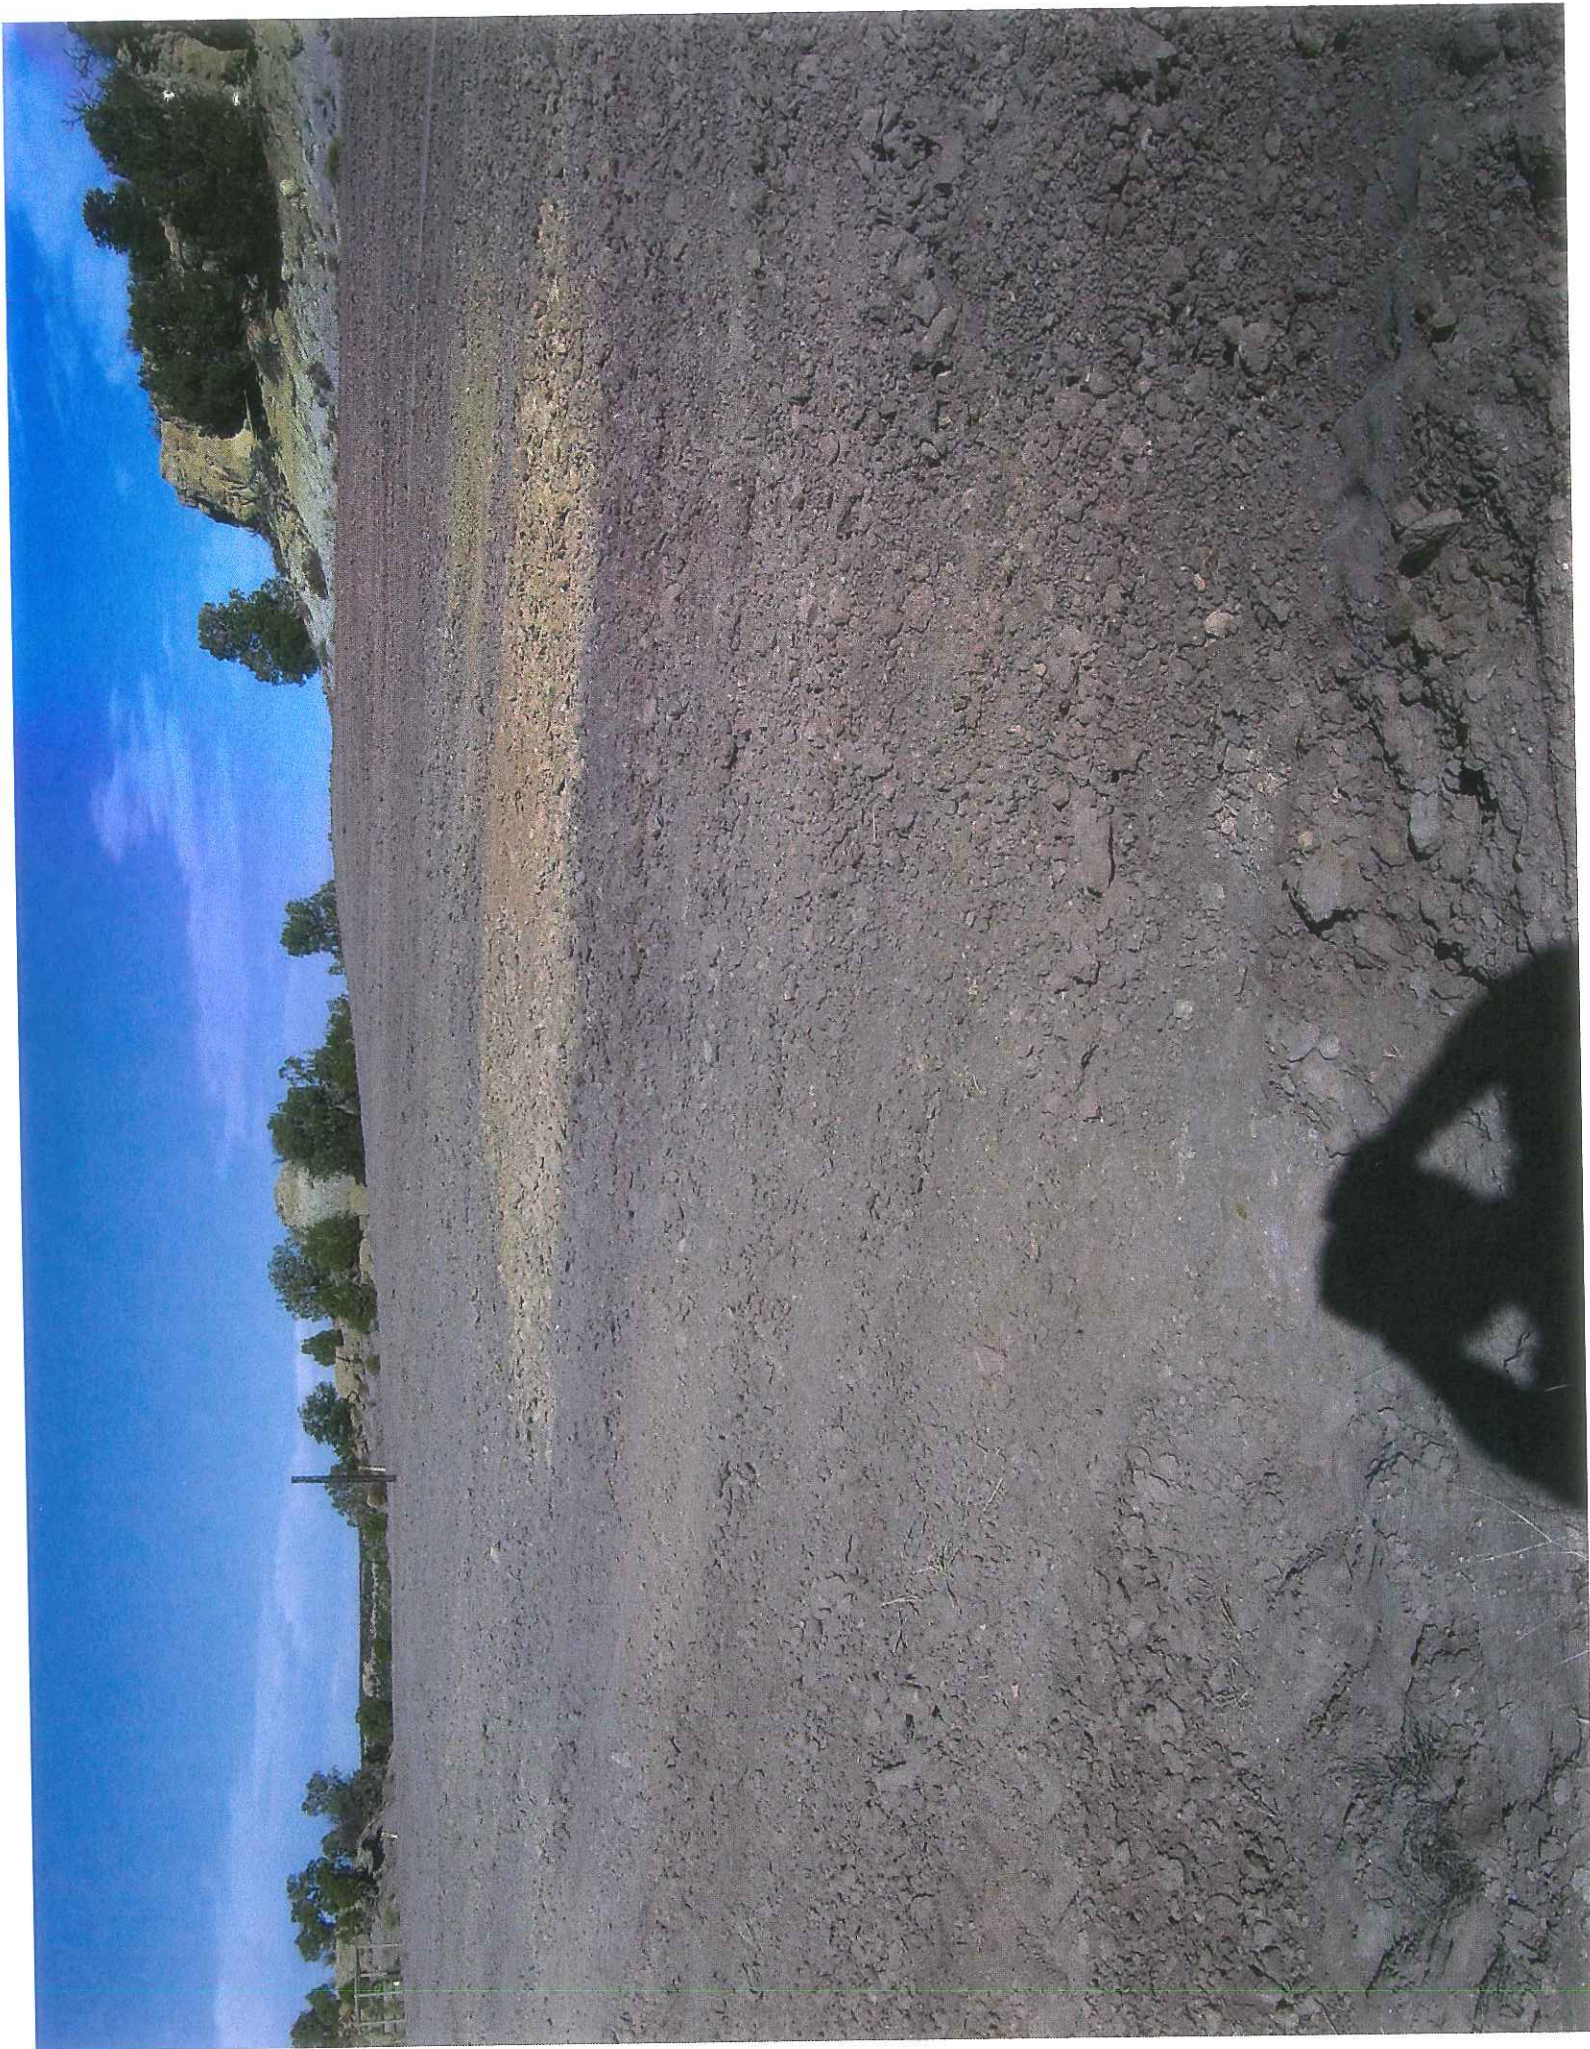
CONOCO PHILLIPS  
SAN JUAN 28-7 UNIT II

**The below-grade tank area passed all requirements of Paragraph (4) of Subsection E of 19.15.17.13 NMAC and was backfilled with compacted, non-waste containing, earthen material.**
