Burlington Resources Oil Gas Company, LP San Juan Basin Below Grade Tank Closure Report

Lease Name: Shiotani Federal Com 400

API No.: 30-045-28909

Below Grade Tank Closure Report Shiotani Federal Com #400 San Juan County, New Mexico

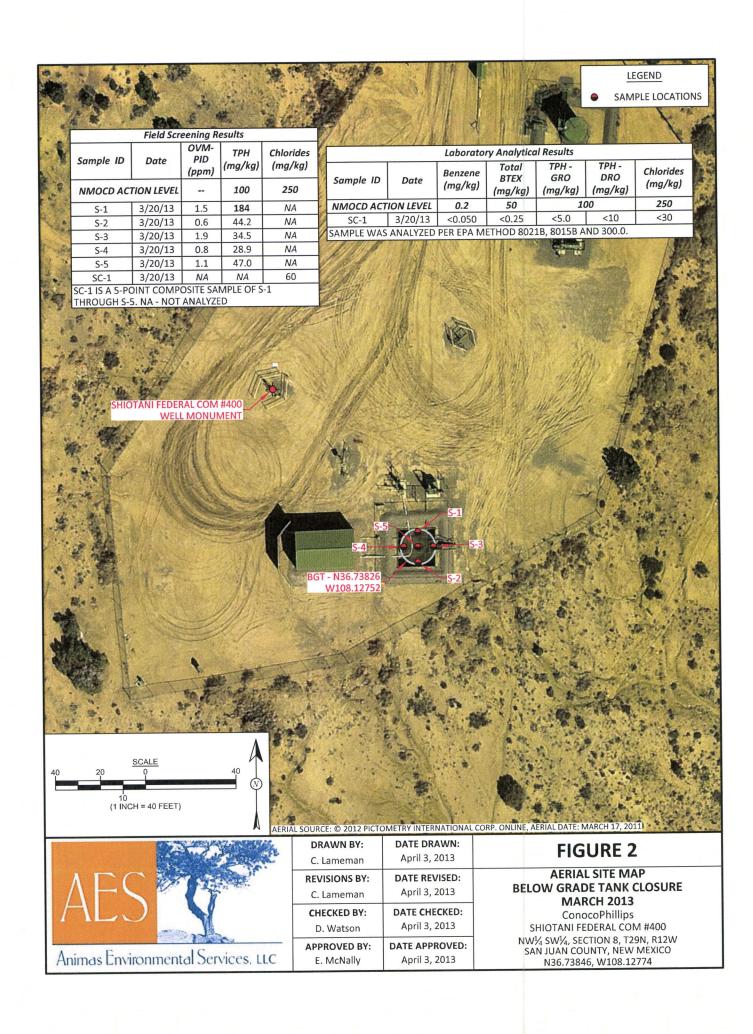
Figure 1. Topographic Site Location Map. Figure 2. Aerial Site Map, March 2013
