Pit, Below-Grade Tank, or  
Proposed Alternative Method Permit or Closure Plan Application

**Burlington Resources Oil & Gas Company, LP**  
**San Juan Basin**  
**Below Grade Tank Closure Report**

**Lease Name: Huerfano Unit 112**

**API No.: 30-045-05866**

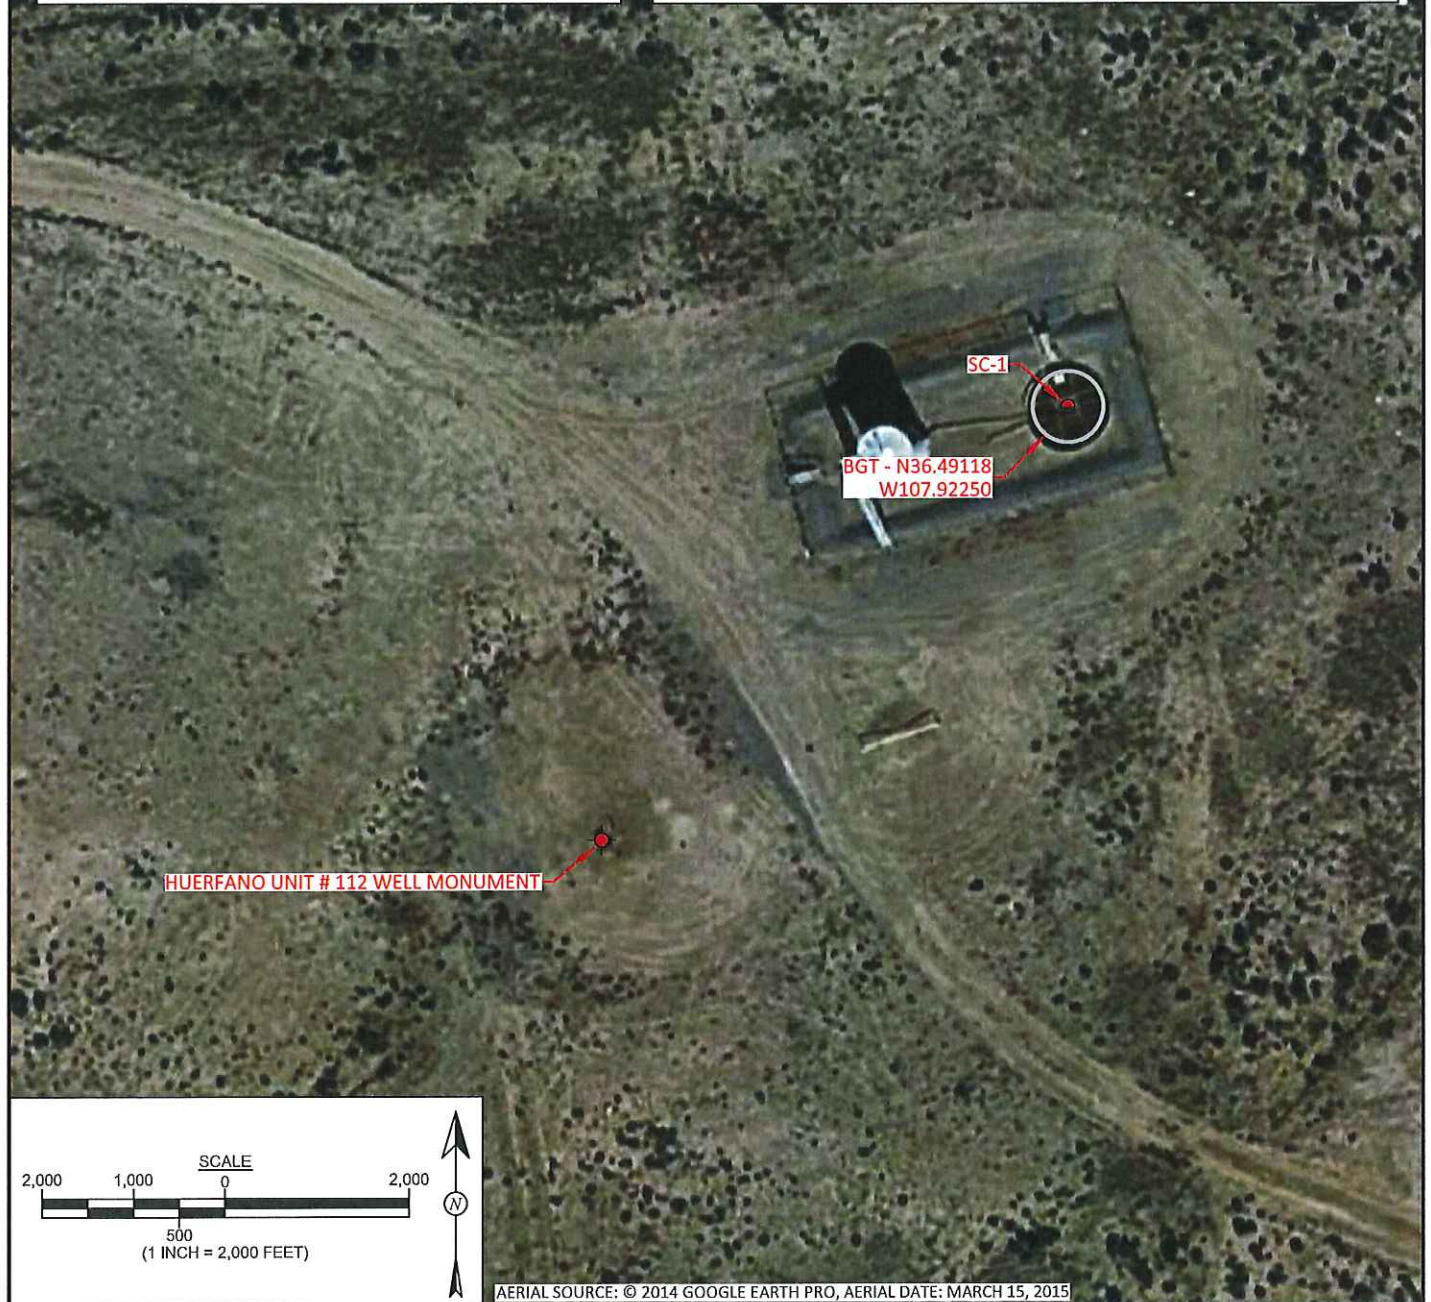
Laboratory Analytical Results						
Sample ID	Date	Depth (ft)	Benzene (mg/kg)	Total BTEX (mg/kg)	TPH (mg/kg)	Chlorides (mg/kg)
NMOCD ACTION LEVEL			0.2	50	100	600
SC-1	6/18/15	0.5	<0.048	<0.241	25	<30

AERIAL SOURCE: © 2014 GOOGLE EARTH PRO, AERIAL DATE: MARCH 15, 2015
