Pit, Below-Grade Tank, or
Proposed Alternative Method Permit or Closure Plan Application

ConocoPhillips Company
San Juan Basin
Below Grade Tank Closure Report

Lease Name: San Juan 29-7 Unit 33

API No.: 30-039-07632

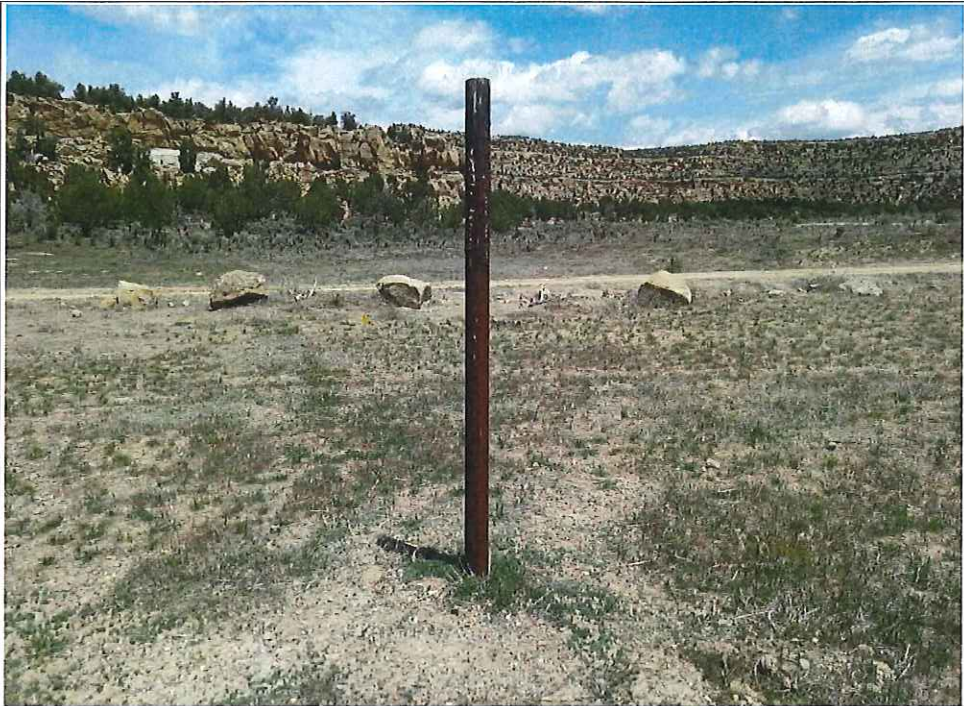
Photo #1

Client: ConocoPhillips	
Project Name: San Juan 29-7 Unit 33 Rio Arriba County, NM	
Date Photo Taken: April 25, 2016	
BGT GPS and Location: 36.73039, -107.51649 NE¼ NE¼, Section 13, T29N, R7W	
Taken by: Delilah Dougi, AES	
Subject: BGT sampling, April 2016	
Description: Facing NE, overview of entire location.

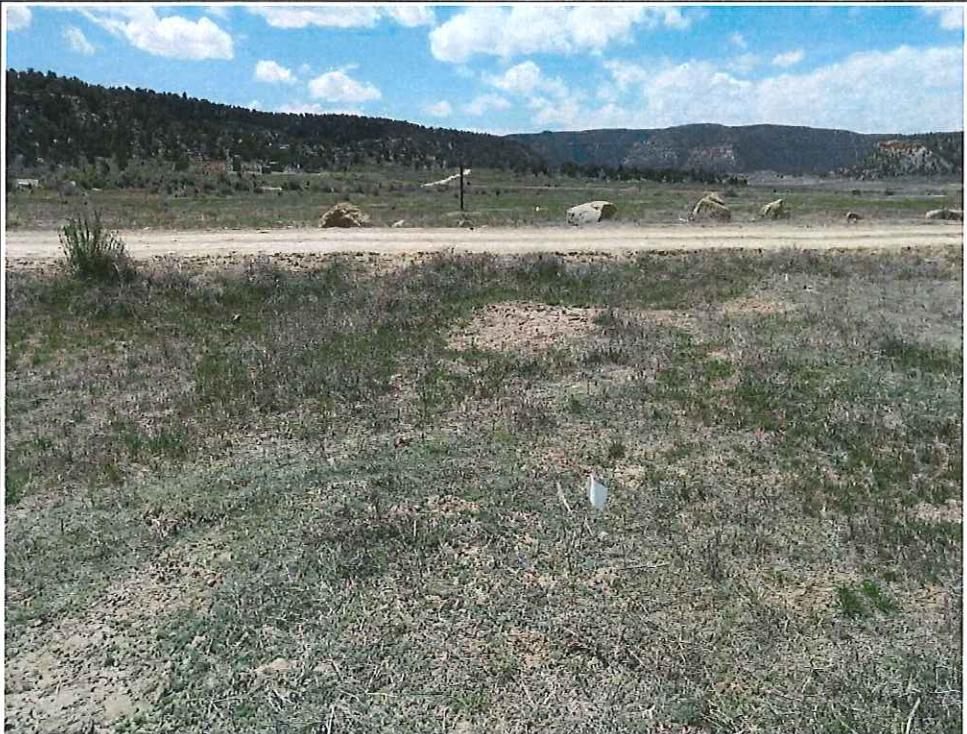
Photo #2

Client: ConocoPhillips	
Project Name: San Juan 29-7 Unit 33 Rio Arriba County, NM	
Date Photo Taken: April 25, 2016	
BGT GPS and Location: 36.73039, -107.51649 NE¼ NE¼, Section 13, T29N, R7W	
Taken by: Delilah Dougi, AES	
Subject: BGT sampling, April 2016	
Description: Facing SW, sample location.
