Pit, Below-Grade Tank, or  
Proposed Alternative Method Permit or Closure Plan Application

Facility or well name: Summit 4

**Burlington Resources Oil & Gas Company, LP**  
**San Juan Basin**  
**Below Grade Tank Closure Report**

**Lease Name: Summit 4**

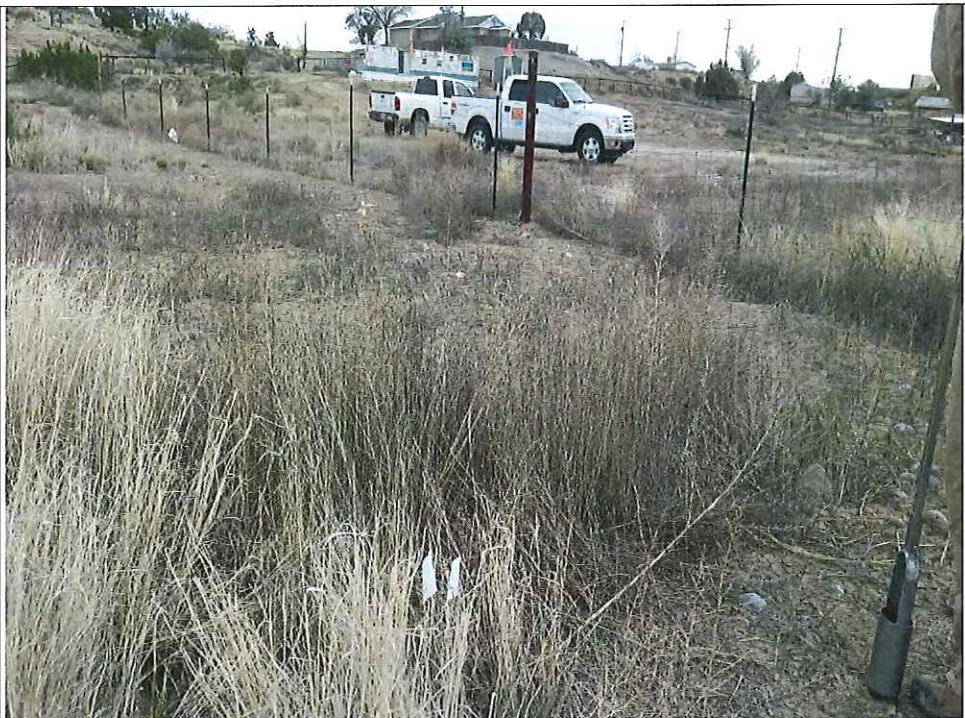
Photo #1

Client: ConocoPhillips	
Project Name: Summit 4  San Juan County, NM	
Date Photo Taken: April 25, 2016	
BGT GPS and Location: 36.68697, -107.99155  NE¼ NE¼, Section 33, T29N, R11W	
Taken by: Delilah Dougi, AES	Subject: BGT sampling, April 2016 Description: Facing NE, overview of location with wellhead in midground of photo.

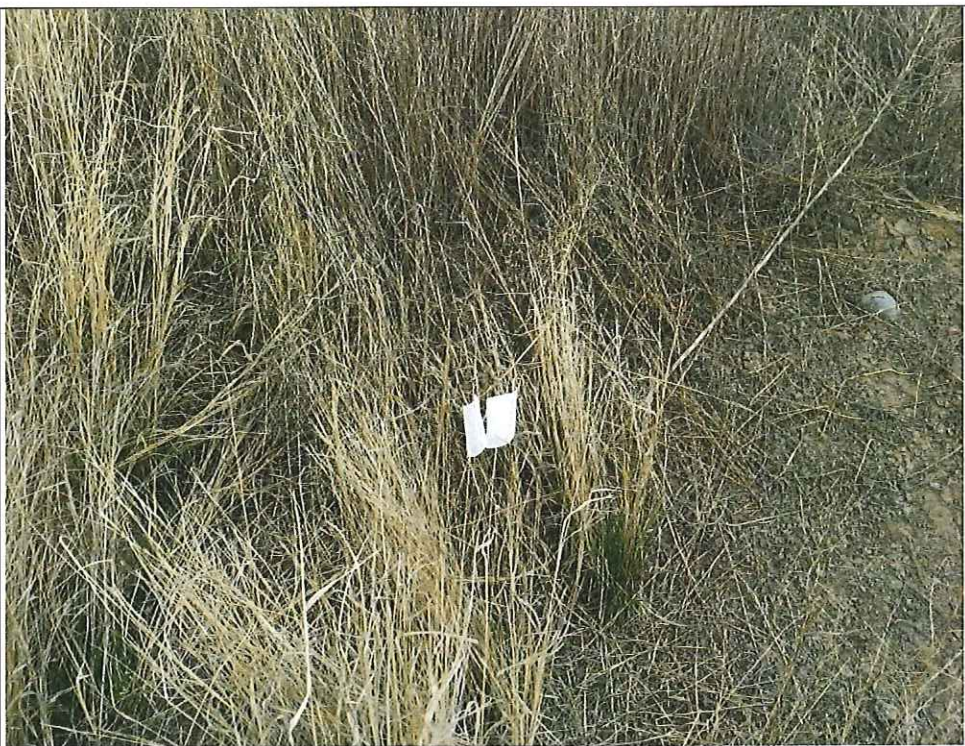
Photo #2

Client: ConocoPhillips	
Project Name: Summit 4  San Juan County, NM	
Date Photo Taken: April 25, 2016	
BGT GPS and Location: 36.68697, -107.99155  NE¼ NE¼, Section 33, T29N, R11W	
Taken by: Delilah Dougi, AES	Subject: BGT sampling, April 2016 Description: Facing NE, sample location.

A five point composite sample was taken of the below-grade tank using sampling tools and all samples tested per Subsection B of 19.15.17.1 3(B)(1)(b). (Sample results attached). Form C-141 is attached.
