Pit, Below-Grade Tank, or
Proposed Alternative Method Permit or Closure Plan Application

ConocoPhillips Company
San Juan Basin
Below Grade Tank Closure Report

Lease Name: Price 2
API No.: 30-045-20173

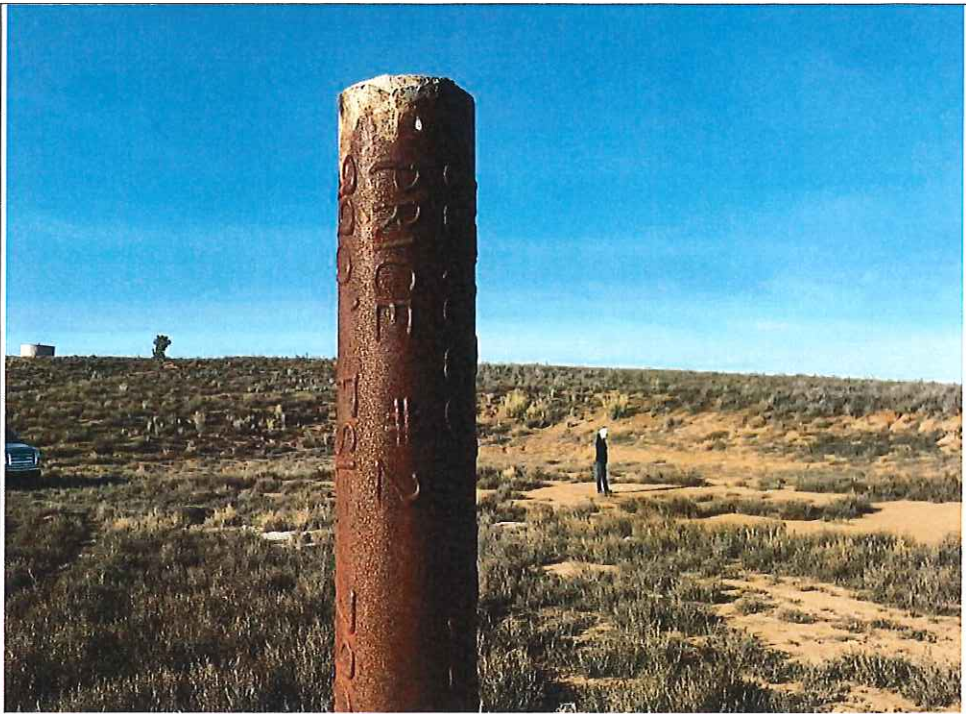
Photo #1

Client: ConocoPhillips	
Project Name: Price 2 San Juan County, NM	
Date Photo Taken: March 16, 2016	
BGT GPS and Location: 36.65685, -107.65694 SW¼ SW¼, Section 14, T28N, R8W	
Taken by: Corwin Lameman, AES	
Subject: BGT sampling, March 2016	
Description: Facing SW, overview of entire location.

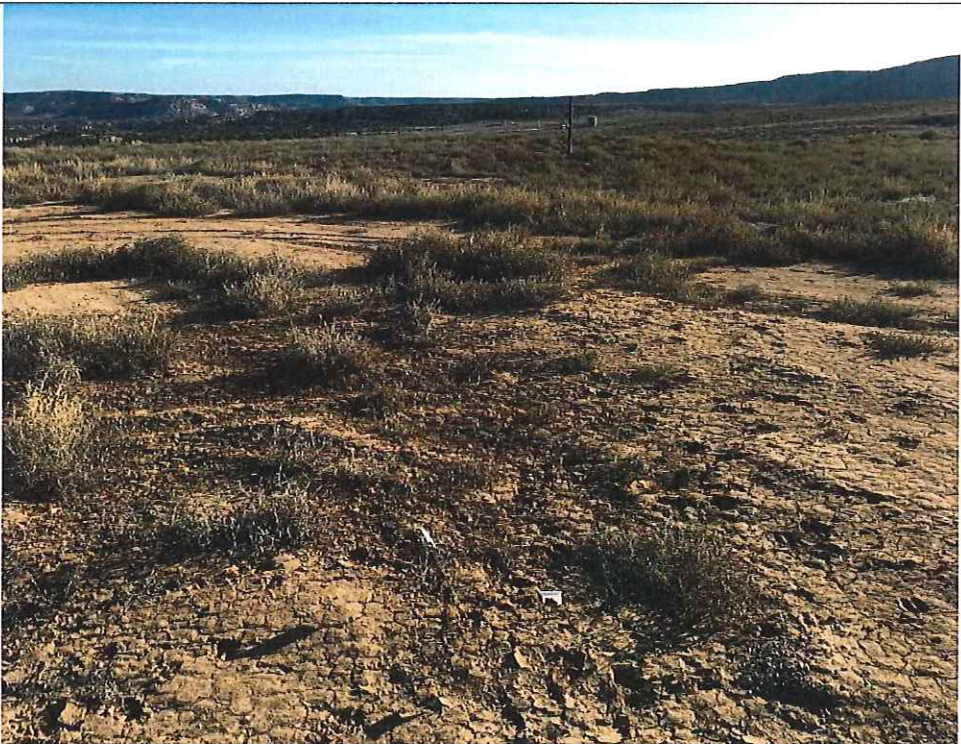
Photo #2

Client: ConocoPhillips	
Project Name: Price 2	
San Juan County, NM	
Date Photo Taken: March 16, 2016	
BGT GPS and Location: 36.65685, -107.65694	
SW¼ SW¼, Section 14, T28N, R8W	
Taken by: Corwin Lameman, AES	Subject: BGT sampling, March 2016
	Description: Facing NE, sample location.

A five point composite sample was taken of the below-grade tank using sampling tools and all samples tested per Subsection B of 19.15.17.1 3(B)(1)(b). (Sample results attached). Form C-141 is attached.
