# Burlington Resources Oil & Gas Company, LP San Juan Basin Below Grade Tank Closure Report

Lease Name: San Juan 28-4 Unit NP 202

API No.: 30-039-24542

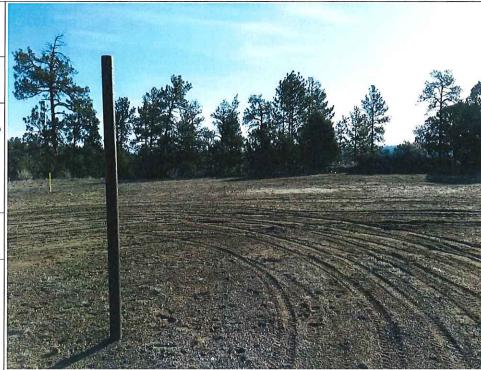
Subject: BGT sampling, March 2016

Description: Facing N, overview of entire location.

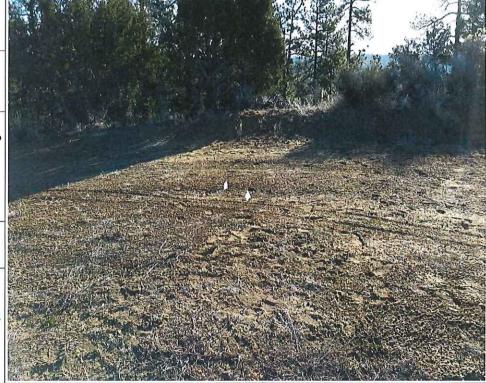
Subject: BGT sampling, March 2016

Description: Facing E, sample location.
