Pit, Below-Grade Tank, or  
Proposed Alternative Method Permit or Closure Plan Application

**Burlington Resources Oil & Gas Company**  
**San Juan Basin: New Mexico Assets**  
Below Grade Tank Closure Report

**Lease Name:** Newberry 9A  
**API No.:** 30-045-26386

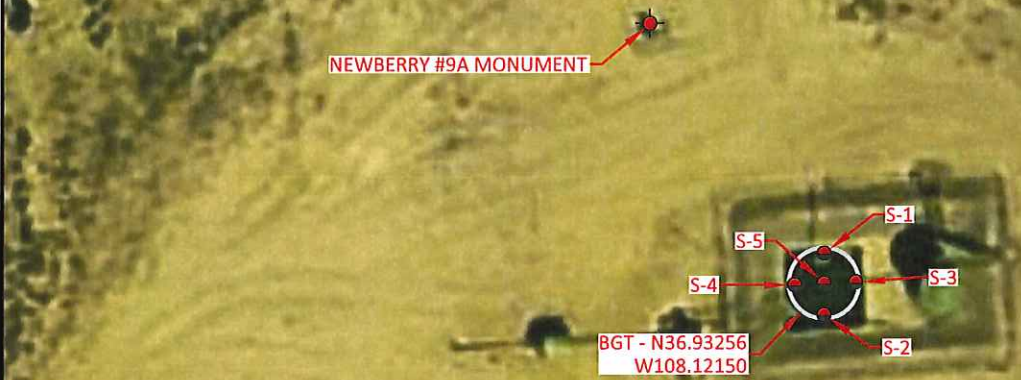
Field Screening Results				
Sample ID	Date	OVM-PID (ppm)	TPH (mg/kg)	Chlorides (mg/kg)
NMOCD ACTION LEVEL		--	100	250
S-1	12/19/12	0.5	84.5	NA
S-2	12/19/12	0.7	<20.0	NA
S-3	12/19/12	0.0	54.5	NA
S-4	12/19/12	0.0	20.7	NA
S-5	12/19/12	0.0	40.3	NA
SC-1	12/19/12	NA	NA	80
SC-1 IS A 5-POINT COMPOSITE SAMPLE OF S-1 THROUGH S-5. NA - NOT ANALYZED

Laboratory Analytical Results						
Sample ID	Date	Benzene (mg/kg)	Total BTEX (mg/kg)	TPH - GRO (mg/kg)	TPH - DRO (mg/kg)	Chlorides (mg/kg)
NMOCD ACTION LEVEL		0.2	50	100		250
SC-1	12/19/12	<0.050	<0.25	NA	NA	<30
SAMPLE WAS ANALYZED PER EPA METHOD 8021B AND 300.0.

NMOCD action levels for BGT closures are specified in New Mexico Administrative Code (NMAC) 19.15.17.13E. Benzene and total BTEX concentrations in SC-1 were below the NMOCD action level of 0.2 mg/kg and 50 mg/kg, respectively. Field TPH concentrations were below the NMOCD action level of 100 mg/kg, with the highest concentration reported in S-1 with 84.5 mg/kg. Chloride concentrations in SC-1 were below the NMOCD action level of 250 mg/kg. Based on field screening and laboratory analytical results for benzene, total BTEX, TPH, and chlorides, no further work is recommended at the Newberry #9A
