# SITE CHARACTERIZATION REPORT AND ABATEMENT PLAN

**KAUFMAN NO. 1  
HILCORP ENERGY COMPANY  
SAN JUAN COUNTY, NEW MEXICO**  
OCD Incident No.: NCS1833331001

**February 21, 2019**

***Timberwolf Project No. HEC-180061***

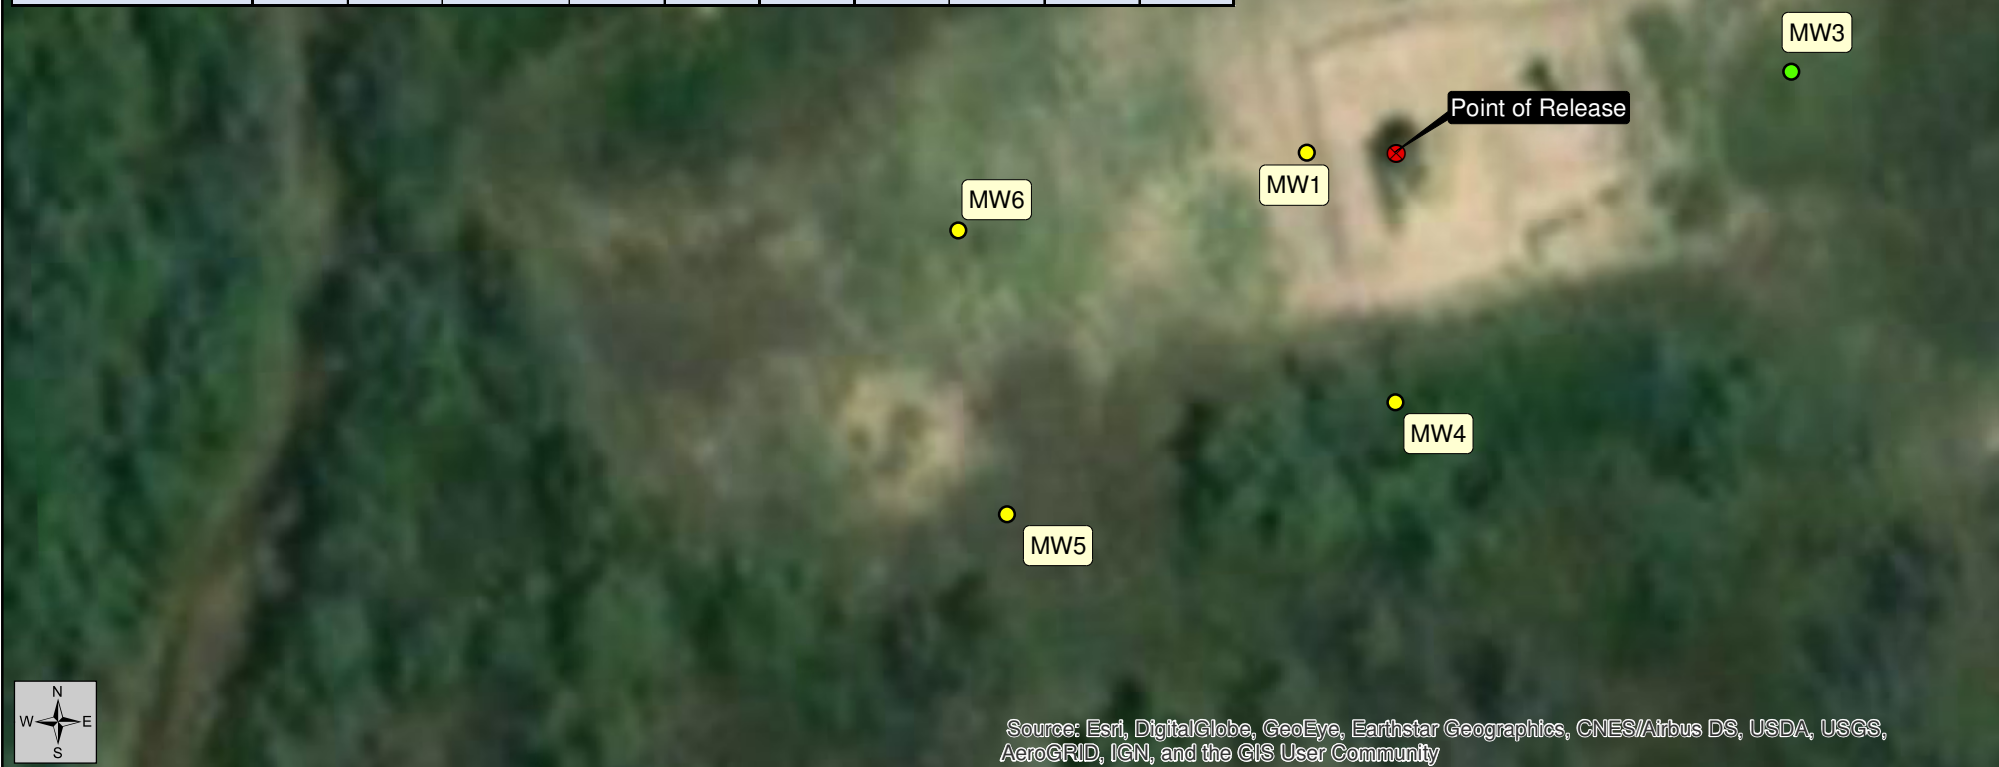
**Figure 5**  
Site Characterization -  
Sample Location Map

Sample ID	Date	Volatile Organic Compounds (mg/kg)				Total BTEX (mg/kg)	Chloride (mg/kg)	TPH-DRO (mg/kg)	TPH-MRO (mg/kg)	TPH-GRO (mg/kg)	Total TPH (mg/kg)
		Benzene	Toluene	Ethylbenzene	Xylenes						
MW1 2.5-3.5'	01/15/19	0.96	22	7	92	121.96	< 30	600	< 49	1,200	1,800
MW1 4.5-5.5'	01/15/19	< 0.025	< 0.049	< 0.049	0.12	0.12	< 30	31	< 46	< 4.9	31
MW1 6.5-7.5'	01/15/19	< 0.023	< 0.046	< 0.046	< 0.092	< 0.0092	< 30	20	48	4.7	72.7
MW1 14-15'	01/15/19	< 0.025	< 0.05	< 0.05	< 0.1	< 0.1	< 30	< 9.3	< 47	< 5.0	< 47
MW2 5'	01/14/19	< 0.024	< 0.048	< 0.048	< 0.096	< 0.096	< 30	< 9.2	< 46	< 4.8	< 46
MW2 6.5-7.5'	01/14/19	< 0.024	< 0.048	< 0.048	< 0.096	< 0.096	< 30	18	< 49	< 4.8	18
MW3 5.0-5.5'	01/14/19	< 0.024	< 0.049	< 0.049	< 0.098	< 0.098	< 30	< 9.8	< 49	< 4.9	< 49
MW3 6.5-7.5'	01/14/19	< 0.024	< 0.049	< 0.049	< 0.097	< 0.097	< 30	< 9.4	< 47	< 4.9	< 47
MW4 5-6'	01/15/19	< 0.024	< 0.048	< 0.048	< 0.096	< 0.096	< 30	< 9.8	< 49	< 4.8	< 49

MW4 8-9'	01/15/19	< 0.024	< 0.047	< 0.047	< 0.094	< 0.094	< 30	130	< 50	< 4.7	130
MW5 4.5-5.5'	01/15/19	< 0.024	< 0.048	< 0.048	< 0.097	< 0.097	< 30	< 9.8	< 49	< 4.8	< 49
MW5 8-9'	01/15/19	< 0.024	< 0.049	< 0.049	< 0.098	< 0.098	< 30	86	< 47	29	115
MW5 14.5-15.5'	01/15/19	< 0.023	< 0.046	< 0.046	< 0.093	< 0.093	< 30	< 9.5	< 47	< 4.6	< 47
MW6 5.0-5.5'	01/14/19	< 0.025	< 0.05	< 0.05	< 0.099	< 0.099	< 30	10	< 49	10	20
MW6 7.5-8.5'	01/14/19	< 0.025	0.057	< 0.05	< 0.1	< 0.1	< 30	110	< 49	120	230
Regulatory Criteria		10	--	--	--	50	600	--	--	--	100

- Point of Release
- Soil Sample (Clean)
- Soil Sample (Elevated)

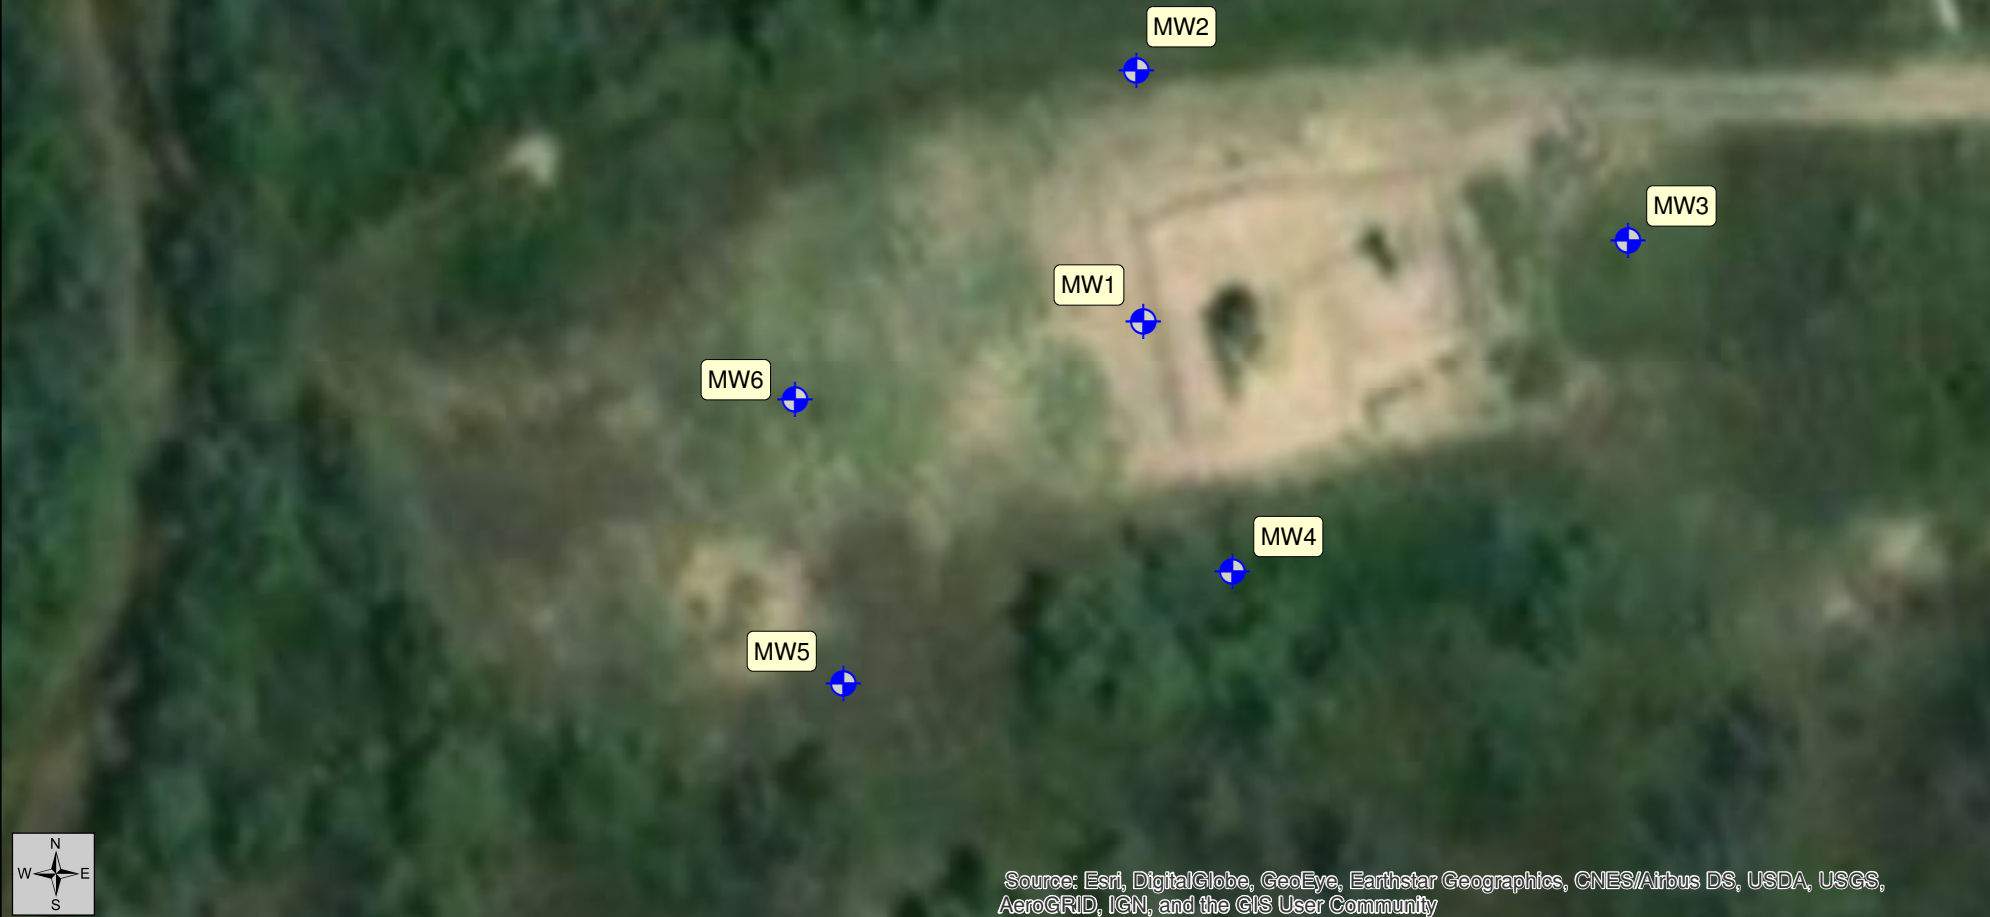
**Figure 6**  
Monitor Well Location Map

Sample ID	Date	Volatile Organic Compounds (mg/L)				Chloride (mg/L)	TPH-GRO (mg/L)	TPH-DRO (mg/L)	TPH-MRO (mg/L)	Total TPH (mg/L)
		B	T	E	X					
MW1	01/18/19	0.074	0.35	0.027	0.33	130	2.0	< 1.0	< 5.0	2.0
MW2	01/17/19	< 0.001	< 0.001	< 0.001	< 0.0015	150	< 0.05	< 1.0	< 5.0	< 5.0
MW3	01/17/19	< 0.001	< 0.001	< 0.001	< 0.0015	140	< 0.05	< 1.0	< 5.0	< 5.0
MW4	01/17/19	< 0.001	< 0.001	< 0.001	< 0.0015	140	< 0.05	< 1.0	< 5.0	< 5.0
MW5	01/17/19	< 0.001	< 0.001	< 0.001	< 0.0015	130	0.32	< 1.0	< 5.0	0.32
MW6	01/18/19	< 0.001	< 0.001	< 0.001	< 0.0015	180	1.1	< 1.0	< 5.0	1.1
Regulatory Criteria		0.01	0.75	0.75	0.62	250	--	--	--	--

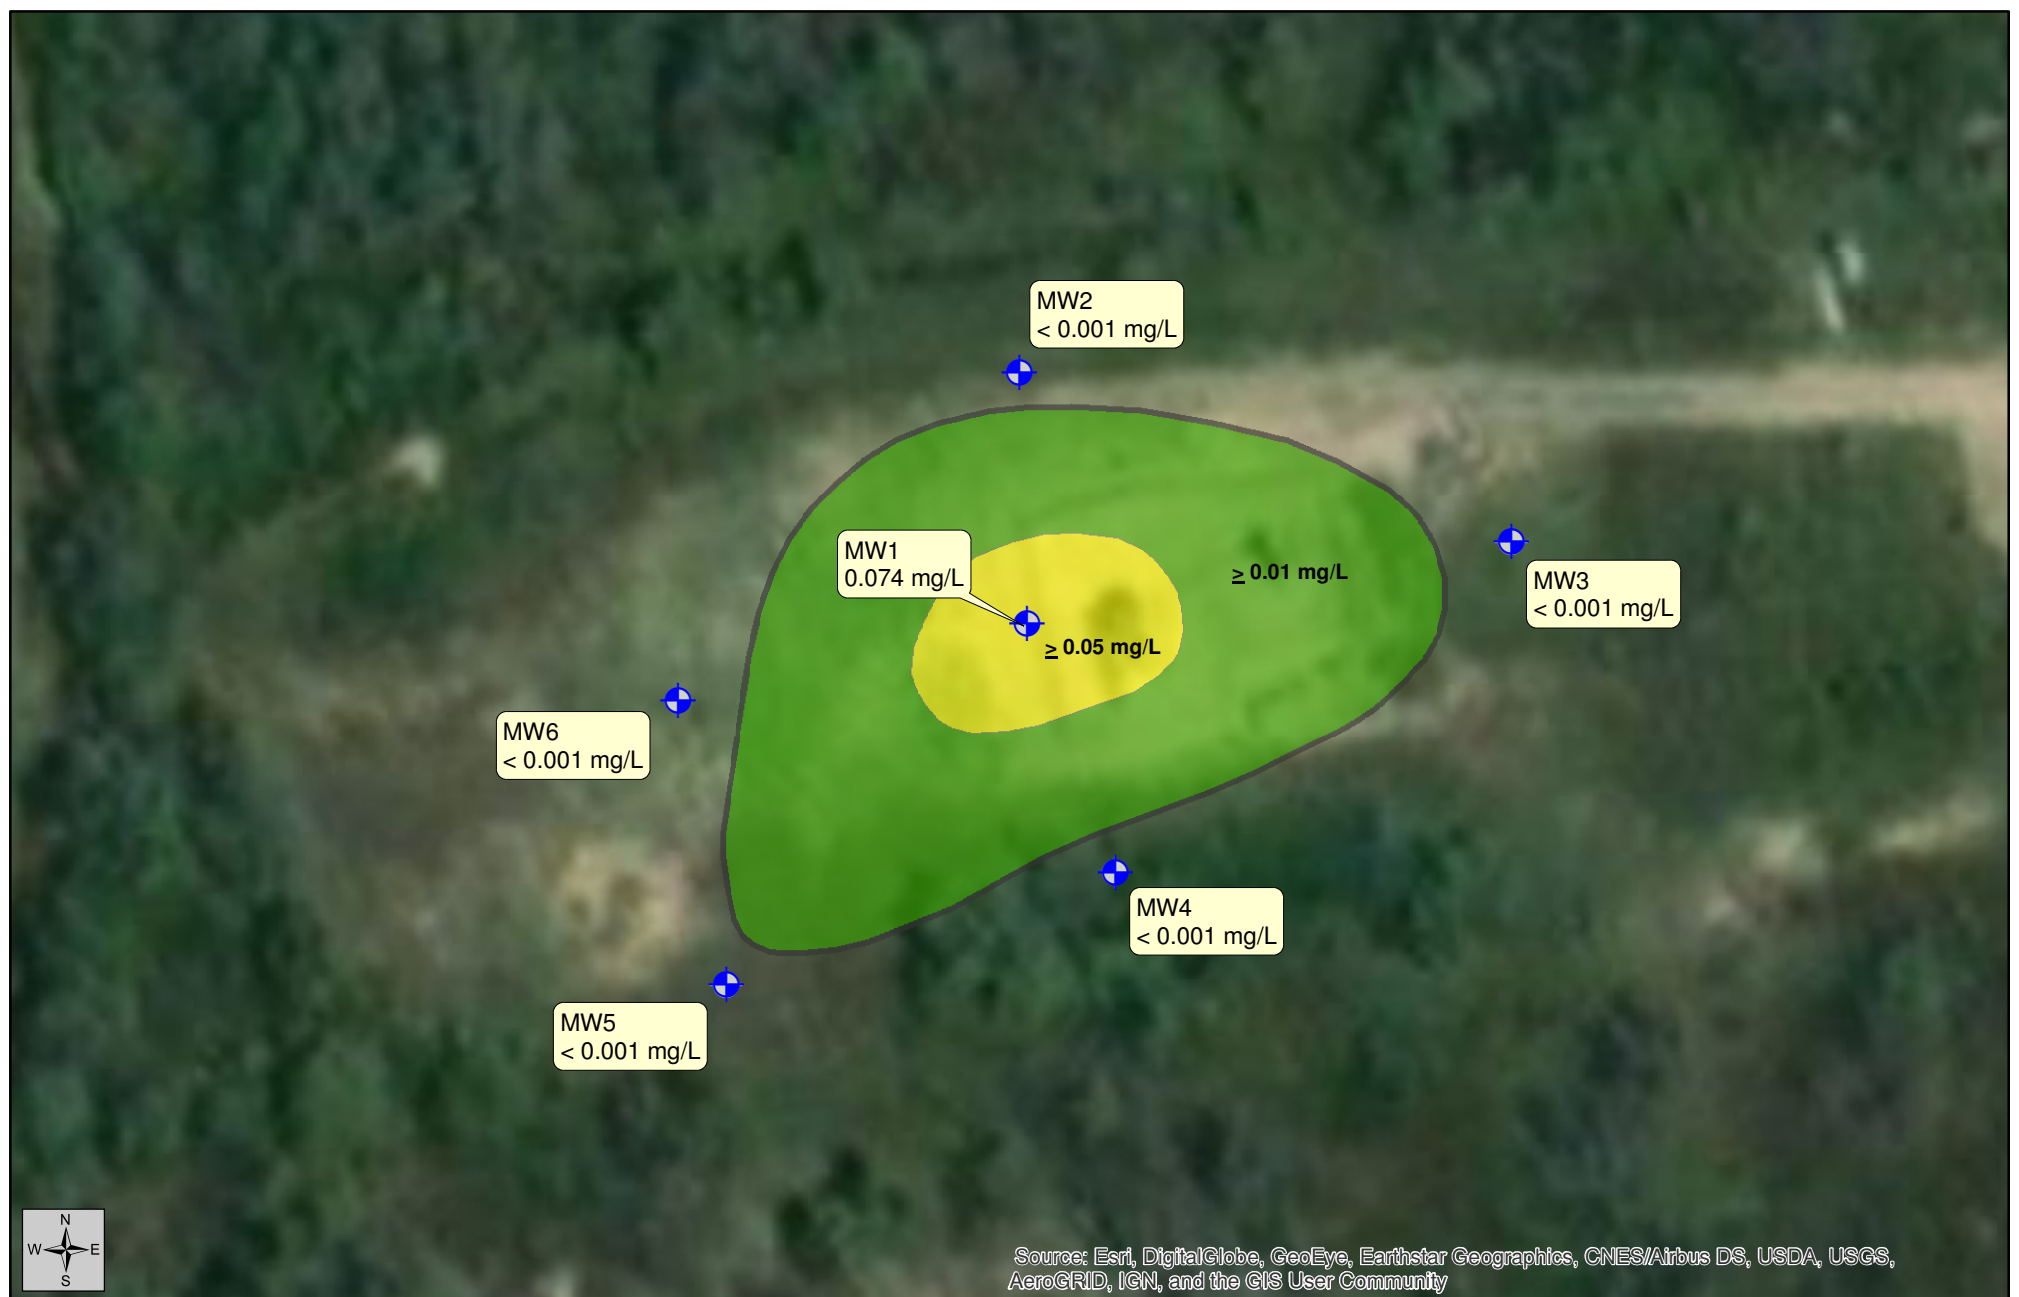
**Figure 7**  
Benzene Isoconcentration Map

Benzene was the only COC identified within Site groundwater. Benzene was observed in only 1 well (i.e., MW1) situated adjacent and downgradient of the point of release. Benzene was horizontally delineated. A benzene isoconcentration map is provided in Figure 7.

- Monitor Well
- Benzene: ≥ 0.01 mg/L
- Benzene: ≥ 0.05 mg/L

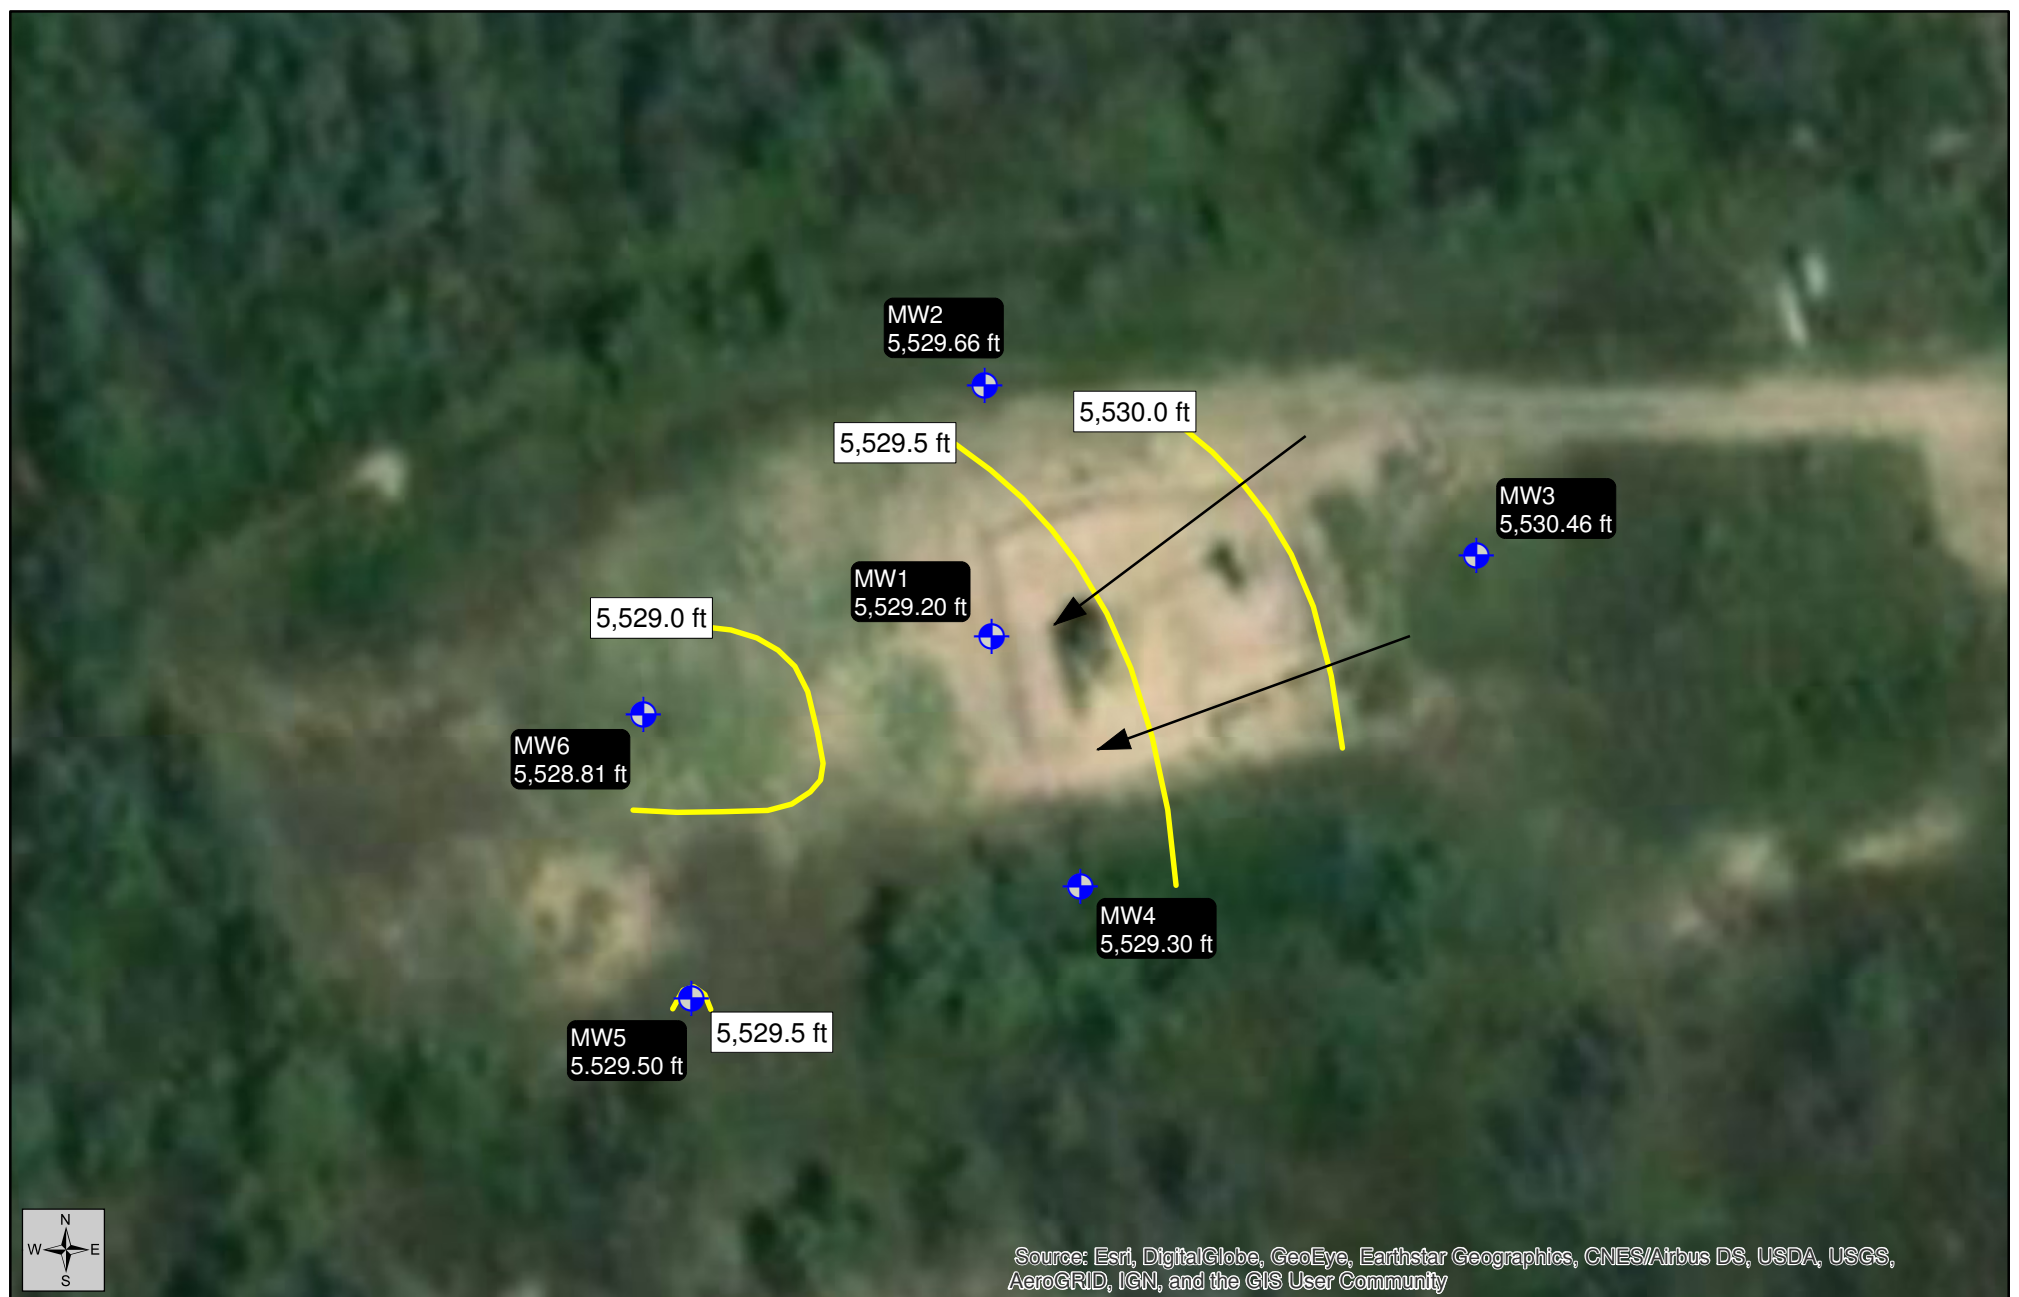
**Figure 8**  
Potentiometric Surface Map

Each well was gauged to determine the depth to water using an oil-water interface probe capable of measuring to the nearest one-hundredth foot. No phase separated hydrocarbons (PSH) were observed. An elevation survey was conducted on the tops of monitor well casings using a survey rod and laser level transit. Depths to groundwater were subtracted from the corresponding monitor well elevation to determine the depth of groundwater above mean sea level in each well.

- Monitor Well
- Groundwater Gradient
- Groundwater Flow

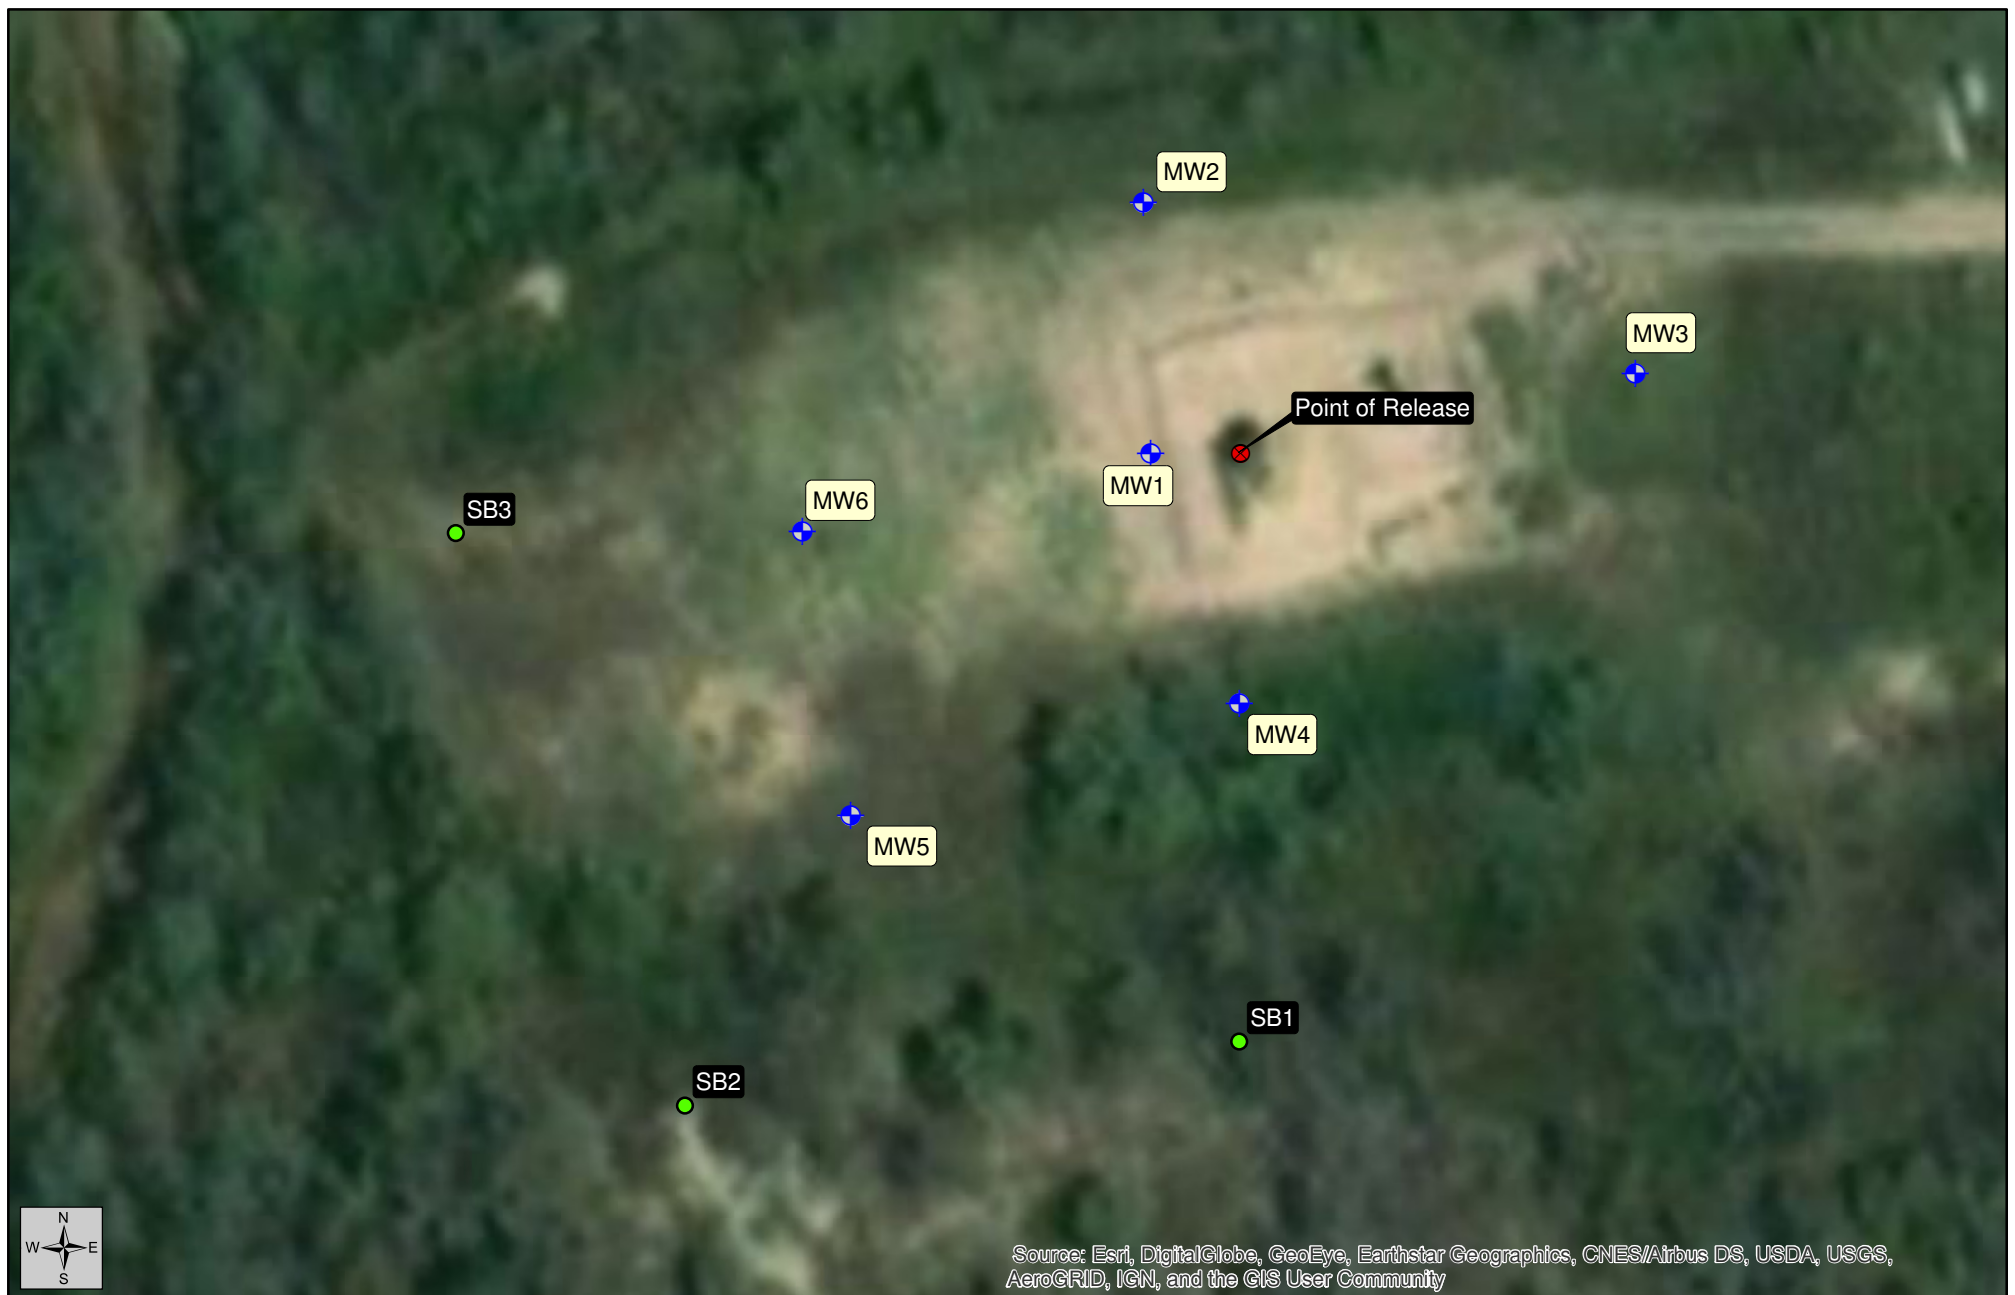
**Figure 9**  
Proposed Soil Boring Locations

- ✕ Point of Release
- ◆ Monitor Well
- Proposed Soil Boring

The soil assessment revealed TPH was not horizontally delineated to the south, southwest or west of the point of release. Timberwolf recommends installation of 3 soil borings to approximately 10 ft bgs to achieve horizontal delineation of TPH in soil. The proposed boring locations are shown in Figure 10.
