Release Notification

Site Name Haney Gas Com B 1E	Site Type Gas Well
Date Release Discovered 3/10/2019	API# (if applicable) 30-045-24646

Executive Summary

On March 10, 2019 Hilcorp Energy had a release of 21 bbls of produced water and 1 bbl of oil at the Haney Gas Com B 1E. The release was due to the pit tank running over because well redelivery flow back fluids were underestimated. A vac truck was able to recover approximately 20 bbls of the released liquid. Most of the liquids were contained in the berm and on the liner. Approximately 2 bbls of liquid went off the liner to the south. Impacted soil was removed and taken to landfarm.

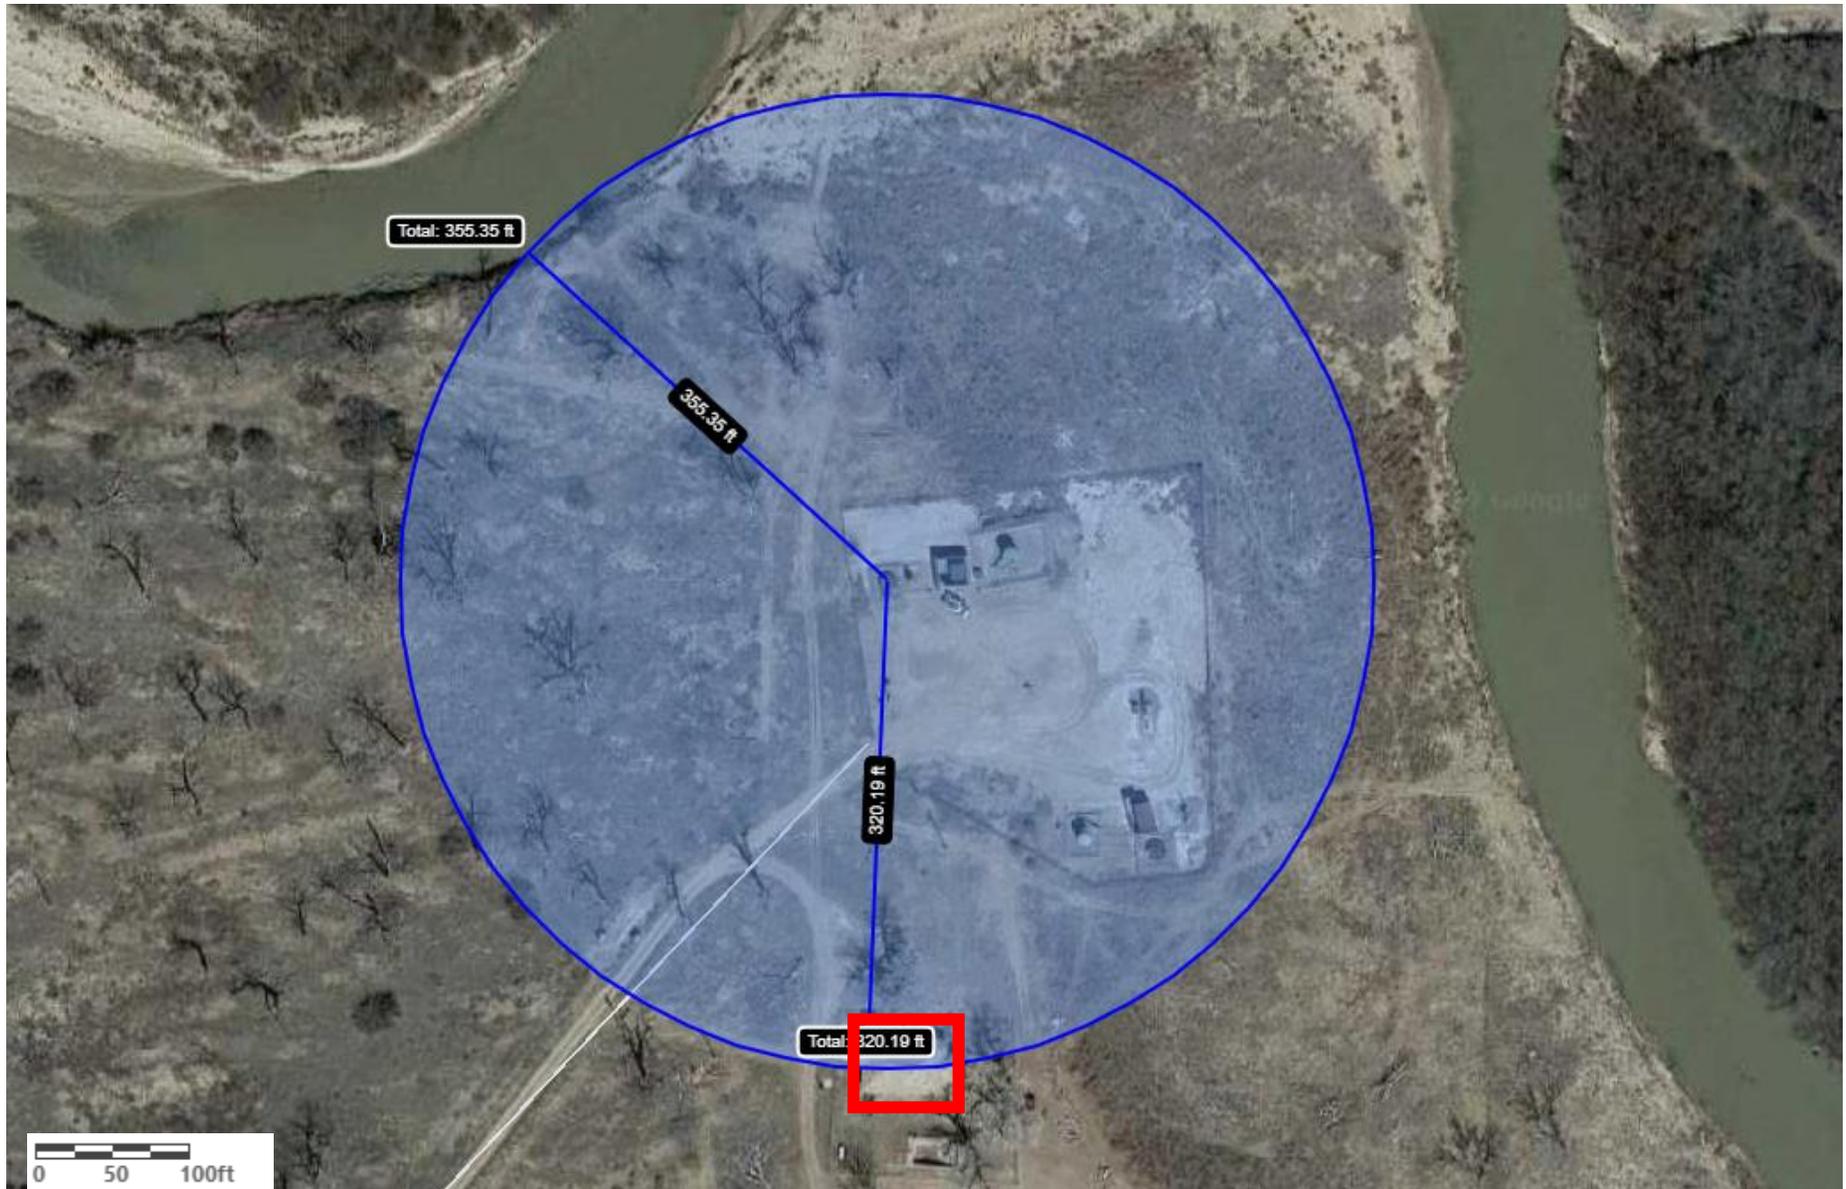
Distance to watercourse and occupied permanent residence

Occupied residence

Distance to watercourse 355.35 ft and to occupied residence 320.19 ft

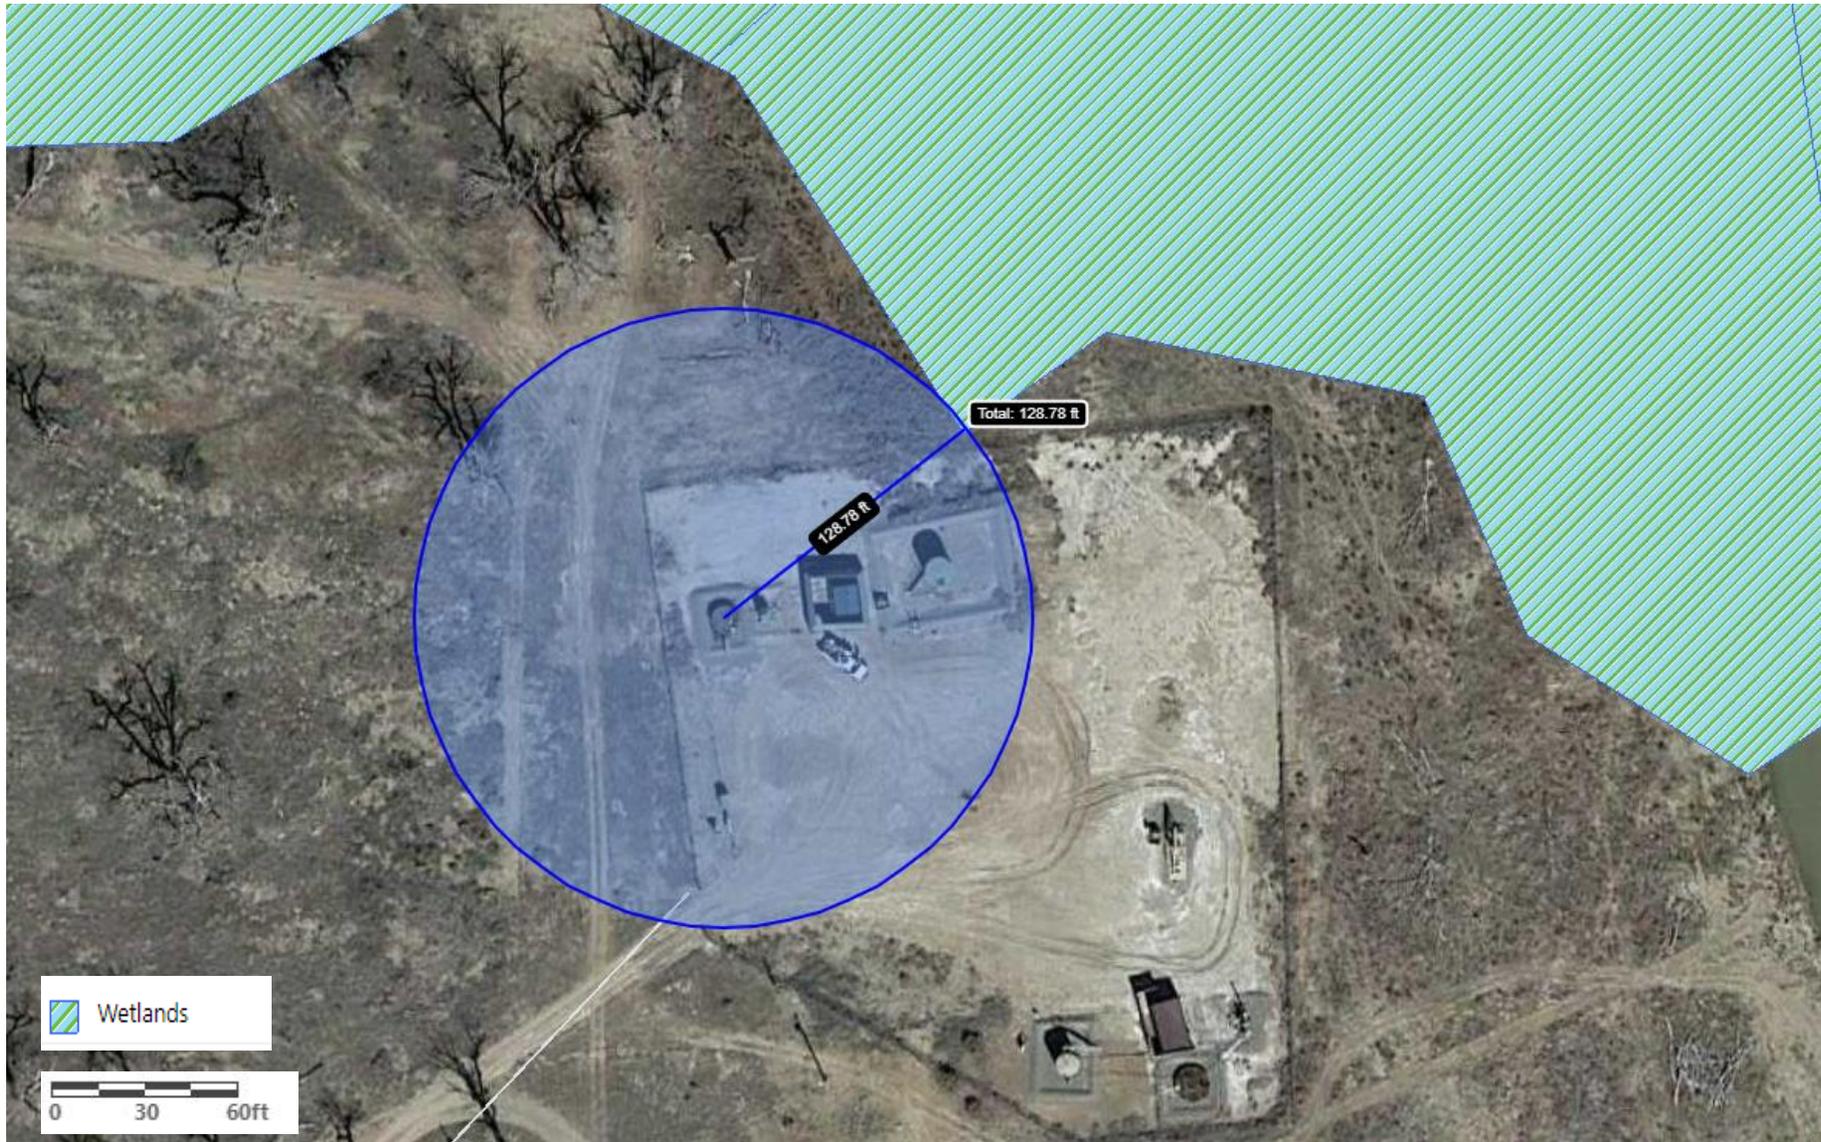
Depth to groundwater < 50ft based on water depth of wells within surrounding 9 sections of the Haney Gas Com B 1E

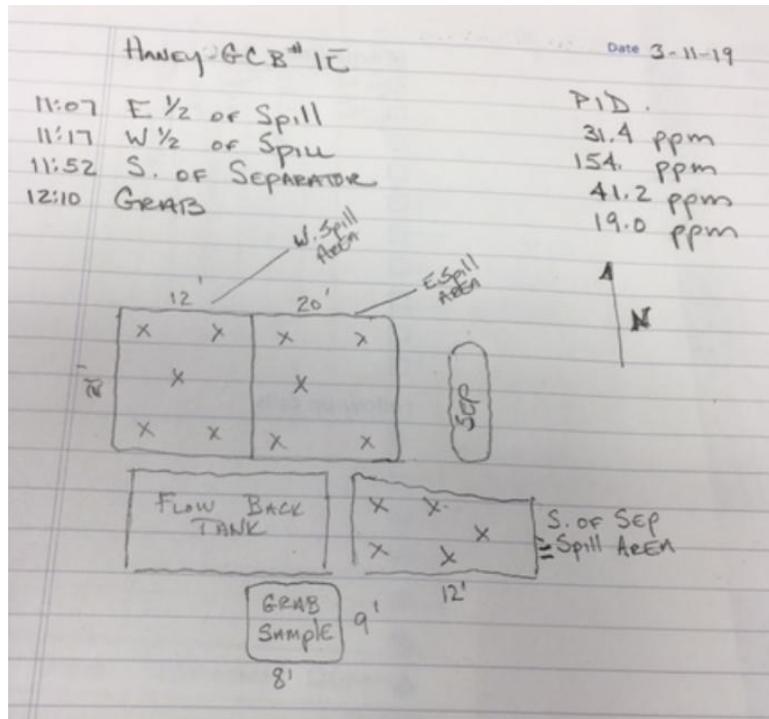
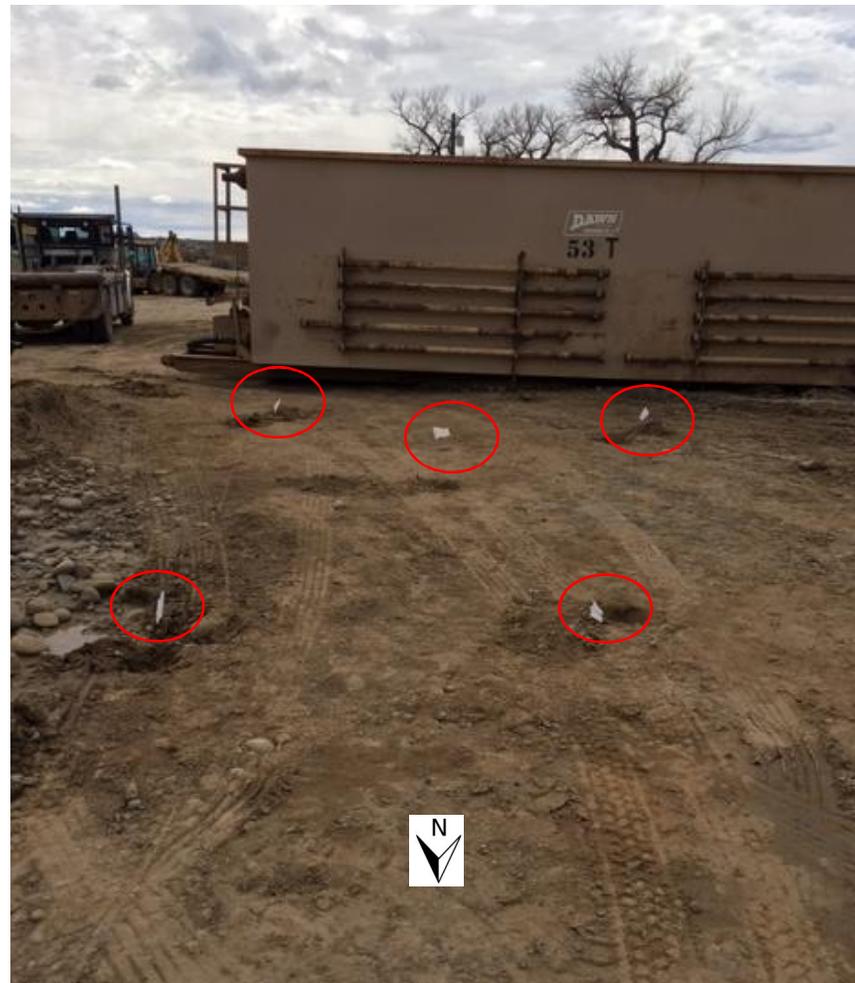
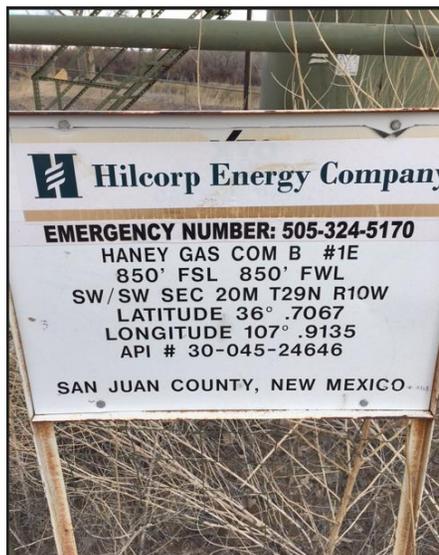
Sample locations/field notes

East spill area sample locations

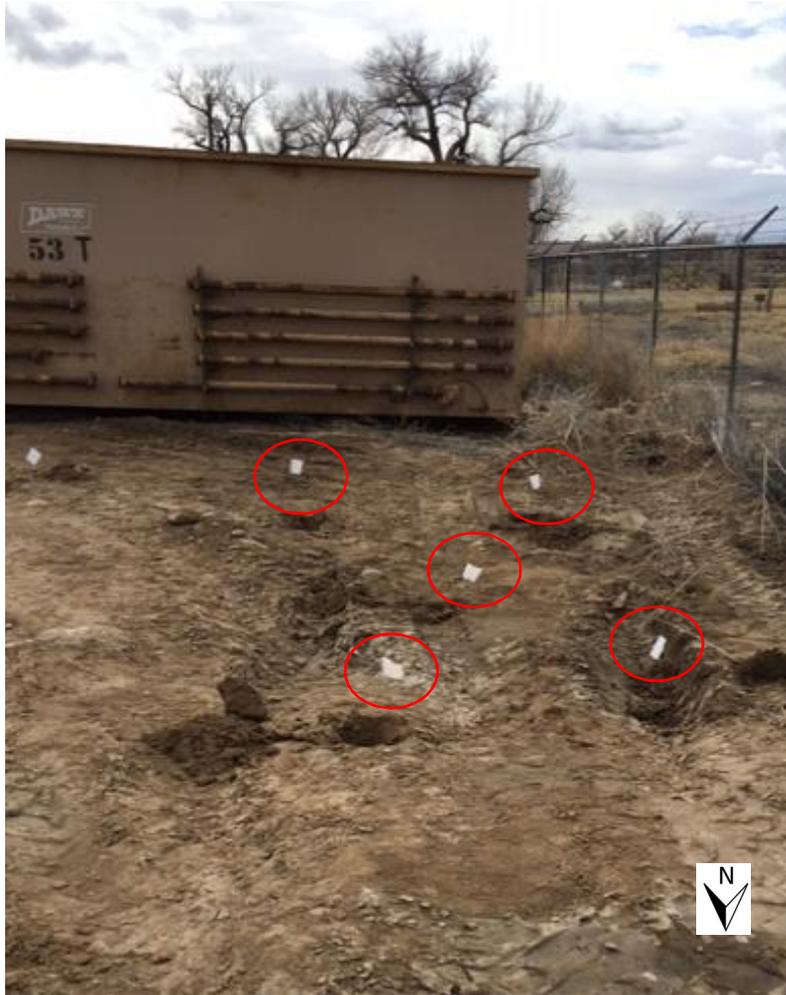
West spill area sample locations

This site is ranked >50 ft per NMAC 19.15.29.12.E. Two of the four samples came back above NMOCD clean up standards (area west of release and grab sample). Additional impacted soil was remove and samples were retaken on April 3, 2019 and came back in compliance with clean up action levels.

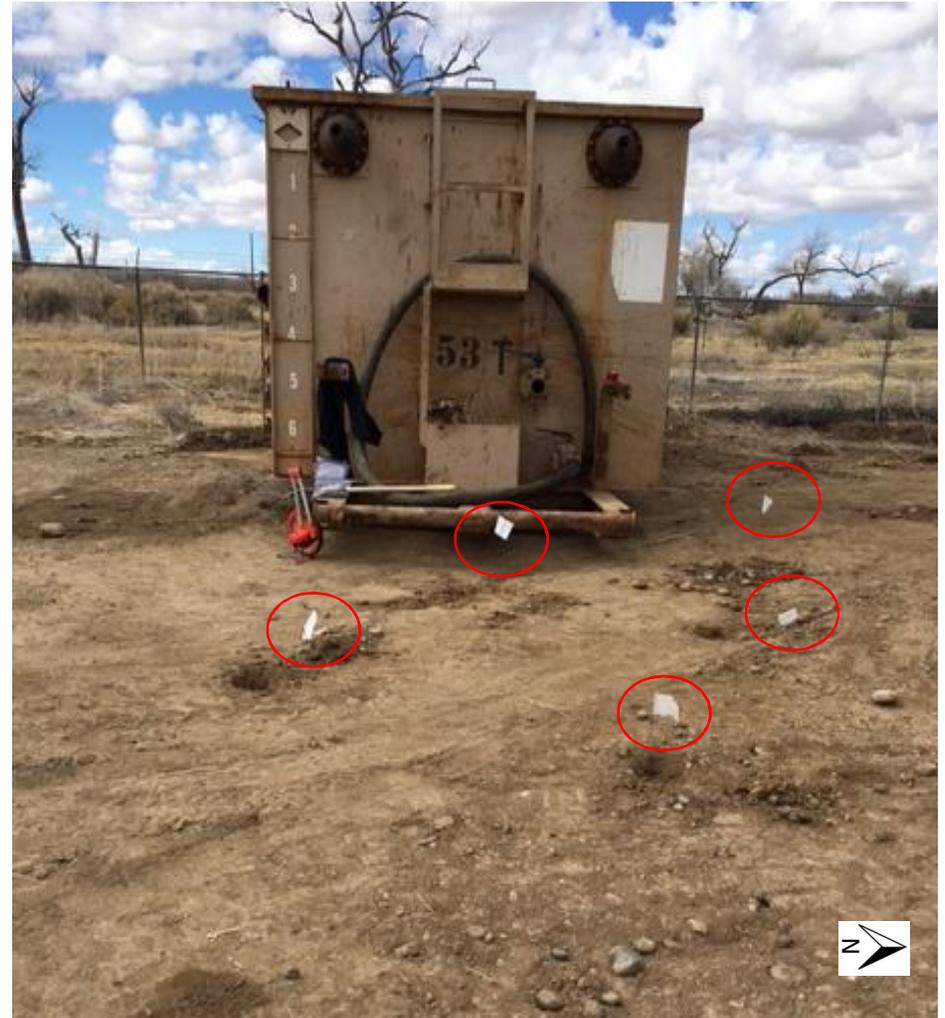
South spill area sample locations

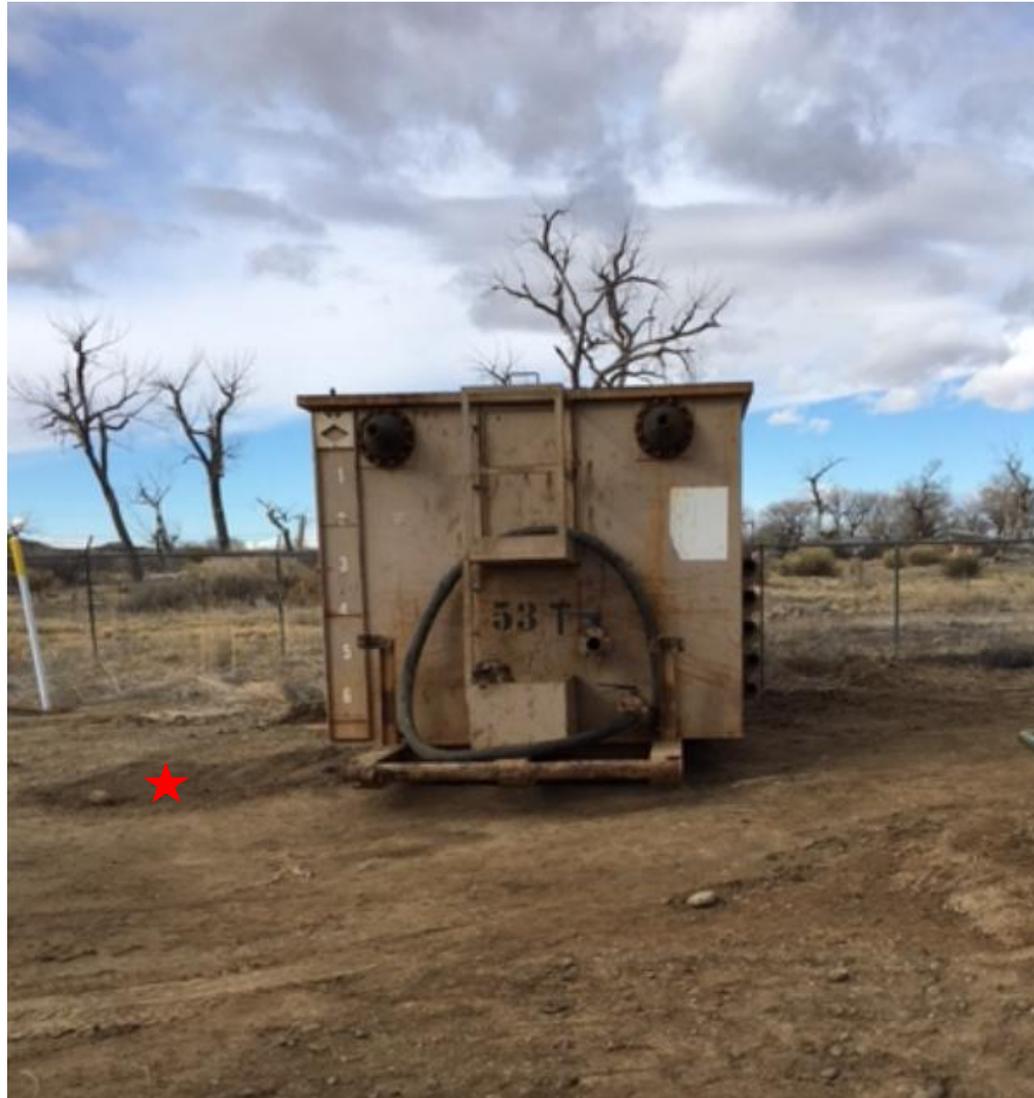
Grab sample location
