Release Notification

**RE: Excavation Clearance Report
South Blanco Federal 23-3
API# 30-045-28163
Incident No. NCS 1826951457
SW¼ SE¼, Section 23, T24N, R8W
San Juan County, New Mexico**

TOPOGRAPHIC SITE LOCATION MAP

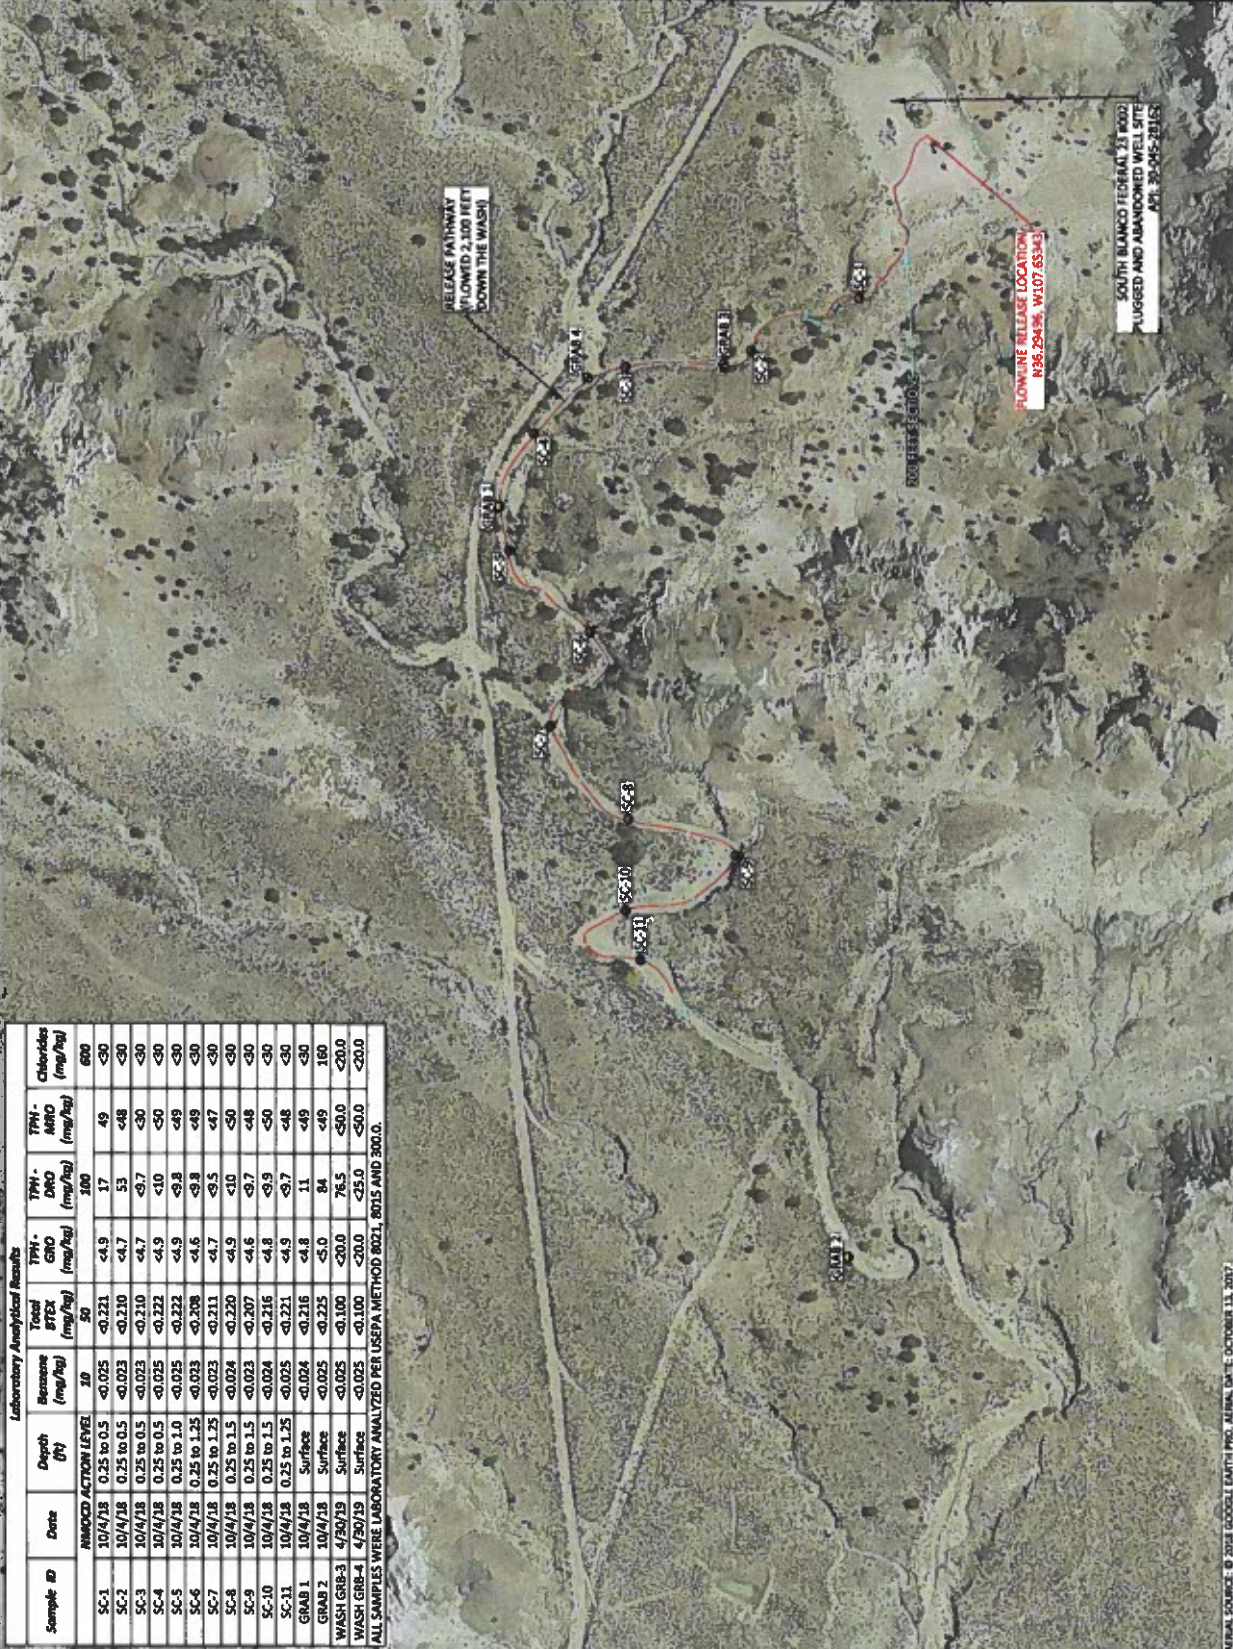
FIGURE 3

**WASH COMPOSITE SAMPLE LOCATIONS
OCTOBER 2018 AND APRIL 2019**

Laboratory Analytical Results									
Sample ID	Date	Depth (ft)	Benzene (mg/kg)	Total PTEX (mg/kg)	TPH - GNO (mg/kg)	TPH - DNO (mg/kg)	TPH - ARO (mg/kg)	Chlorides (mg/kg)	
NIMCO ACTION LEVEL									
			10	50	100	100		600	
SC-1	10/4/18	0.25 to 0.5	<0.025	<0.221	<4.9	17	49	<30	
SC-2	10/4/18	0.25 to 0.5	<0.023	<0.210	<4.7	53	<48	<30	
SC-3	10/4/18	0.25 to 0.5	<0.023	<0.210	<4.7	<3.7	<30	<30	
SC-4	10/4/18	0.25 to 0.5	<0.025	<0.222	<4.9	<1.0	<30	<30	
SC-5	10/4/18	0.25 to 1.0	<0.025	<0.222	<4.9	<3.8	<49	<30	
SC-6	10/4/18	0.25 to 1.25	<0.023	<0.208	<4.6	<3.8	<49	<30	
SC-7	10/4/18	0.25 to 1.25	<0.023	<0.211	<4.7	<3.5	<47	<30	
SC-8	10/4/18	0.25 to 1.5	<0.024	<0.220	<4.9	<1.0	<50	<30	
SC-9	10/4/18	0.25 to 1.5	<0.023	<0.207	<4.6	<3.7	<48	<30	
SC-10	10/4/18	0.25 to 1.5	<0.024	<0.216	<4.8	<3.9	<50	<30	
SC-11	10/4/18	0.25 to 1.25	<0.025	<0.221	<4.9	<3.7	<48	<30	
GRAB 1	10/4/18	Surface	<0.024	<0.216	<4.8	11	<49	<30	
GRAB 2	10/4/18	Surface	<0.025	<0.225	<5.0	84	<49	160

WASH GRB-3	4/30/19	Surface	<0.025	<0.100	<20.0	76.5	<50.0	<20.0	
WASH GRB-4	4/30/19	Surface	<0.025	<0.100	<20.0	<25.0	<50.0	<20.0

Laboratory analytical results for the final clearance samples were below applicable action levels for benzene, total BTEX, TPH (as GRO, DRO, and MRO), and chlorides, except for SC-3, which was collected near the flowline on April 30, 2019. Sample results at this location showed 1,990 mg/kg chlorides. Subsequent sampling near the SC-3 location was conducted on May 31, 2019, and these samples, SC-1 (Upper) and SC-2 (Lower), showed chloride concentrations of 523 mg/kg and 566 mg/kg, respectively. Laboratory analytical results are summarized on Figures 3 and 4, and laboratory analytical reports are attached.

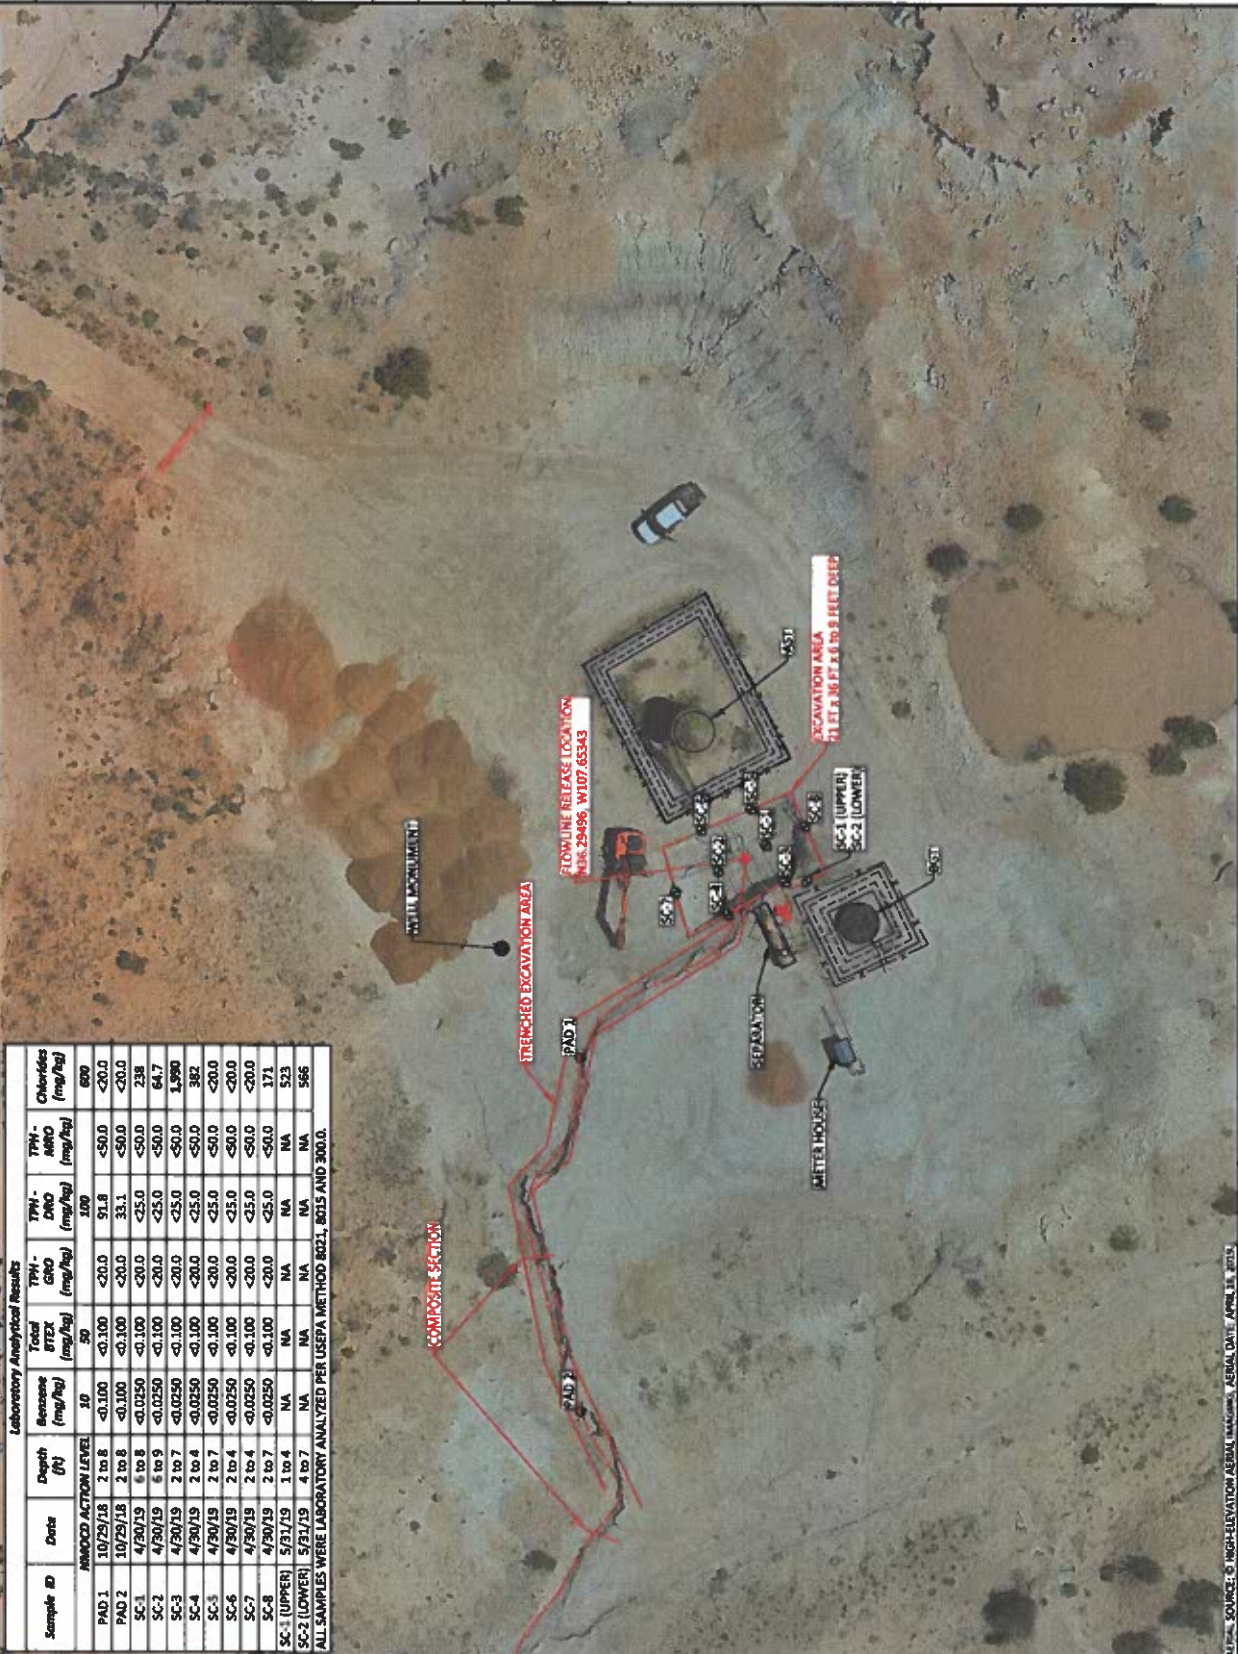
FIGURE 4

**SITE LOCATION COMPOSITE
SAMPLE LOCATIONS
OCTOBER 2018, APRIL AND MAY 2019**
DIR OPERATING
SOUTH BLANCO FEDERAL 23 M003
API: 30-045-38163
SW¼ SE¼ SECTION 23, T24N, R8W
SAN JUAN COUNTY, NEW MEXICO
N36.29420, W107.64853

Laboratory Analytical Results									
Sample ID	Date	Depth (ft)	Benzenes (mg/kg)	Total BTEX (mg/kg)	TPH - GND (mg/kg)	TPH - DND (mg/kg)	TPH - AMRO (mg/kg)	Chlorides (mg/kg)	
NMIQCD ACTION LEVEL									
PAD 1	10/29/18	2 to 8	<0.100	<0.100	<20.0	91.8	<50.0	<20.0	600
PAD 2	10/29/18	2 to 8	<0.100	<0.100	<20.0	33.1	<50.0	<20.0	
SC-1	4/30/19	6 to 8	<0.0250	<0.100	<20.0	<25.0	<50.0	238	
SC-2	4/30/19	6 to 9	<0.0250	<0.100	<20.0	<25.0	<50.0	64.7	
SC-3	4/30/19	2 to 7	<0.0250	<0.100	<20.0	<25.0	<50.0	1,990	
SC-4	4/30/19	2 to 4	<0.0250	<0.100	<20.0	<25.0	<50.0	382	
SC-5	4/30/19	2 to 7	<0.0250	<0.100	<20.0	<25.0	<50.0	<20.0	
SC-6	4/30/19	2 to 4	<0.0250	<0.100	<20.0	<25.0	<50.0	<20.0	
SC-7	4/30/19	2 to 4	<0.0250	<0.100	<20.0	<25.0	<50.0	<20.0	
SC-8	4/30/19	2 to 7	<0.0250	<0.100	<20.0	<25.0	<50.0	171	
SC-1 (UPPER)	5/31/19	1 to 4	NA	NA	NA	NA	NA	NA	523
SC-2 (LOWER)	5/31/19	4 to 7	NA	NA	NA	NA	NA	NA	566

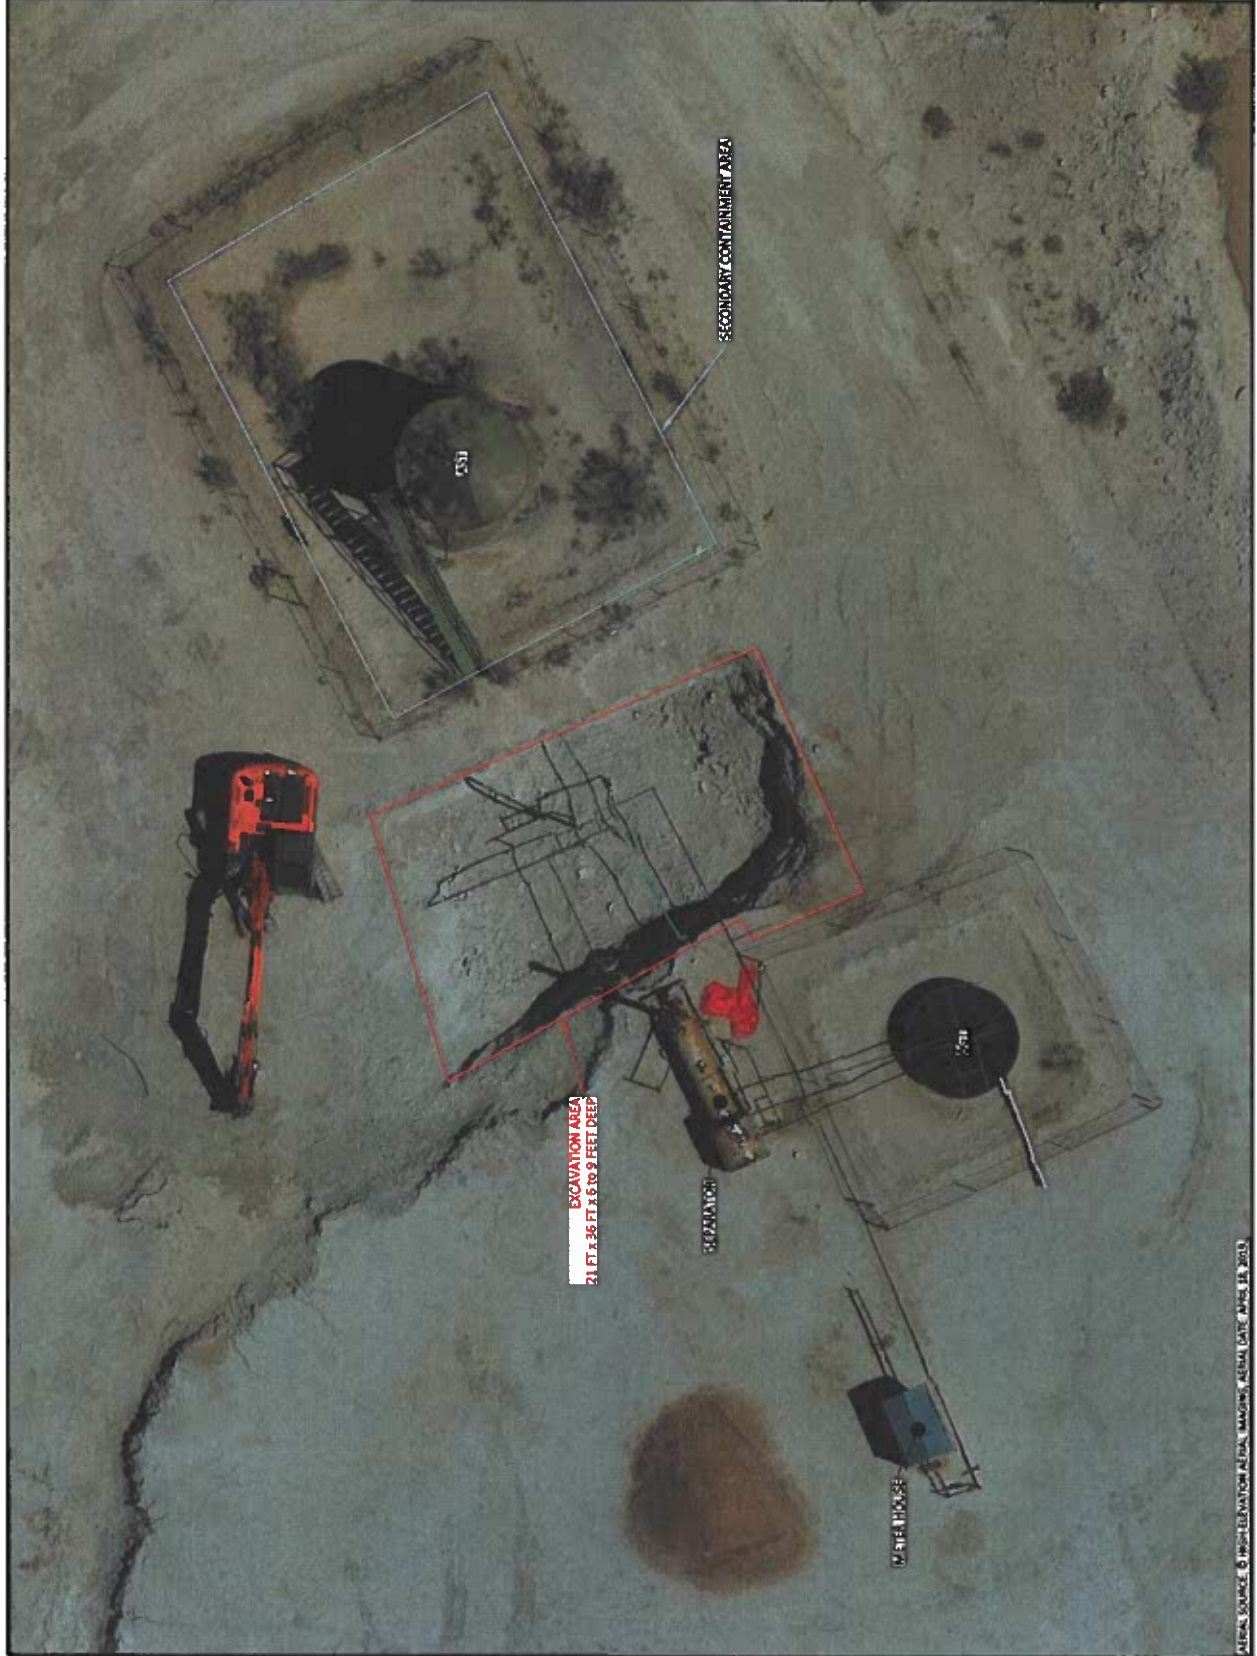
FIGURE 5

**SITE LOCATION WITH FLOWLINE
EXCAVATION AREA**
DIR OPERATING
SOUTH BLANCO FEDERAL 23 #008
API: 30-045-28153
SW¼ SE¼, SECTION 23, T4N, 18W
SAN JUAN COUNTY, NEW MEXICO
N36.29420, W107.64853

(55 yd³). Sample locations and final excavation extents are presented on Figures 3, 4, and 5, and excavation activities are documented in the photograph log. Waste disposal manifests are being maintained separately by DJR.

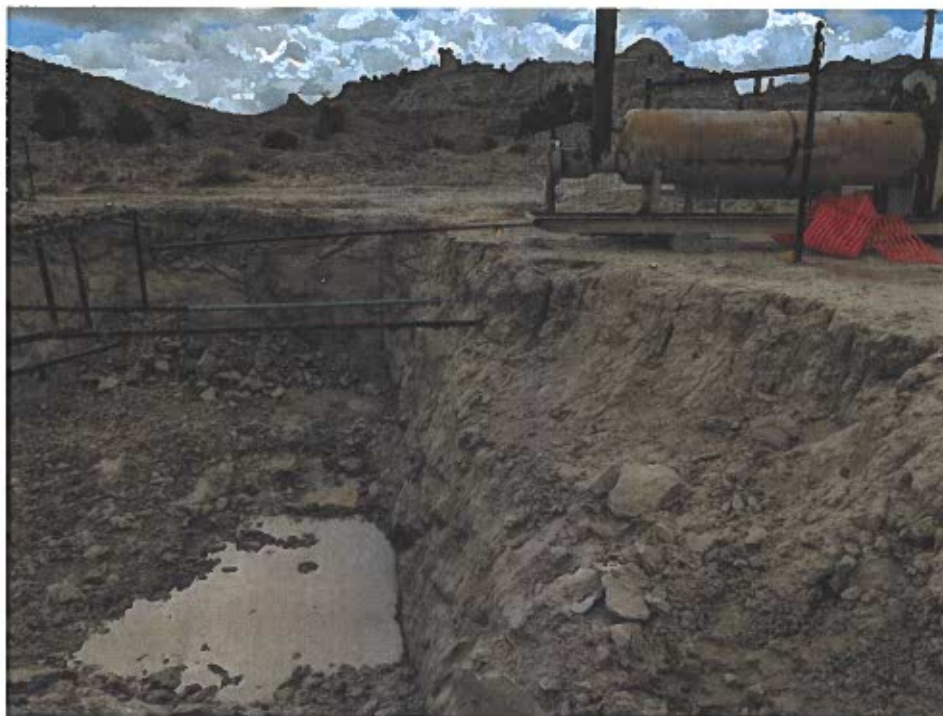
Photo 1: South excavation wall. Date taken: 4/30/19.

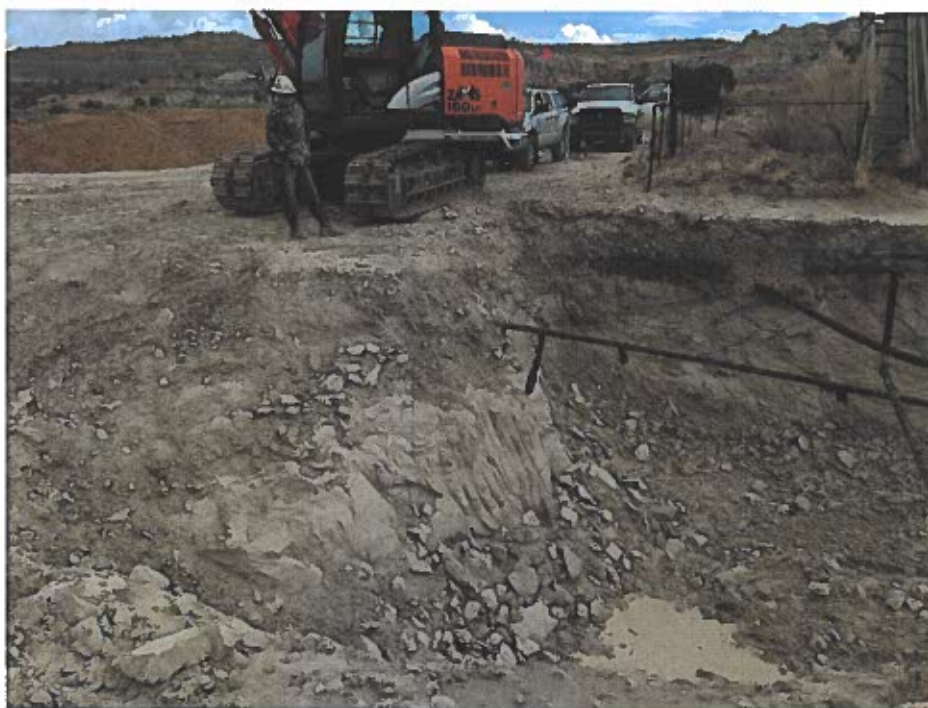
Photo 2: East (right) and north (left) excavation walls. Date taken: 4/30/19.

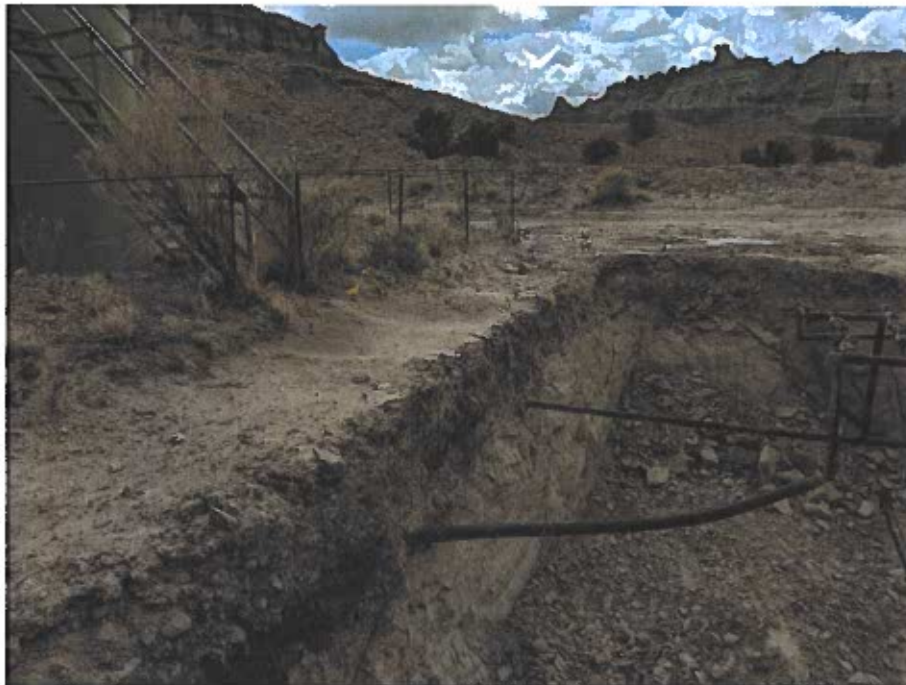
Photo 3: East (left) and south (right) excavation walls. Date taken: 4/30/2019.

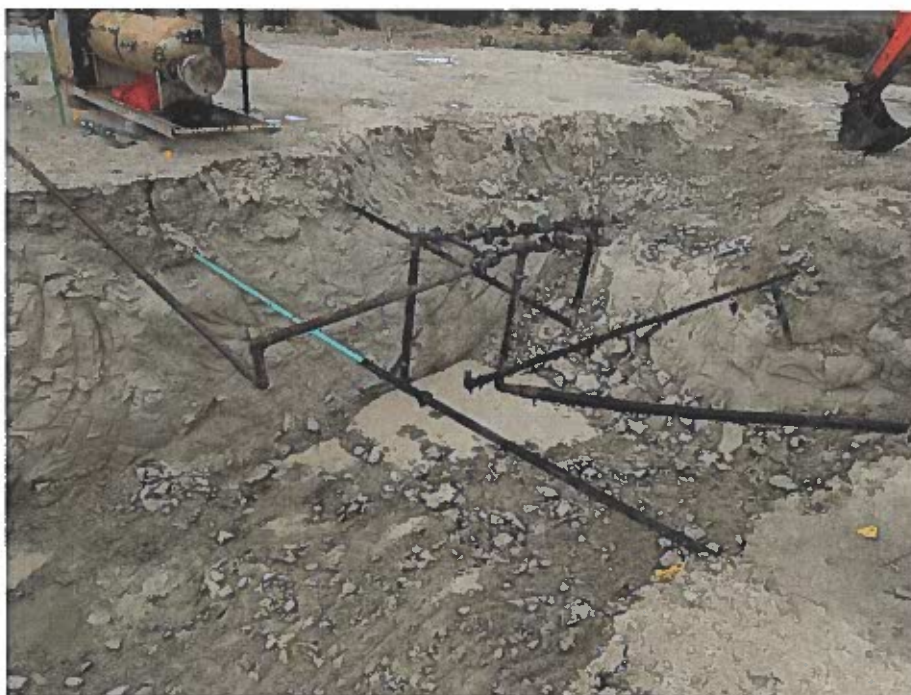
Photo 4: West (left) and north (right) excavation walls. Date taken: 4/30/2019.

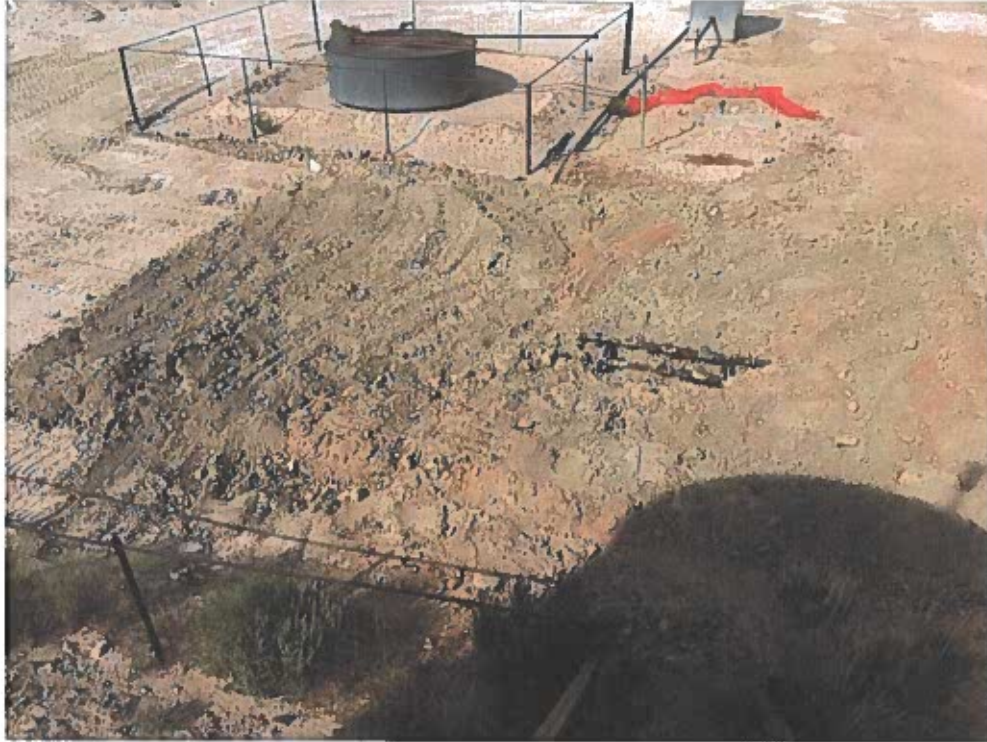
Photo 5: Completion of backfilling the excavation. Date taken: 6/10/2019.

DJR completed backfilling of the excavation area on June 3, 2019. The area is not currently scheduled for reclamation since it is part of the active well location.
