Release Notification

Site Name Huerfano #142	Site Type Gas Well
Date Release Discovered 4/16/2019	API# (if applicable) 30-045-05501

Executive Summary

On April 16, 2019 Hilcorp Energy had a release of 20 bbls of produced water and 5 bbl of oil at the Huerfano 142. The release was due to corrosion at the bottom of the tank. The liquids were contained in the berm and impacted soil below the tank. Impacted soil was removed and taken to landfarm.

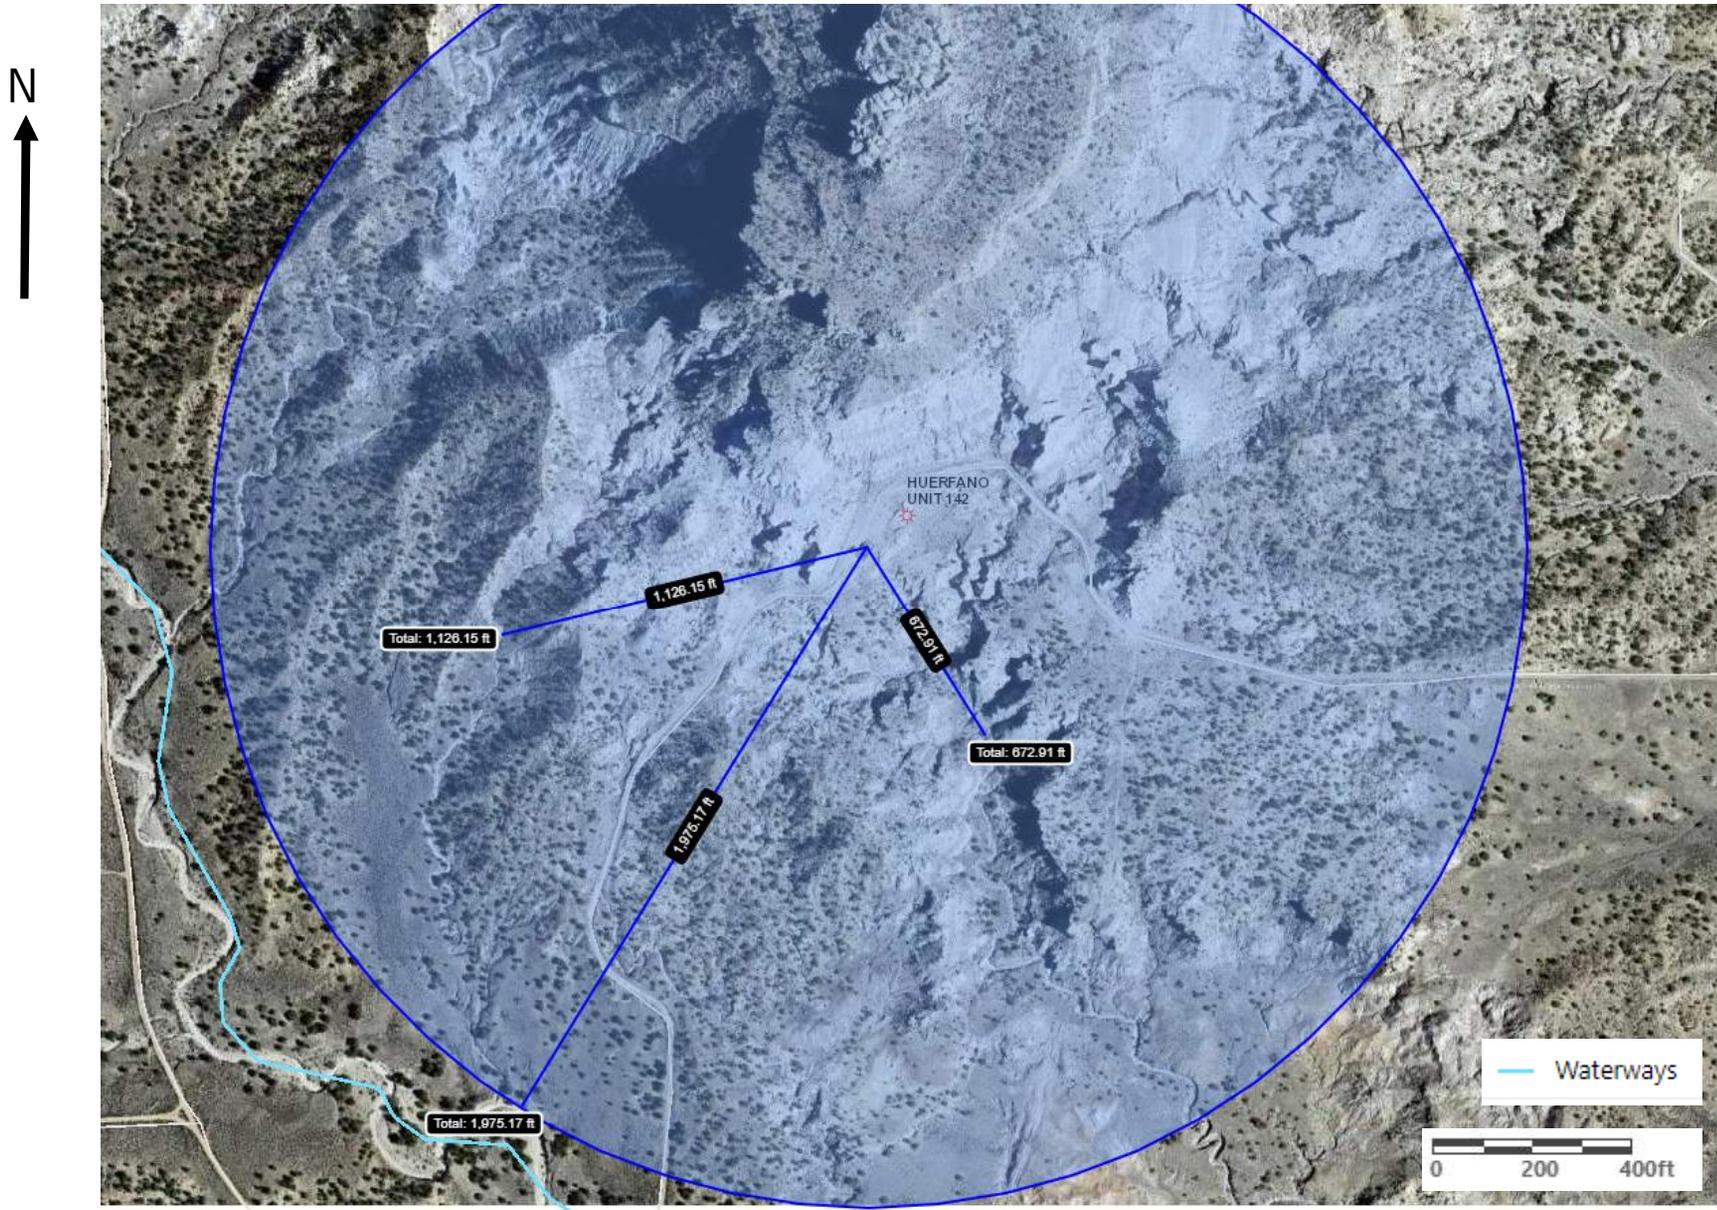
Distance to watercourse 1,975 ft and 673 ft /1,128 ft to nearby washes

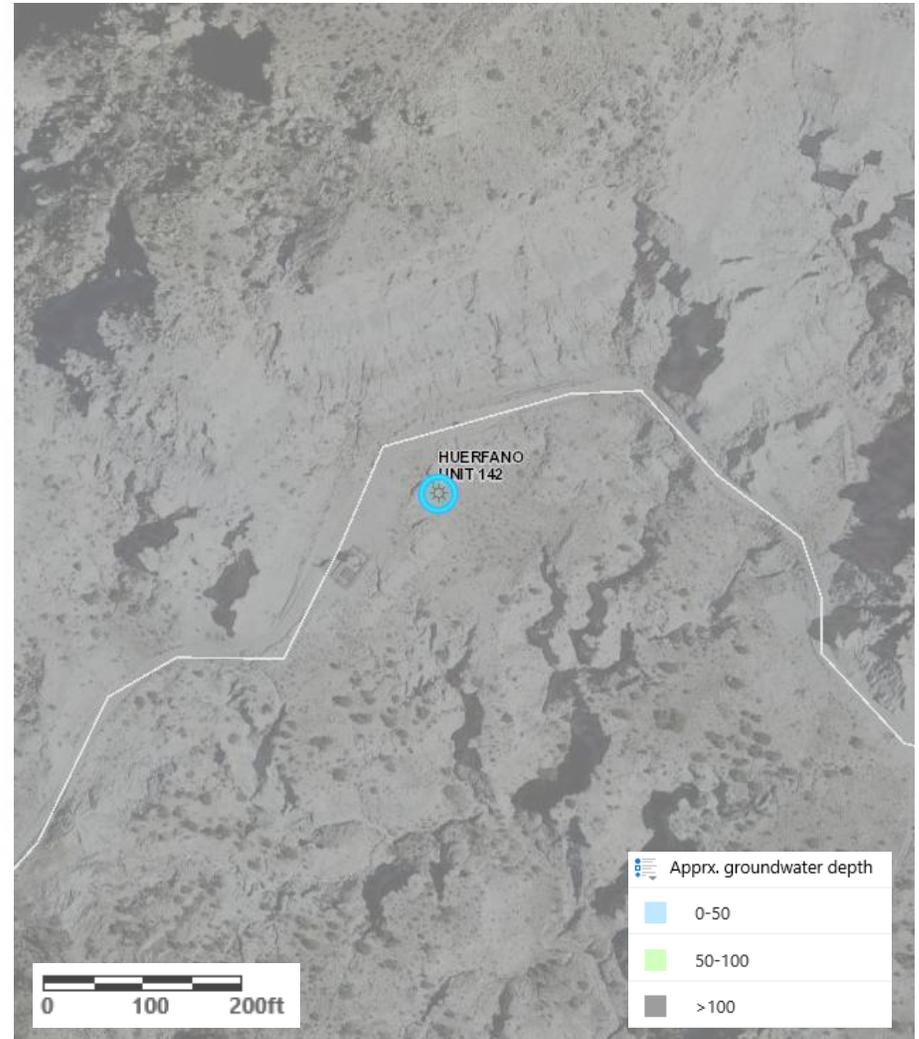
Depth to groundwater

Hilcorp mapping supports groundwater depth > 100 ft

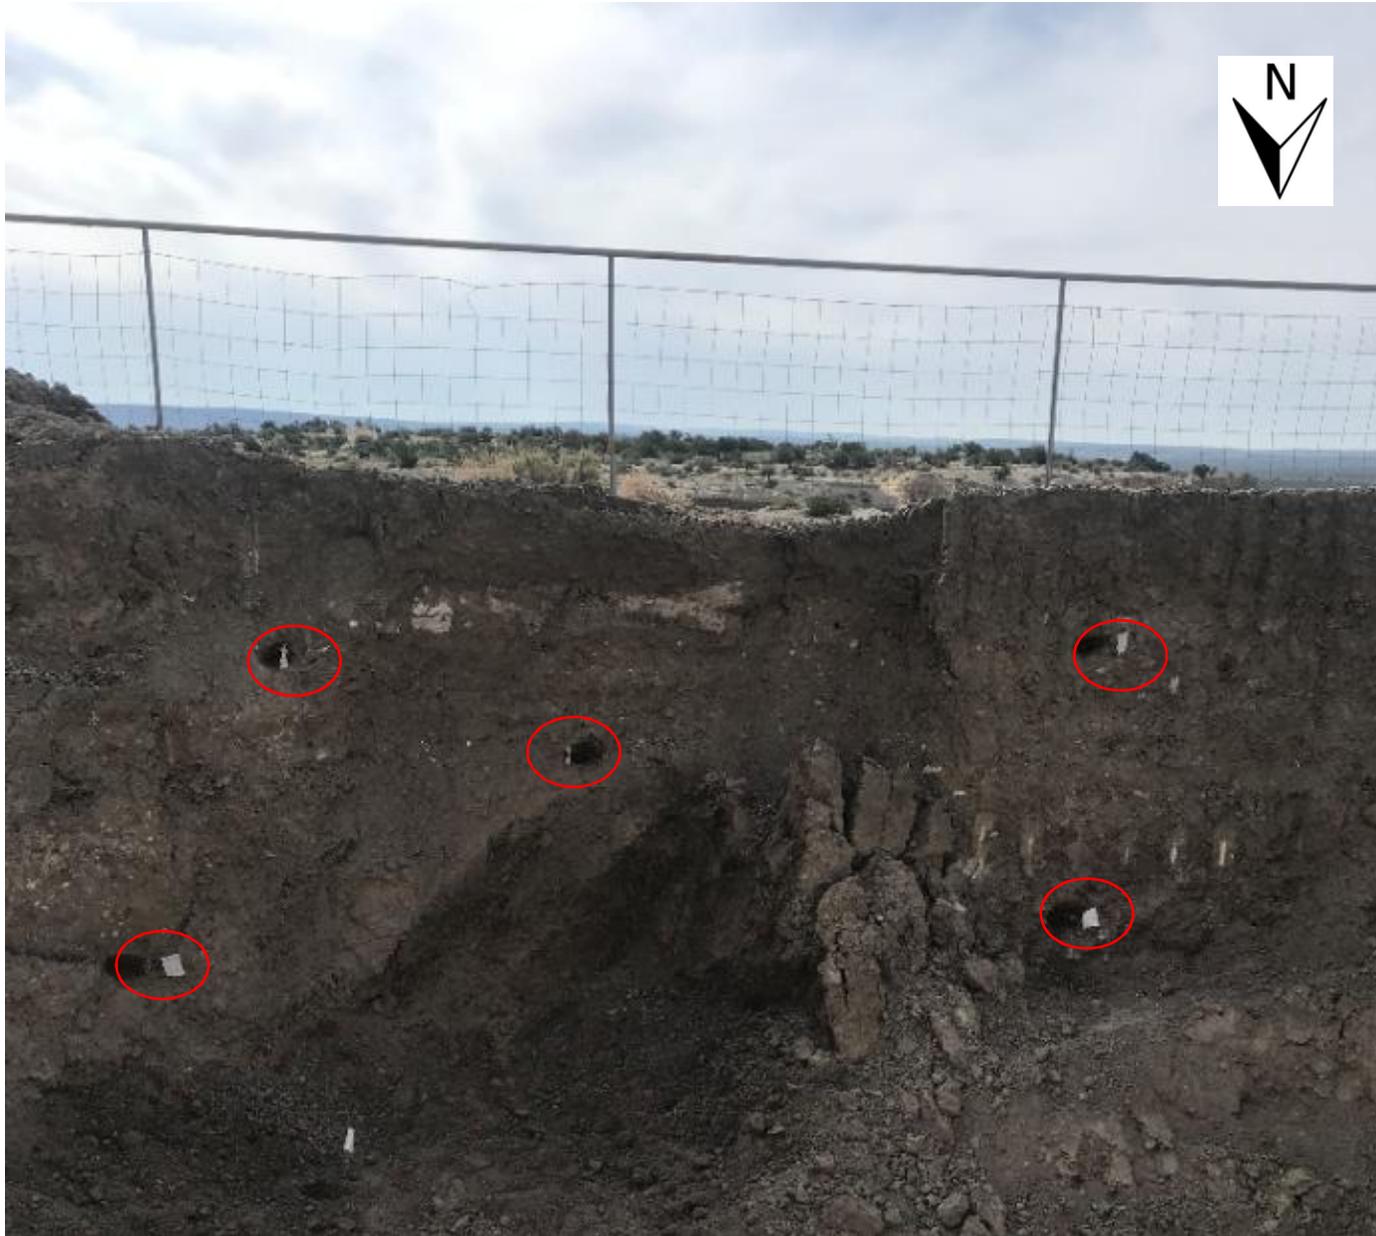
Sample locations/field notes

South wall excavation sample locations

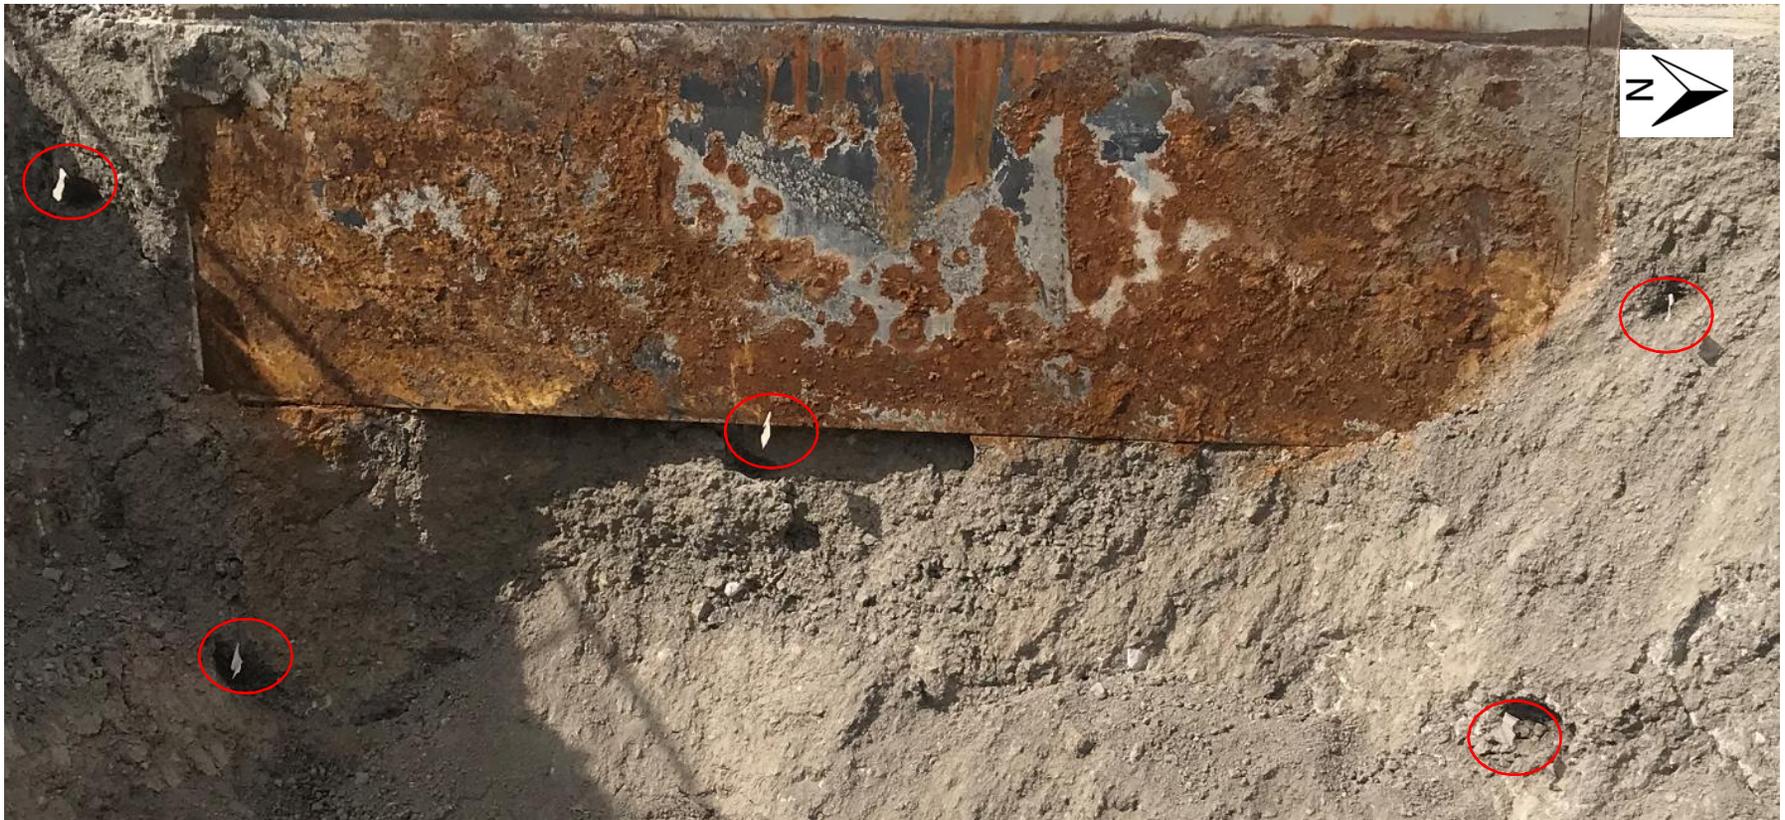
Sample locations/field notes

West wall excavation sample locations

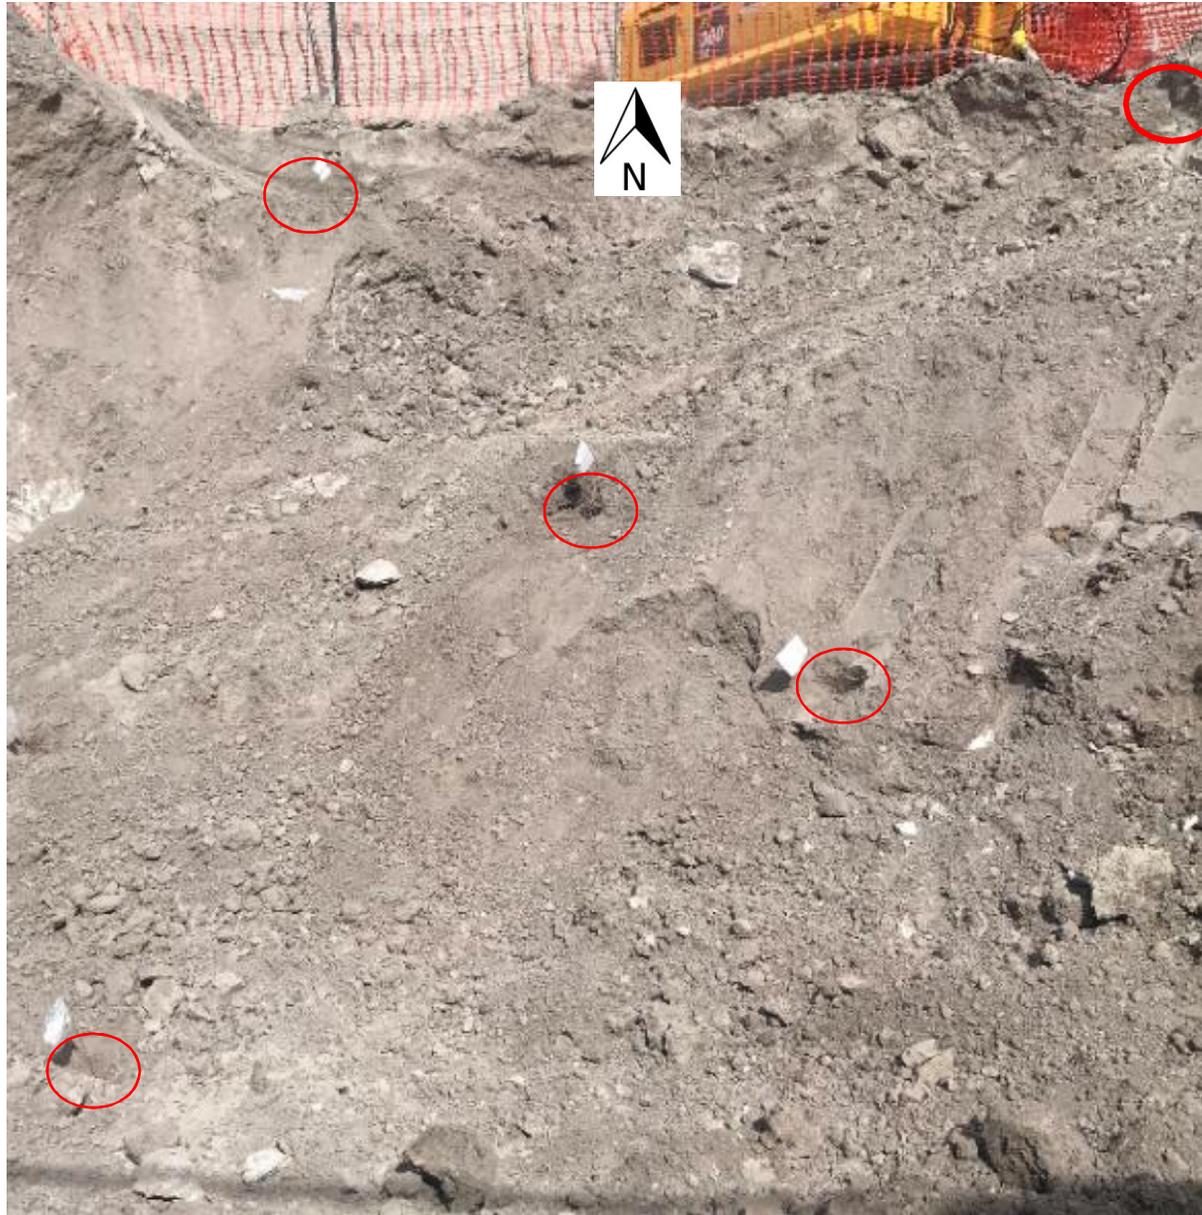
Sample locations/field notes

North wall excavation sample locations

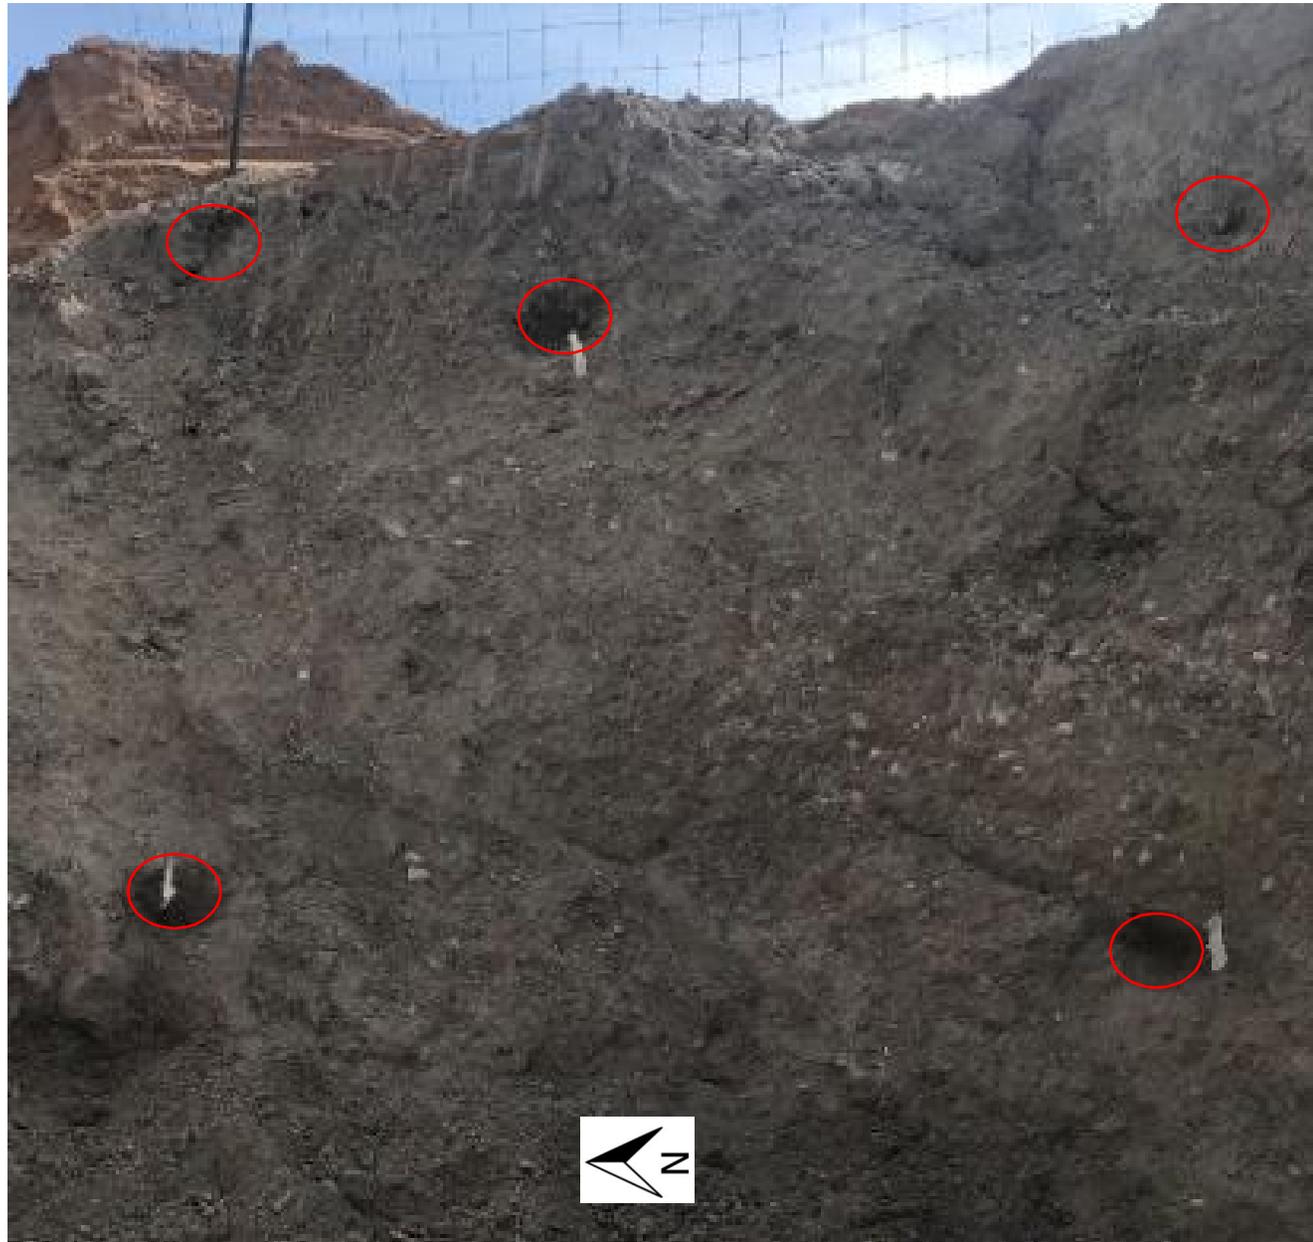
Sample locations/field notes

East wall excavation sample locations

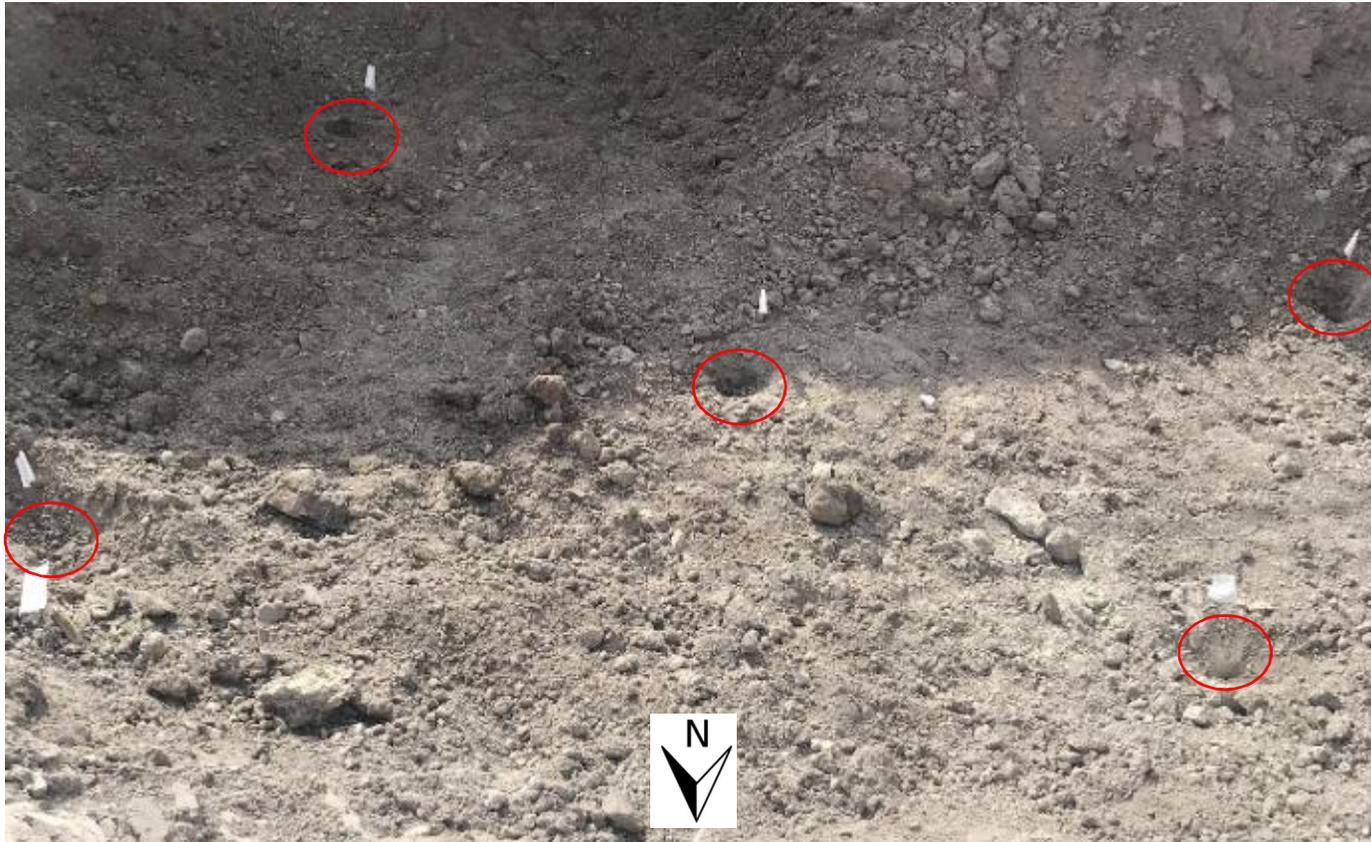
Sample locations/field notes

Base of excavation sample locations
