RE: CLOSURE REPORT FOR A RELEASE OF PRODUCED WATER LOCATED AT THE JICARILLA APACHE B 15E WELL SITE (API: 30-039-27724), RIO ARRIBA COUNTY, NEW MEXICO

RELEASE CLOSURE REPORT

**LOCATION:
JICARILLA APACHE B 15E WELL SITE
SECTION 30, TOWNSHIP 24N, RANGE 5W
RIO ARRIBA COUNTY, NEW MEXICO**

**PROJECT #17035-0090
JULY 2019**

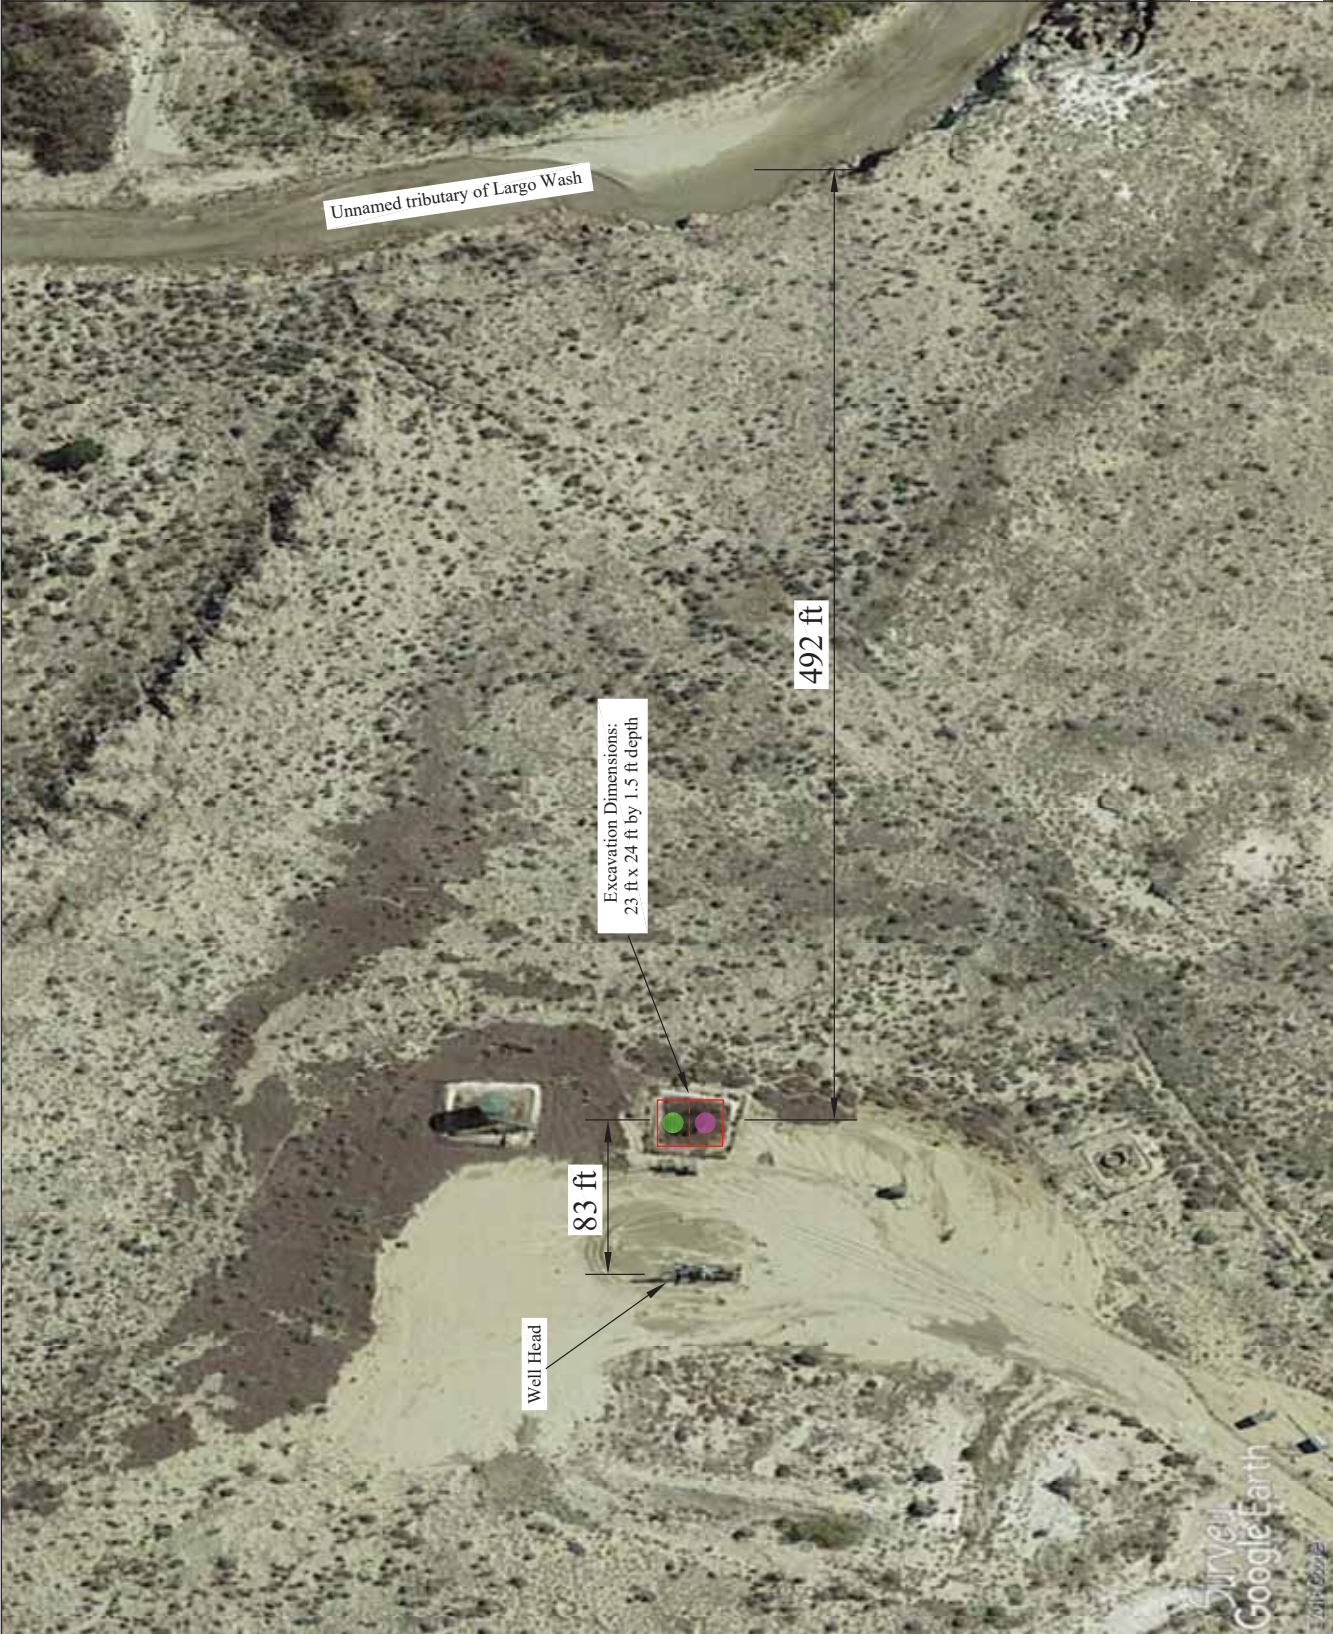
Figure 2, Site Map

The excavated area was divided into a north section (Area 1) and a south section (Area 2). One (1) five-point composite sample was collected from each section (B15E Area #1 and B15E Area #2). Samples were placed into individual laboratory provided 4-ounce jars, capped head space free, and transported on ice to Envirotech's analytical laboratory. Soil samples were analyzed for total petroleum hydrocarbons (TPH) as gasoline, diesel, and oil range organics (GRO/DRO/ORO) using EPA Method 8015D; benzene, toluene, ethylbenzene, and total xylenes (BTEX) using EPA Method 8021B; and chlorides using EPA Method 300.0. Soil sample locations are illustrated in **Figure 2, Site Map and Appendix A, Site Photography and Field Notes**.

Sample locations represent 5-point composite samples collected along the excavation walls and base

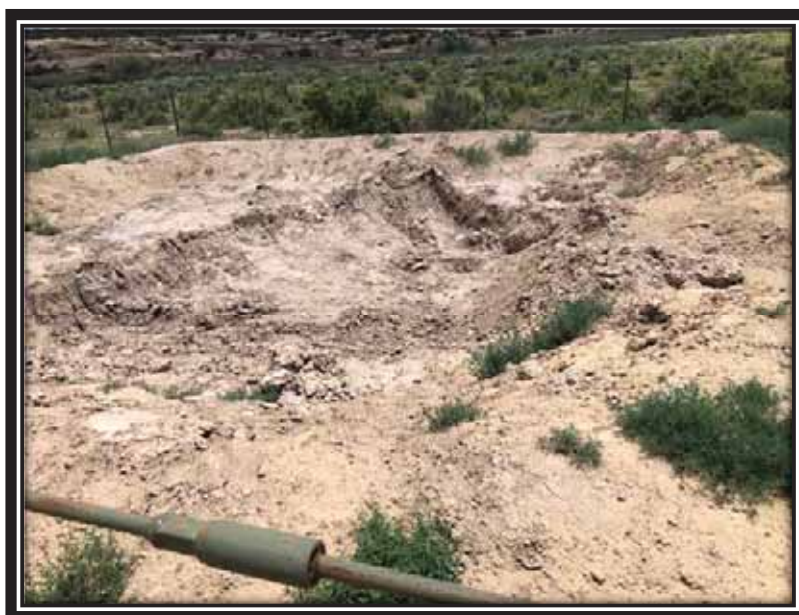
Prior to Envirotech's arrival, DJR had removed the produced water tank and excavated the contaminated soil. Excavation dimensions were approximately 23 feet by 24 feet by 1.5 feet depth. Confirmation soil samples were collected under witness of Hobson Sandoval, Jicarilla Apache Nation Oil and Gas (JOGA) representative, on July 2, 2019.

Picture 2: View of Excavation looking East

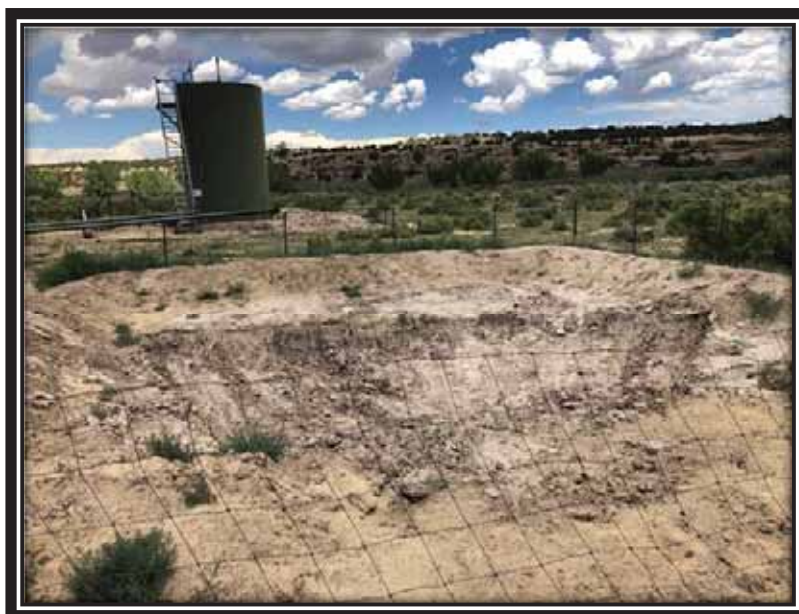
Picture 3: View of Excavation Looking North

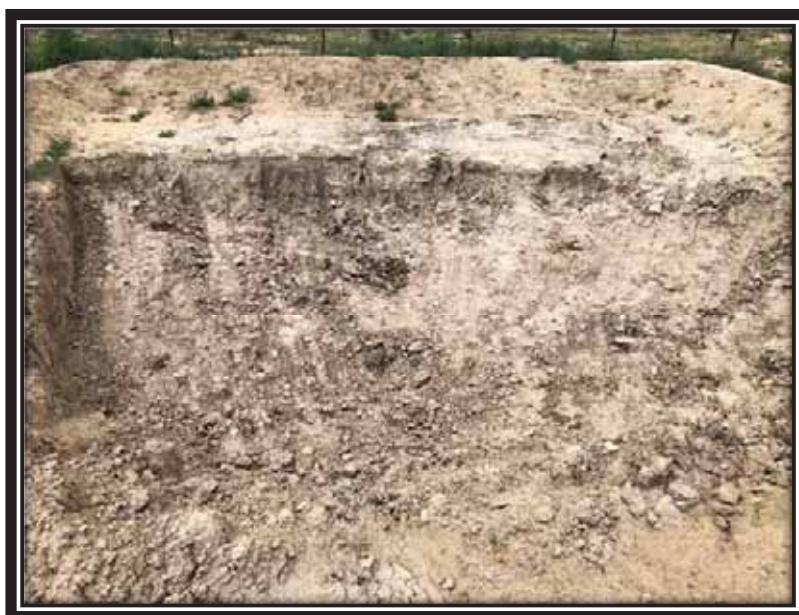
Picture 4: View of Sampling Points

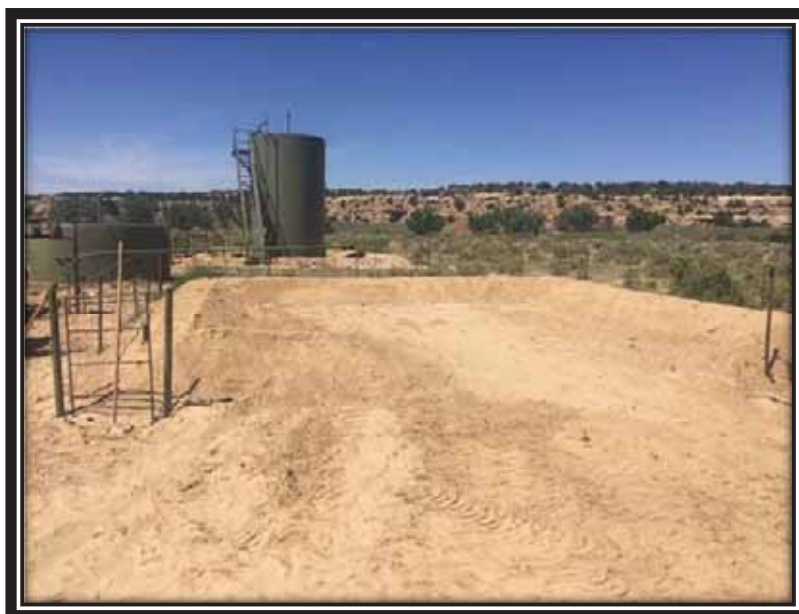
Picture 5: Subsequent Backfill of Release Site

Based on the final laboratory analytical results of the excavation at the location, GRO, DRO, ORO, BTEX, and chlorides were below the applicable NMOCD and JOGA Closure Criteria for Soils Impacted by a Release. DJR Operating will place a tank back in operation at the location; therefore, reclamation will not be required at this time. Envirotech recommends **No Further Action** regarding the subject release site.

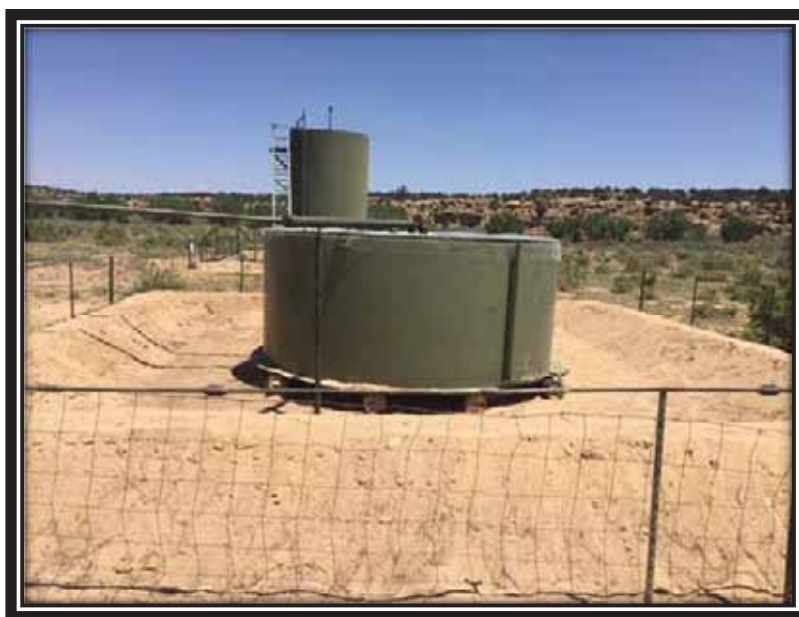
Picture 6: View of New In-Service Tank
