## Release Notification

| Site Name Lambe 2C | Site Type Gas Well |

On December 17, 2018, Hilcorp personnel discovered a pinhole leak due to corrosion in the bottom of a condensate tank. The leak resulted in approximately 97 barrels (bbls) of condensate draining onto the ground and infiltrating the subsurface. The release was contained within the earthen berm, but no liquids were recovered. The defective tank was immediately shut-in, drained of remaining liquids, and taken out of service. The release was reported to the New Mexico Oil Conservation Division (NMOCD) by Hilcorp on a Form C-141 Release Notification and Corrective Action Form dated December 24, 2018.

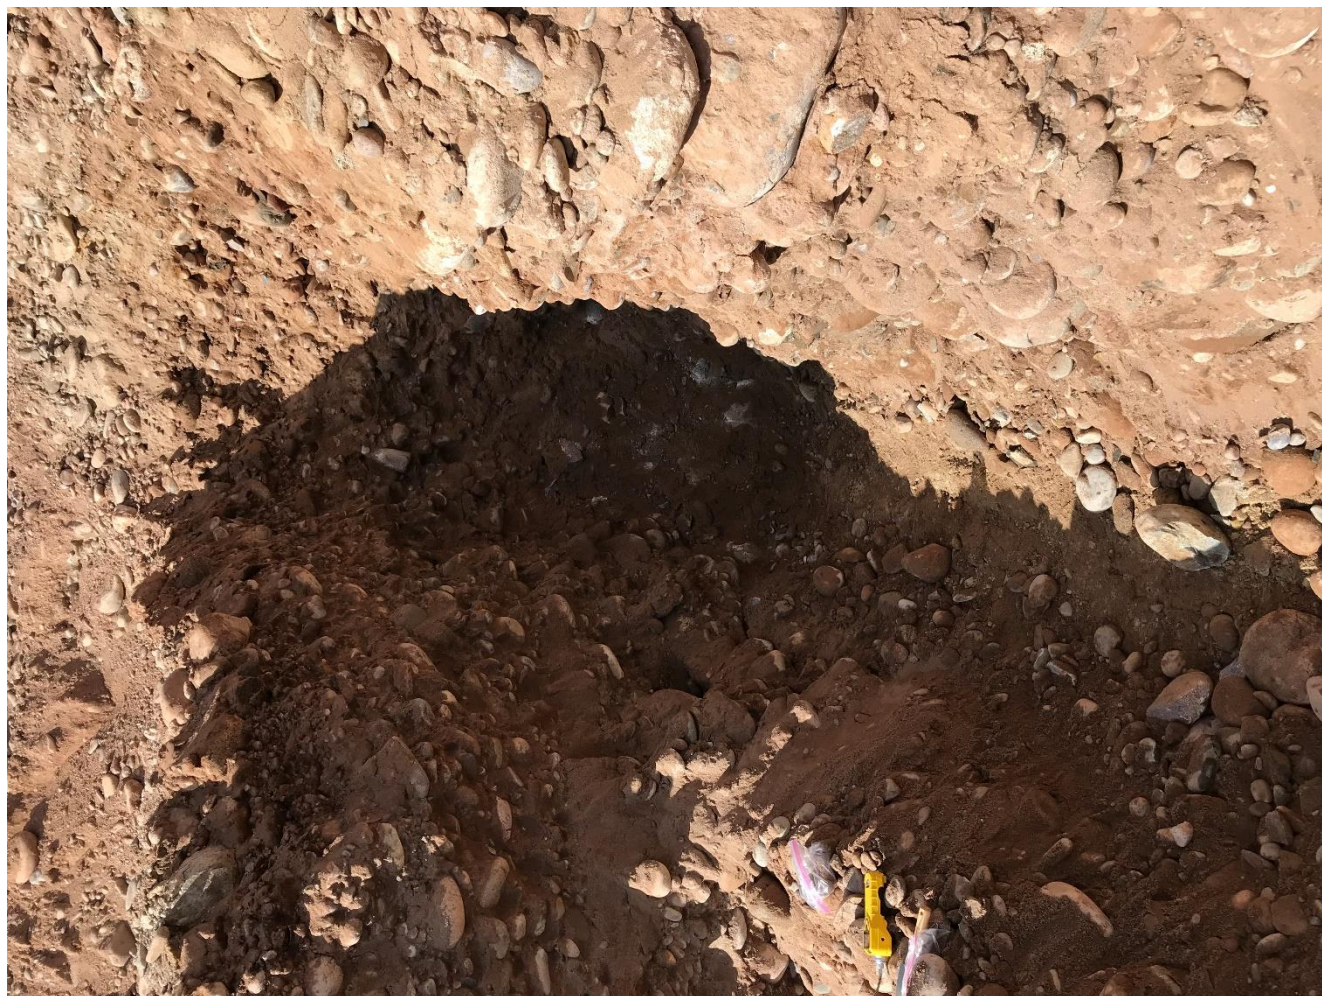
**Cobbles in the subsurface**

The geology at the Site consists of dark reddish-brown, dry, silty sand to approximately 14 feet bgs, followed by a loose, dry, sand and gravel with cobbles greater than eight inches in diameter to approximately 25 feet bgs. From approximately 25 feet to 35 feet bgs, a dense, light brown, slightly moist, sandy silt was encountered. Moist sediments were encountered near 30 feet bgs, but no saturated sediments were observed and no clear water table was identified in the soil borings. LTE set the groundwater monitoring wells with screened intervals corresponding to the moist intervals and the depth of the excavation where potential groundwater was previously observed.

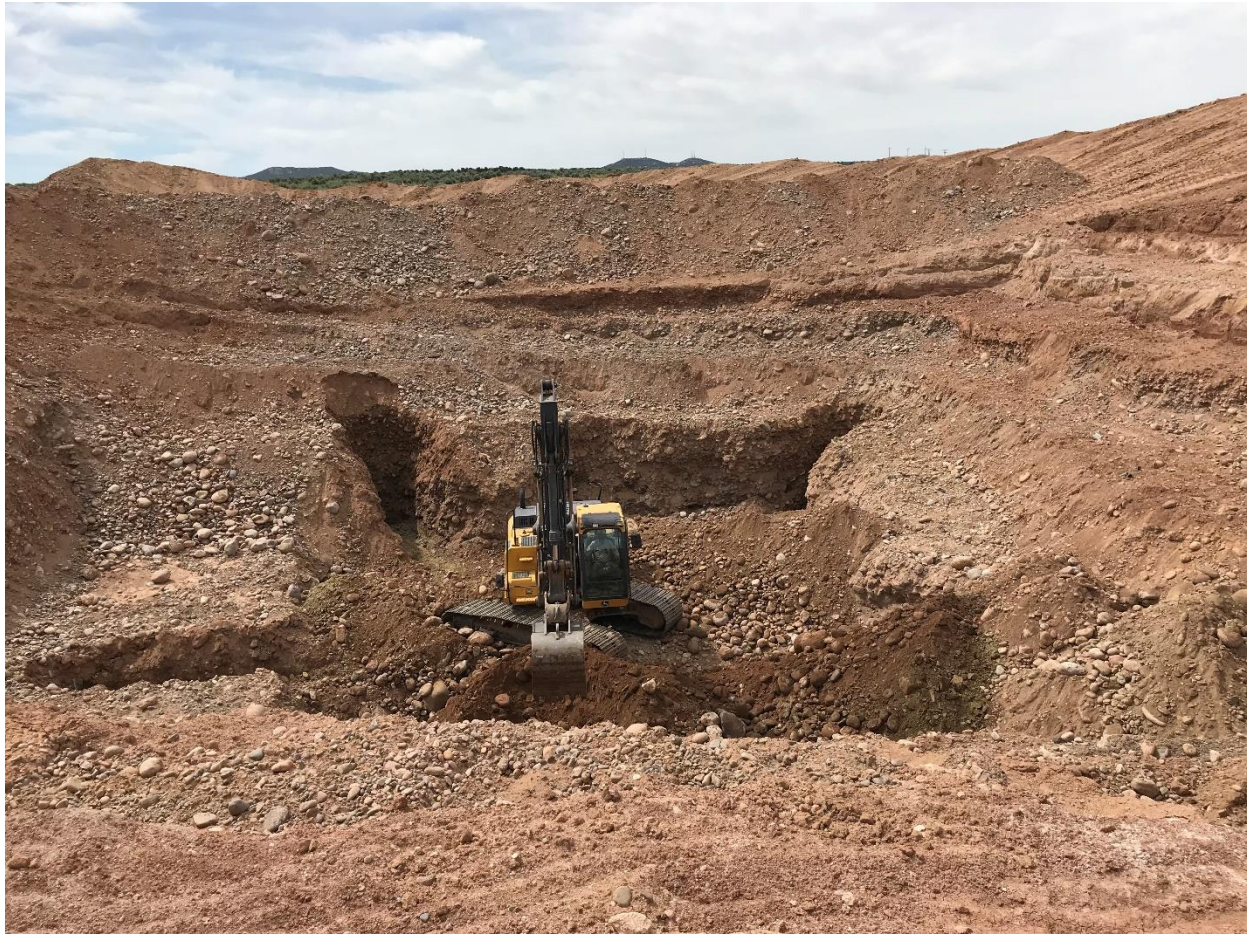
### Trenching Activities
