Release Notification

Site Name: Rosa Unit 169D	Site Type: Well Site
Date Release Discovered: 7/15/2019	API# (if applicable) 30-03930755

Cory Smith
New Mexico Oil Conservation Division
1000 Rio Brazos Road
Aztec, NM 87410
RE: Rosa Unit 240A Release (nCS1920539720)

LOGOS Operating, LLC – Rosa Unit 169D
 30-039-30755
 Sampling Diagram
 Unit J, Section 3, T31N, R6W
 Rio Arriba County, NM

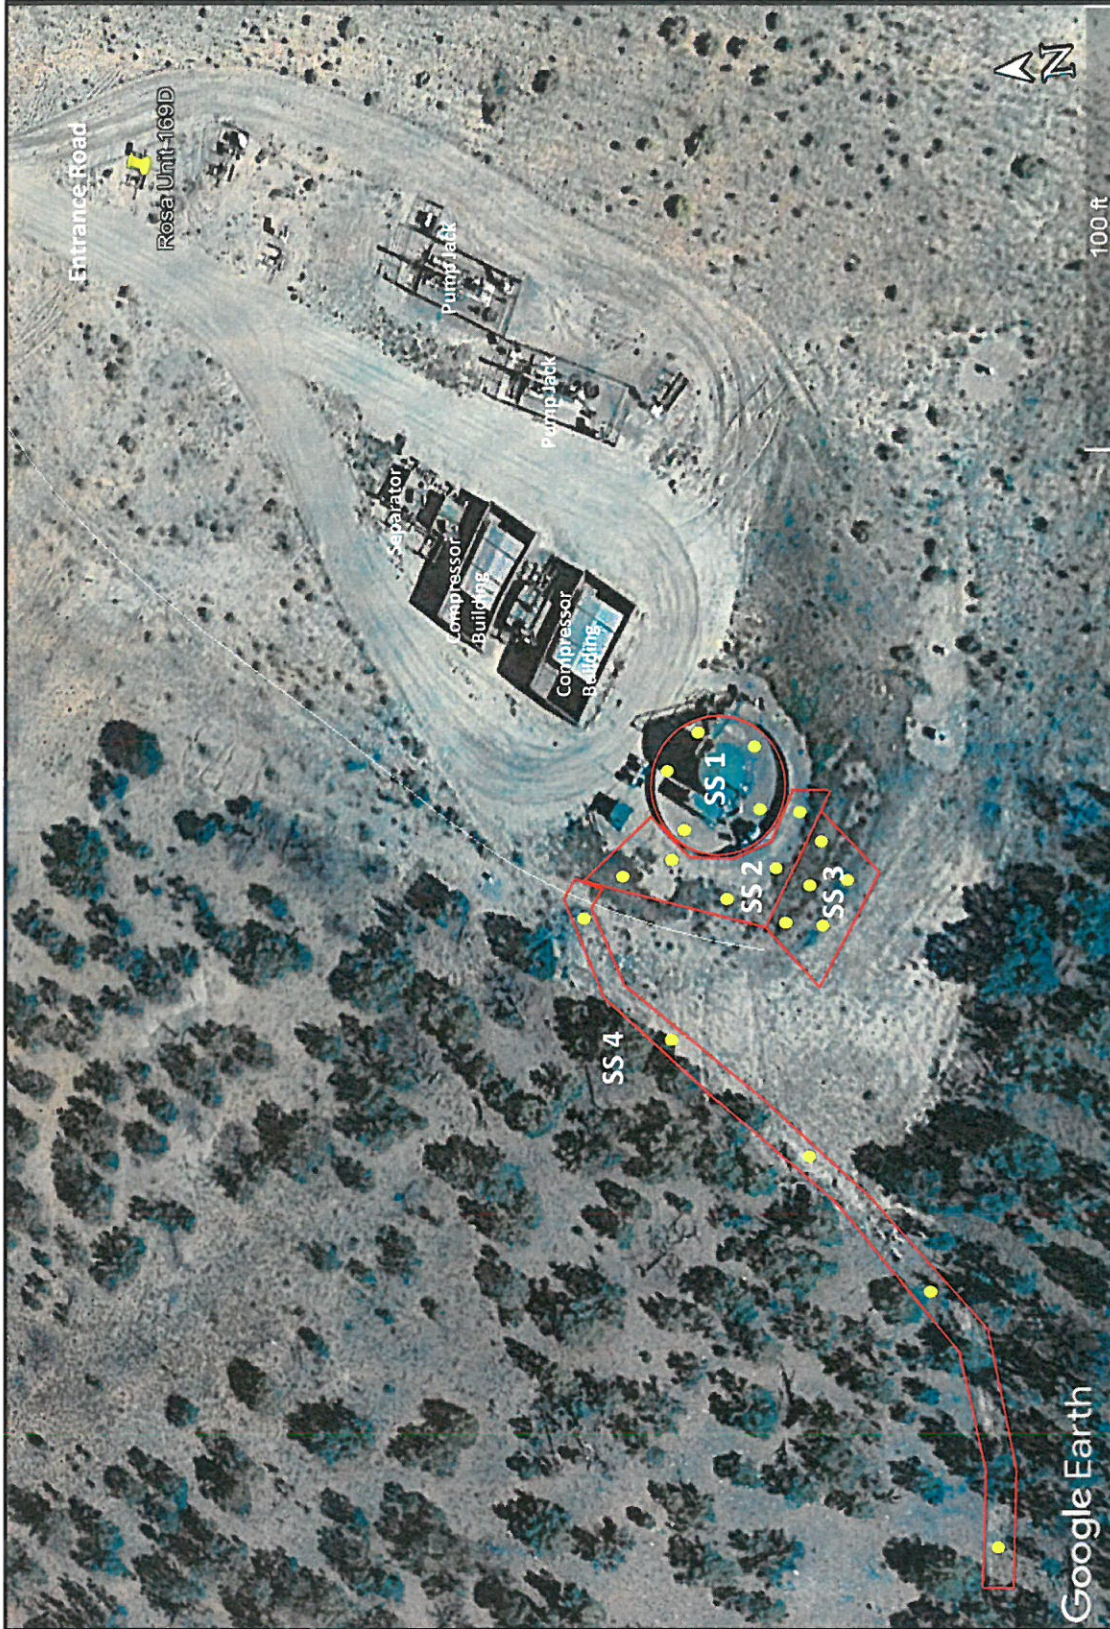
The release at the Rosa Unit 169D was discovered on July 15, 2019 by BLM Inspectors. LOGOS Operating (LOGOS) was notified on July 16, 2019 and immediately shut in the well and dispatched a water truck to pull the fluid from the affected area. Approximately 327 bbls were released from the rock basket on the produced water tank. The secondary containment is not lined and fluid began seeping under the metal berm and left the location area on the southwest corner of the pad. The fluid followed the natural drainage down towards the lake for approximately 180'. LOGOS was able to recover 35 bbls of fluid from the secondary containment. Due to the sensitive archaeological area, LOGOS requested the services of La Plata Archaeological Consultants to conduct a survey to identify any possible impact to archaeological sites. The survey confirmed that there were no cultural resources impacted by this release. There is a cathodic well on the well pad that depicts groundwater at 113' below surface. LOGOS sampled the area on October 08, 2019 with the witness of NM Oil Conservation Division and BLM. The analytical results showed that all constituents were under the Table I thresholds and no further remediation was required. Please see attached analytical results
