Pit, Closed-Loop System, Below-Grade Tank, or
Proposed Alternative Method Permit or Closure Plan Application

1.
Operator: BPX ENERGY INC. (formerly BP America Production Co.) OGRID #: 778
Address: 1199 Main Ave., Suite 101, Durango, CO 81301
Facility or well name: GALLEGOS CANYON UNIT 189
API Number: 3004507678 OCD Permit Number: _____
U/L or Qtr/Qtr E Section 36.0 Township 29.0N Range 13W County: San Juan County
Center of Proposed Design: Latitude 36.68301 Longitude -108.16285 NAD: ☐ 1927 ☒ 1983
Surface Owner: ☐ Federal ☒ State ☐ Private ☐ Tribal Trust or Indian Allotment

BELOW-GRADE TANK CLOSURE PLAN

GCU # 189 – Tank ID: A

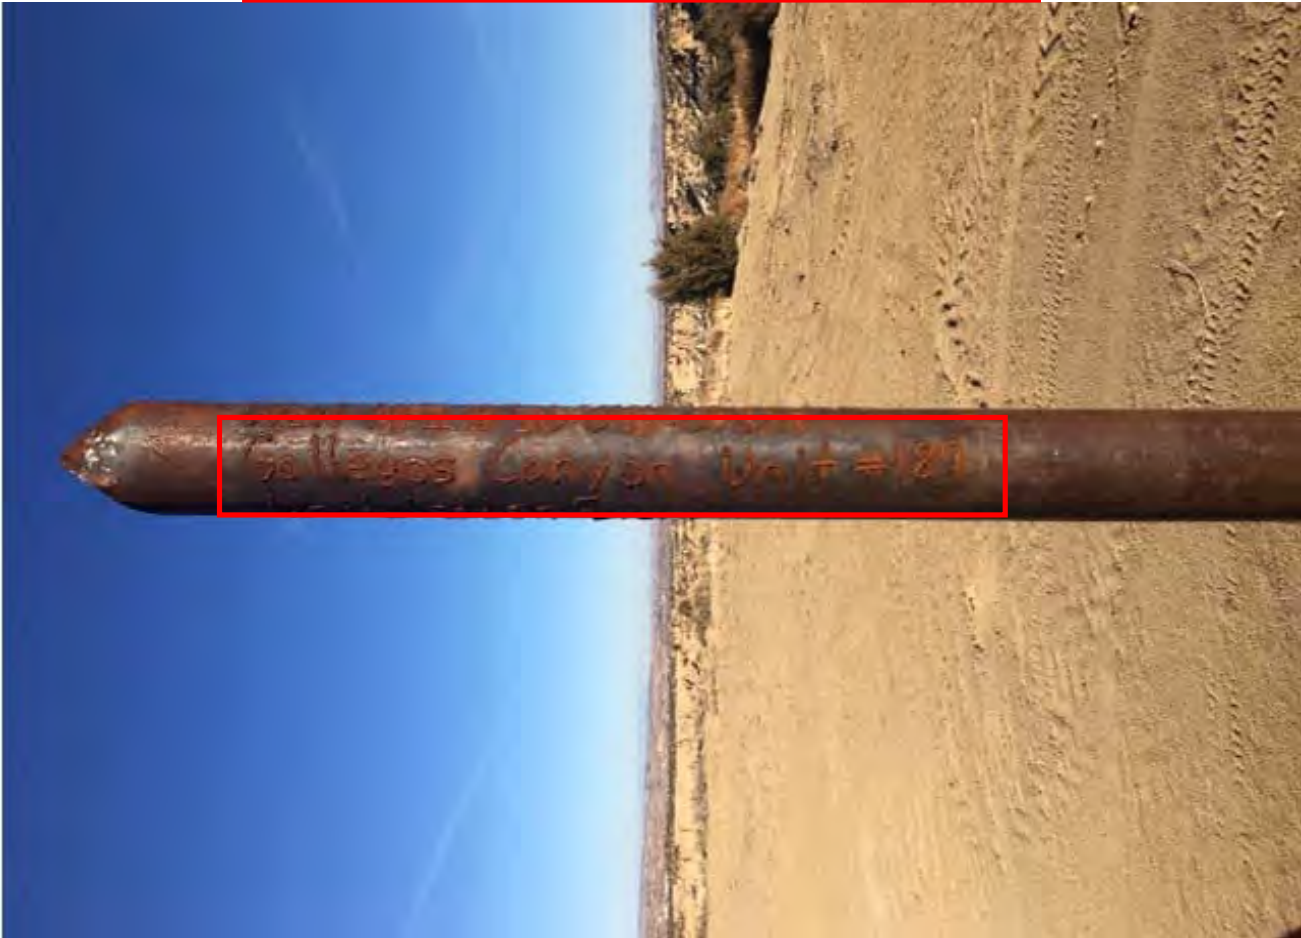
GALLEGOS CANYON UNIT 189

SITE OBSERVATIONS: LOST INTEGRITY OF EQUIPMENT: YES <u>NO</u> EXPLANATION - _____ APPARENT EVIDENCE OF A RELEASE OBSERVED AND/OR OCCURRED: <u>YES</u> / NO EXPLANATION: EAST QUADRANT OF BGT FOOTPRINT PERIMETER ONLY EQUIPMENT SET OVER RECLAIMED AREA: YES <u>NO</u> EXPLANATION - _____ OTHER: NMOC REP. PRESENT TO WITNESS COMPOSITE & GRAB SAMPLING. GAS WELL HAS BEEN PLUGGED & ABANDONED (P&A). IMPORTED GRAVEL DIRECTLY BENEATH BGT ONLY. IMPACTED SOILS/BEDROCK QUANTITY APPEARS MINIMAL. EXCAVATION DIMENSION ESTIMATION: _____ ft. X _____ ft. X _____ ft. EXCAVATION ESTIMATION (Cubic Yards): _____ DEPTH TO GROUNDWATER: >100' NEAREST WATER SOURCE: >1,000' NEAREST SURFACE WATER: < 300' NMOC TPH CLOSURE STD: 100 ppm		
SITE SKETCH BGT Located: off / <u>on</u> site PLOT PLAN circle: <u>attached</u>		OVM CALIB. READ: = 102.4 ppm RF=1.00 OVM CALIB. GAS = 100 ppm TIME: 7:00 am/pm DATE: 09/19/19
		MISCELL. NOTES PO #: AFE #: SIO #: 190040007672 GL #: 745277 Permit date(s): 06/14/10 OCD Appr. date(s): 01/24/17 Tank ID: A OVM = Organic Vapor Meter ppm = parts per million BGT Sidewalls Visible: <u>Y</u> / N BGT Sidewalls Visible: Y / N BGT Sidewalls Visible: Y / N Magnetic declination: 10° E

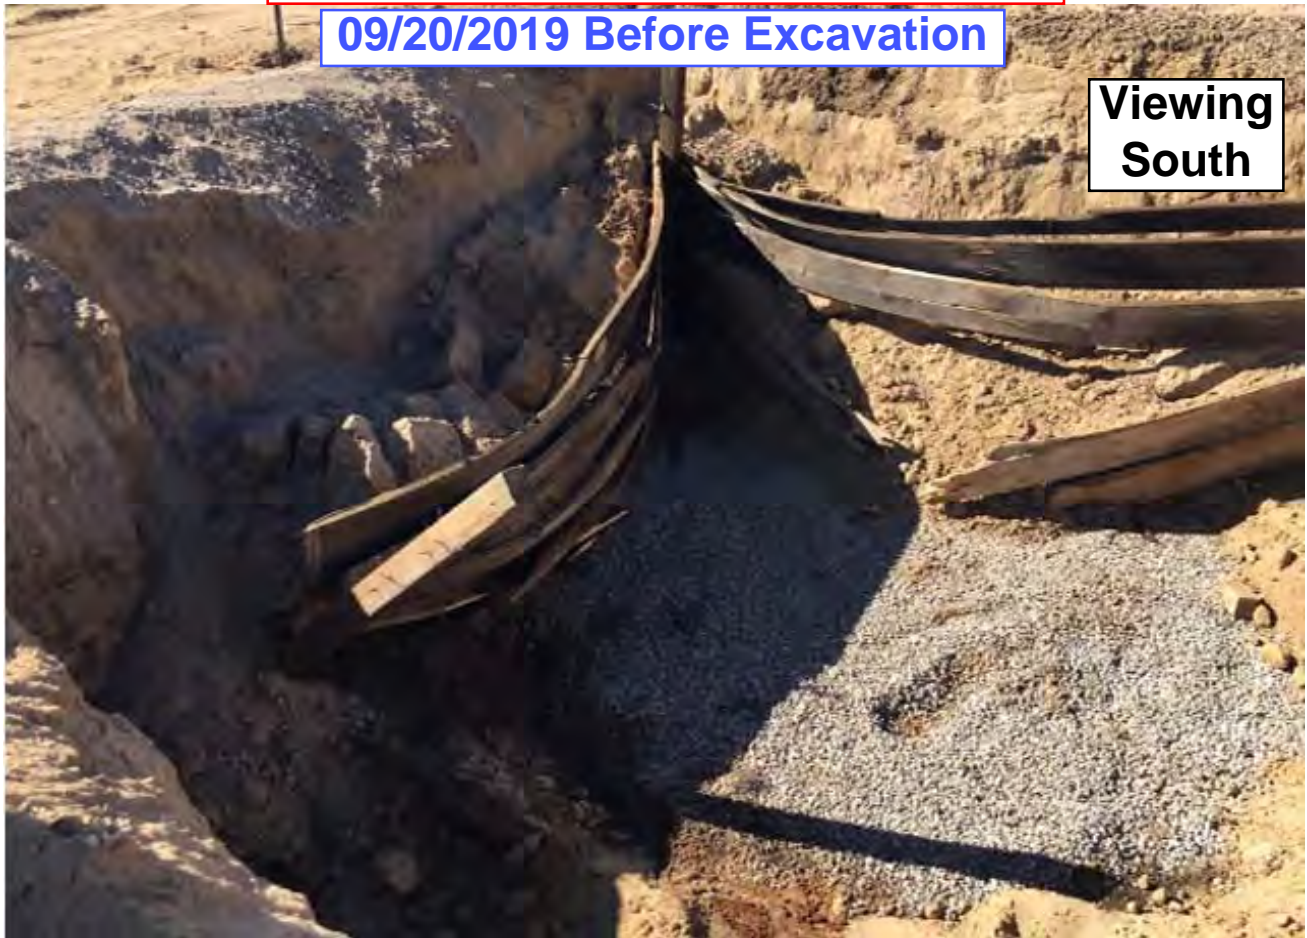
09/20/2019 Before Excavation

SITE OBSERVATIONS: LOST INTEGRITY OF EQUIPMENT: YES <u>NO</u> EXPLANATION - _____ APPARENT EVIDENCE OF A RELEASE OBSERVED AND/OR OCCURRED: <u>YES</u> NO EXPLANATION: SURFACE STAINING AT EAST SIDE OF BGT FOOTPRINT DURING INITIAL VISIT. EQUIPMENT SET OVER RECLAIMED AREA: YES <u>NO</u> EXPLANATION - _____ OTHER: NMOC D REP. NOT PRESENT TO WITNESS COMPOSITE SAMPLING. IMPACTED SOILS/BEDROCK SCRAPPED & REMOVED PRIOR TO ARRIVAL. GAS WELL HAS BEEN PLUGGED & ABANDONED (P&A). EXCAVATION DIMENSION ESTIMATION: 15 ft. X 15 ft. X 1 ft. EXCAVATION ESTIMATION (Cubic Yards): 8 - 10 DEPTH TO GROUNDWATER: >100' NEAREST WATER SOURCE: >1,000' NEAREST SURFACE WATER: < 300' NMOC D TPH CLOSURE STD: 100 ppm		
SITE SKETCH <div style="display: flex; justify-content: space-between;"> <div style="width: 45%;"> <p>BGT Located: off / <u>on</u> site</p> <p>PLOT PLAN circle: <u>attached</u></p> </div> <div style="width: 45%;"> <p>OVM CALIB. READ: = 101.5 ppm RF=1.00 OVM CALIB. GAS = 100 ppm TIME: 10:10 am/pm DATE: 10/01/19</p> </div> </div>
