BELOW-GRADE TANK CLOSURE PLAN

Northeast Blanco Unit # 319M – Tank ID: A

API #: 3004531090

Unit Letter E, Section 7, T31N, R06W

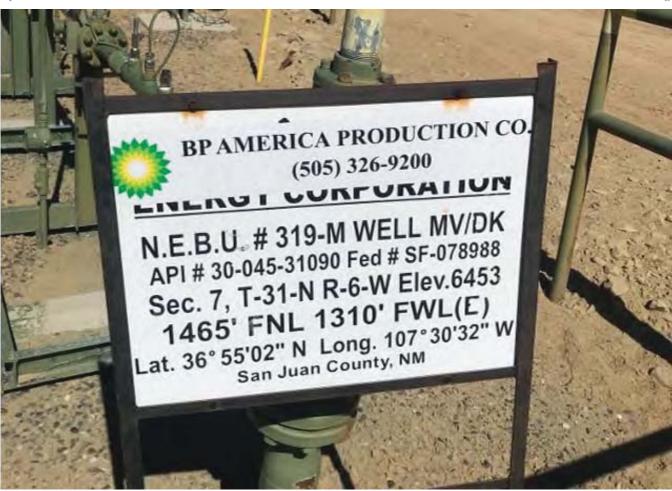
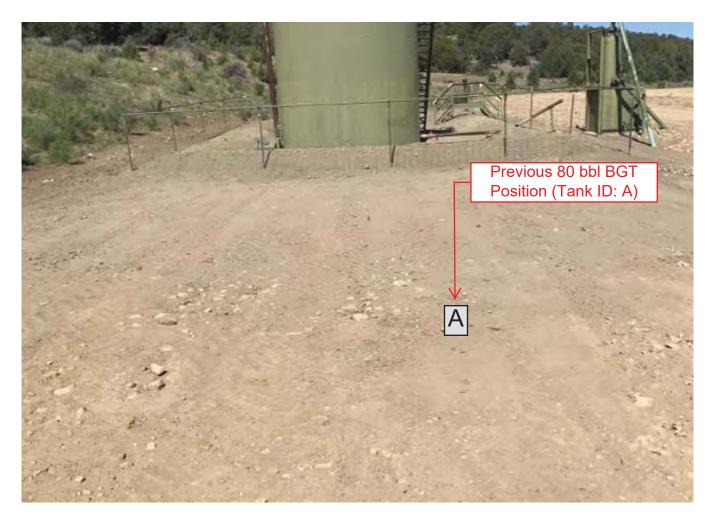
<u>Closure report on C-144 form is included & contains a photo of the current reclamation requirements completed.</u>

BGT area has been backfilled with clean, earthen material. Reclamation will be completed within the allowable timeframe and will meet the specified requirements of 19.15.17.13 NMAC.
