BGT 2 Pit, Below-Grade Tank, or  
Proposed Alternative Method Permit or Closure Plan Application

**RE: Below Grade Tank Closure Report  
Gallegos Com #5  
API #3004521306  
San Juan County, New Mexico**

Animas Environmental Services, LLC (AES) is pleased to provide the final closure report for the 45-bbl below grade tank (BGT) under operational control of Harvest Four Corners (Harvest) at the Hilcorp Gallegos Com #5 (API #3004521306), located in San Juan County, New Mexico. Tank removal and closure sampling was completed by Harvest.

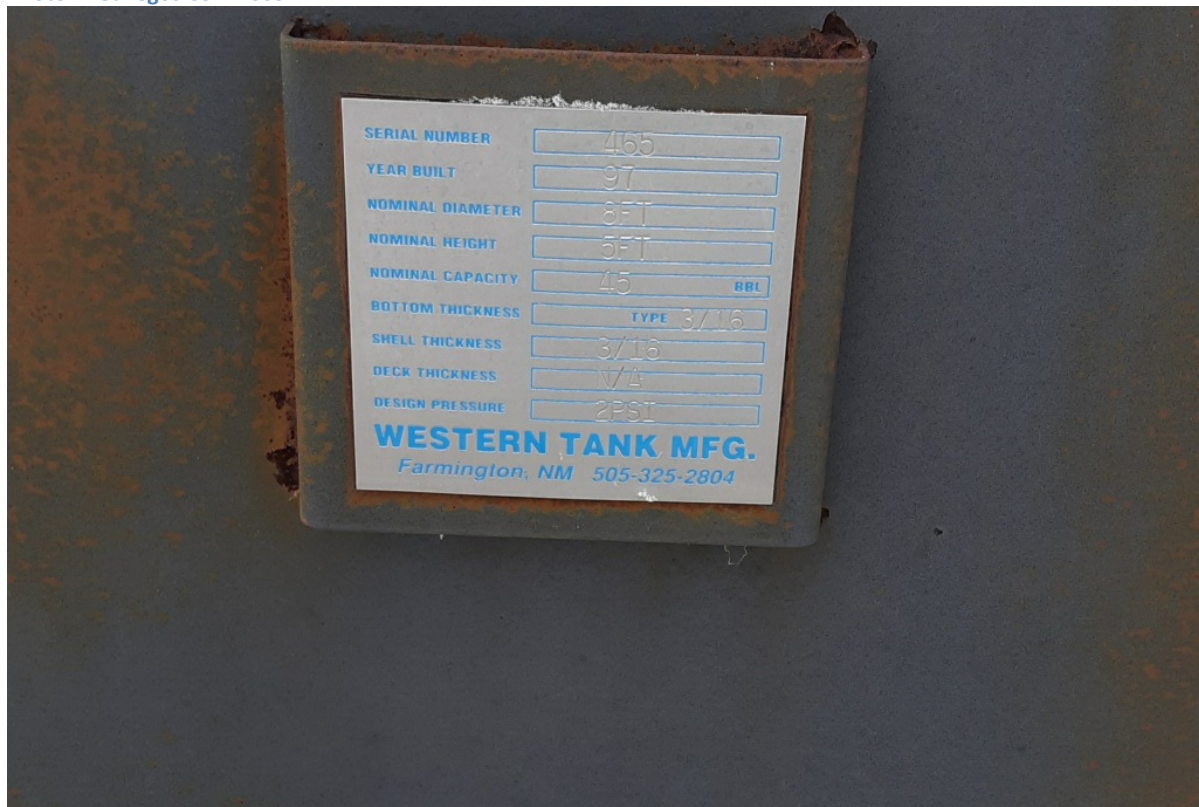
Photo 2: Gallegos Com #005.
