Release Notification and Corrective Action

Name of Company Burlington Resources Oil & Gas Company	Contact Crystal Tafoya
Address 3401 East 30th St, Farmington, NM	Telephone No. (505) 326-9837
Facility Name: Allison Unit 71	Facility Type: Gas Well

**RE: Below Grade Tank Closure and Release Report
Allison #71
San Juan County, New Mexico**

Site Name – Allison #71

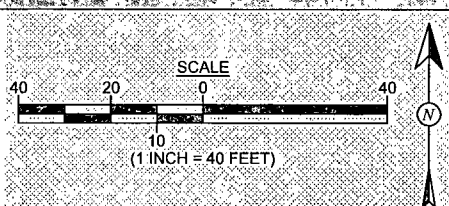
FIGURE 2

On September 24, 2012, AES personnel conducted field screening and collected five soil samples (S-1 through S-5) and one 5-point composite (SC-1) from below the BGT. Soil samples S-1 through S-5 were collected from approximately 0.5 feet below the former BGT for field screening of volatile organic compounds (VOCs) and total petroleum hydrocarbons (TPH). Soil sample SC-1 was field screened for chlorides and submitted for confirmation laboratory analysis. Soil sample locations are included on Figure 2.

Field screening for VOCs via OVM showed readings ranging from 0.5 ppm in SC-1 up to 1.7 ppm in S-4. Field TPH concentrations ranged from 38.1 mg/kg in S-4 up to 51.4 mg/kg in S-1. The field chloride concentration in SC-1 was 120 mg/kg. Field screening results are summarized in Table 1 and presented on Figure 2. The AES Field Screening Report is attached.

Laboratory analytical results showed that the benzene and total BTEX concentrations in SC-1 were below the laboratory detection limits of 0.050 mg/kg and 0.25 mg/kg, respectively. The laboratory chloride concentration was 98 mg/kg. Laboratory analytical results are summarized in Table 2 and included on Figure 2. Laboratory analytical reports are attached.

**AERIAL SITE MAP
BELOW GRADE TANK CLOSURE
SEPTEMBER 2012**

NMOCD action levels for BGT closures are specified in New Mexico Administrative Code (NMAC) 19.15.17.13E. Benzene and total BTEX concentrations in SC-1 were below the NMOCD action levels of 0.2 mg/kg and 50 mg/kg, respectively. Field TPH concentrations were below the NMOCD action level of 100 mg/kg in each sample (S-1 through S-5), and the chloride concentration in SC-1 was below the NMOCD action level of 250 mg/kg. Based on field screening and laboratory analytical results for benzene, BTEX, TPH, and chlorides, no further work is recommended.
