Release Notification and Corrective Action

Name of Company Burlington Resources, a Wholly Owned Subsidiary of ConocoPhillips Company	Contact Ashley Maxwell	
Address 3401 East 30th St, Farmington, NM	Telephone No. (505) 324-5169	
Facility Name: San Juan 27-4 Unit 36A	Facility Type: Gas Well	
Surface Owner Forest	Mineral Owner Federal	API No. 3003922377 SF-079527

**RE: Initial Release Assessment and Final Excavation Report
San Juan 27-4 Unit #36A
Rio Arriba County, New Mexico**

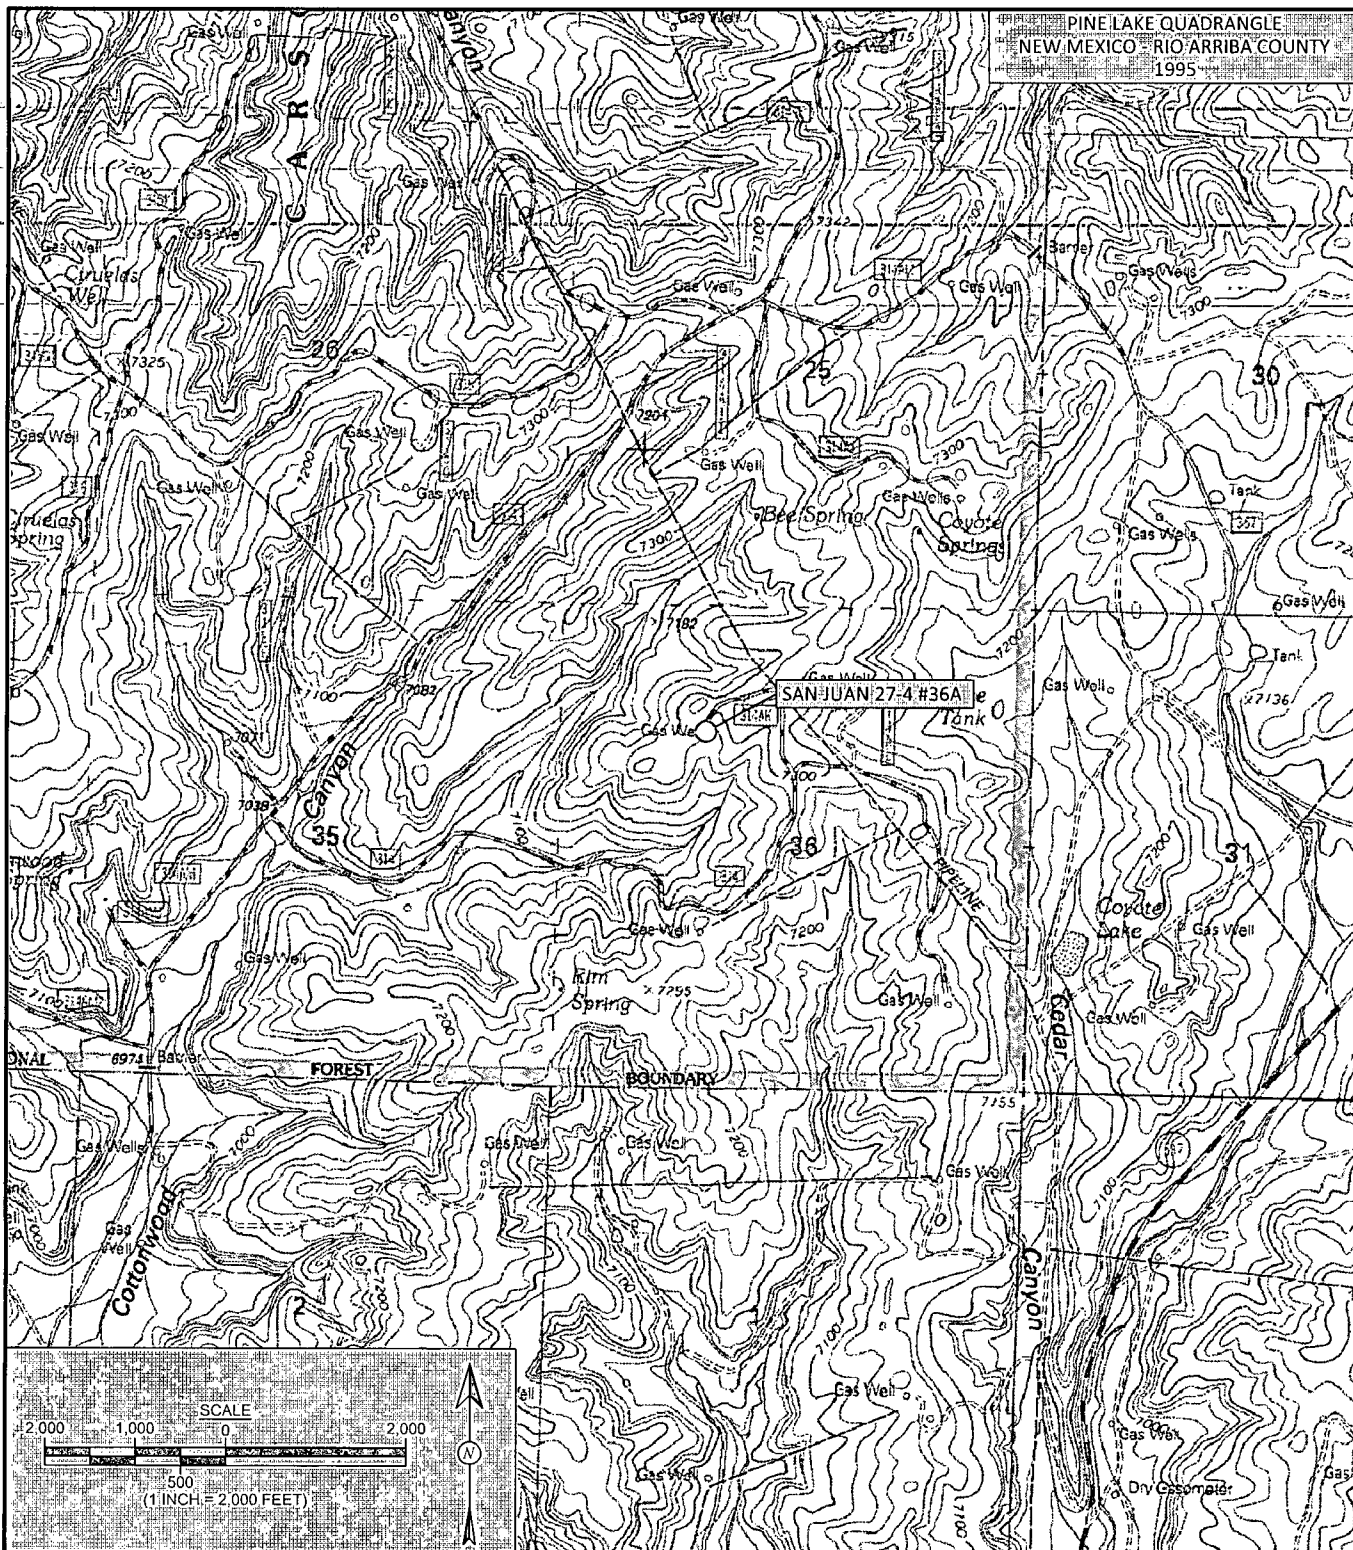
FIGURE 1

TOPOGRAPHIC SITE LOCATION MAP

ConocoPhillips
SAN JUAN 27-4 #36A
RIO ARriba COUNTY, NEW MEXICO
SE $\frac{1}{4}$ NW $\frac{1}{4}$, SECTION 36, T27N, R4W
N36.53299, W107.20641
