Release Notification and Corrective Action

**RE: Below Grade Tank Closure Report
Howell D #4
San Juan County, New Mexico**

**AERIAL SITE MAP
BELOW GRADE TANK CLOSURE
NOVEMBER 2012**

ConocoPhillips
HOWELL D #4

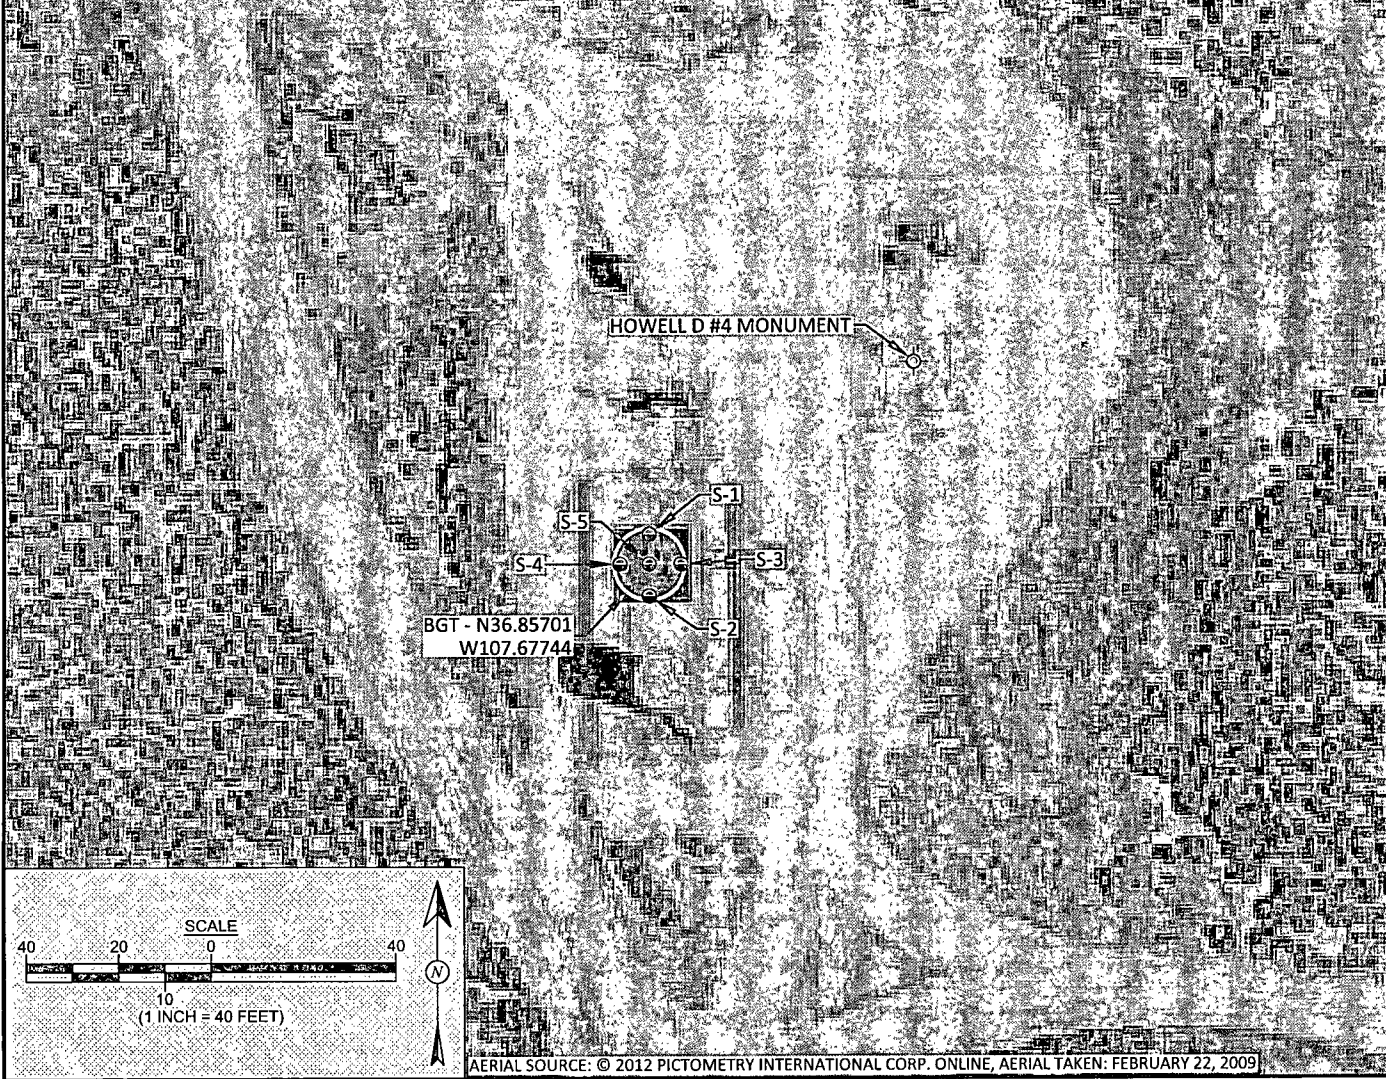
FIGURE 2

Field Screening Results				
Sample ID	Date	OVM-PID (ppm)	TPH (mg/kg)	Chlorides (mg/kg)
NMOC ACTION LEVEL		—	100	250
S-1	11/30/12	5.4	30.1	NA
S-2	11/30/12	5.9	27.8	NA
S-3	11/30/12	4.8	28.9	NA
S-4	11/30/12	3.1	26.6	NA
S-5	11/30/12	2.0	26.6	NA
SC-1	11/30/12	3.7	NA	40

SC-1 IS A 5-POINT COMPOSITE SAMPLE OF S-1 THROUGH S-5. NA - NOT ANALYZED

Laboratory Analytical Results						
Sample ID	Date	Benzene (mg/kg)	Total BTEX (mg/kg)	TPH - GRO (mg/kg)	TPH - DRO (mg/kg)	Chlorides (mg/kg)
NMOC ACTION LEVEL		0.2	50	100		250
SC-1	11/30/12	<0.050	<0.25	NA	NA	32

On November 30, 2012, AES personnel conducted field screening and collected five soil samples (S-1 through S-5) and one 5-point composite (SC-1) from below the BGT. Soil samples were collected from approximately 0.5 feet below the former BGT for field screening of volatile organic compounds (VOCs) and total petroleum hydrocarbon (TPH). Soil sample SC-1 was field screened for VOCs and chloride and was submitted for confirmation laboratory analysis. Soil sample locations are included on Figure 2.

Field screening readings for VOCs via OVM ranged from 2.0 ppm in S-5 up to 5.9 ppm in S-2. Field TPH concentrations ranged from 26.6 mg/kg in S-4 and S-5 up to 30.1 mg/kg in S-1. The field chloride concentration in SC-1 was 40 mg/kg. Field screening results are summarized in Table 1 and presented on Figure 2. The AES Field Screening Report is attached.

Laboratory analytical results reported benzene and total BTEX concentrations in SC-1 as less than 0.050 mg/kg and 0.25 mg/kg, respectively. The laboratory chloride concentration was 32 mg/kg. Laboratory analytical results are summarized in Table 2 and included on Figure 2. Laboratory analytical reports are attached.
